Photographic Review of the Exit Hole at the Pentagon

Prepared for the August 30, 2017 9/11 Truth and Other Deep State Crimes Teleconference

> Wayne H. Coste, PE Truth Outreach, Inc.

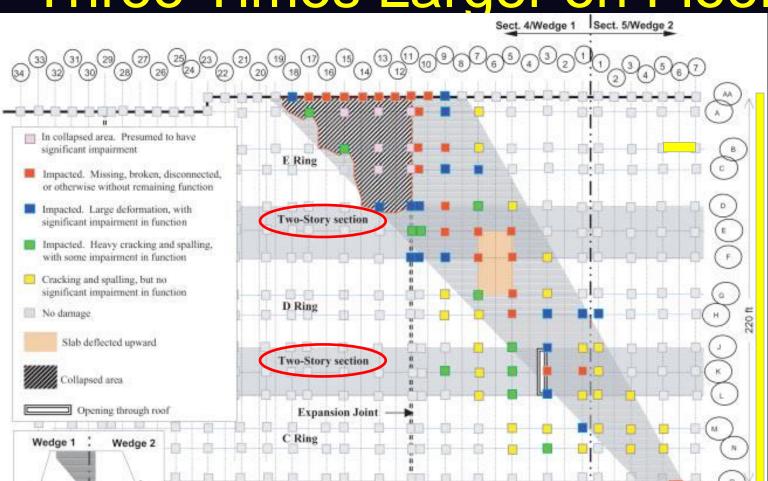
ASCE Depicts Columns Three Times Larger on Floor Plan

At the scale shown, each column is represented as 5.4 feet square

Across the front, space between the columns appears to be slightly smaller than the width of the column shown.

ASCE report says most columns on the first floor are 21" square (or 1.75 ft)

This is 3.08 times larger than if they were drawn to scale.

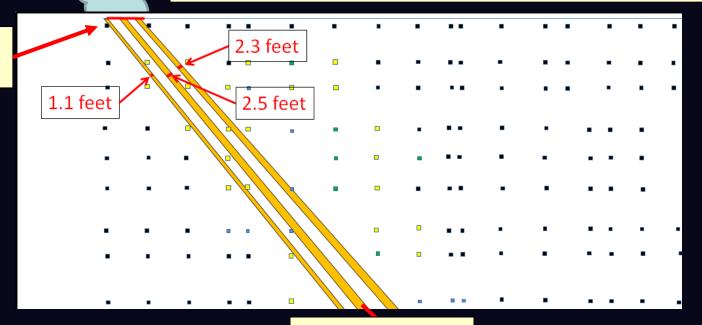
Estimated Width of Paths (With Impaired Columns Shown)

With the column size in the ASCE Report adjusted to the correct 21 inch by 21 inch, a graphical analysis shows three paths without obstruction (see Appendix)

Debris in AE Drive continues at same angle as internal paths

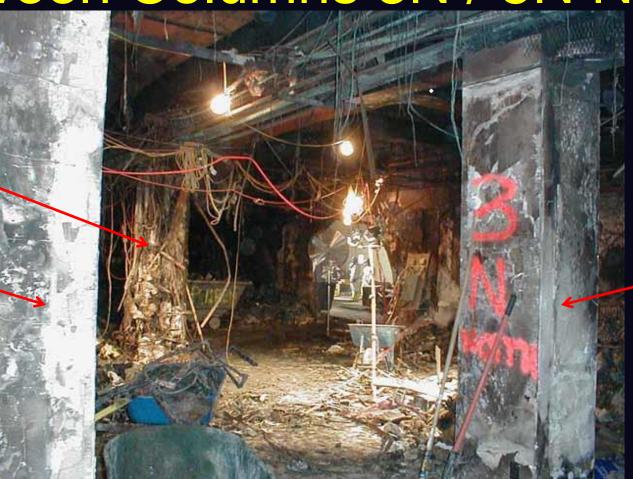
Exit Hole From the Inside — Between Columns 3N / 5N North

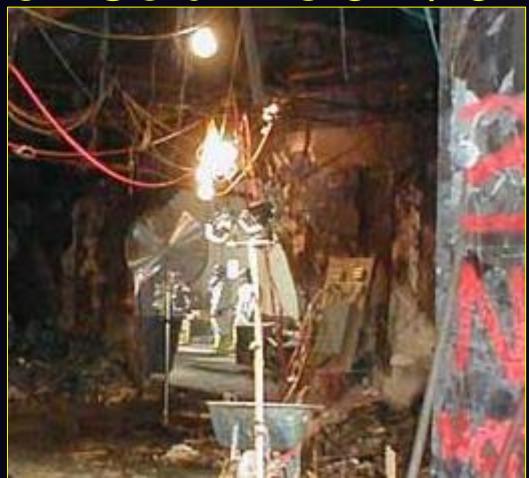
Exit Hole From the Inside — Between Columns 3N / 5N North

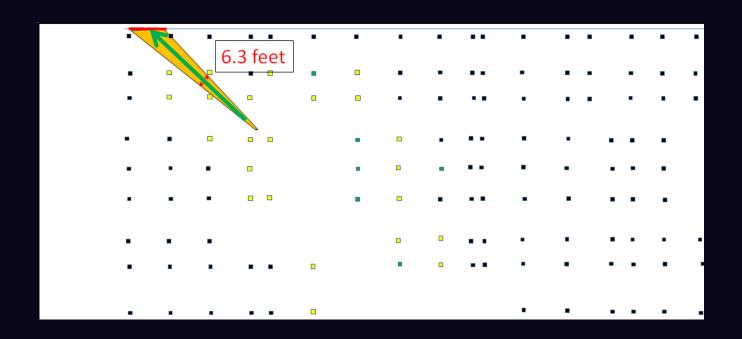
Columns 3M and 3N Spacing Estimated at 6.3 ft

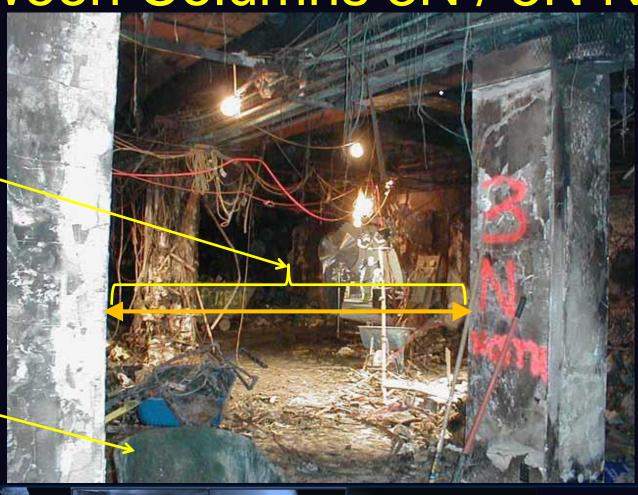
Exit Hole From the Inside – Between Columns 3N / 5N North

Estimated 6.3 foot distance

Wheel Barrow (~20")

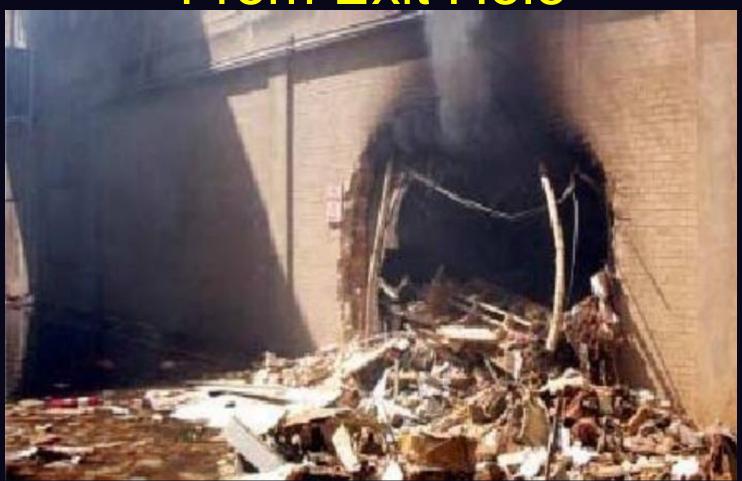
Early Photo with Smoke Rising From Exit Hole

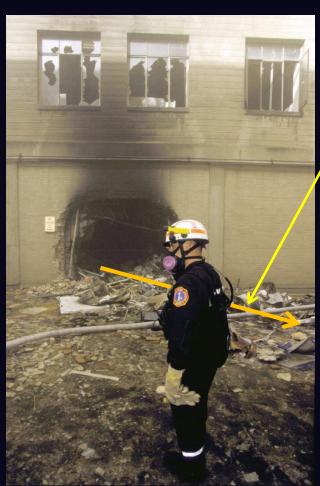
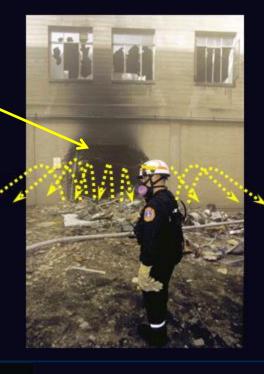
Early Photo (Probably 9/12)

Debris path continues in AE Drive at same angle as the internal path between the columns (see Slide 5)

Internally detonated
explosives would have
created a symmetric
debris pattern - not a
debris path at same angle
as the internal path

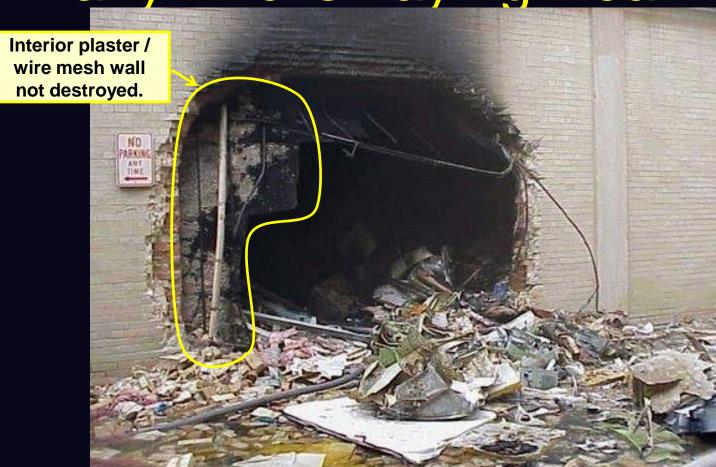
Debris Outside of Exit Hole Many Bricks Laying Near Wall

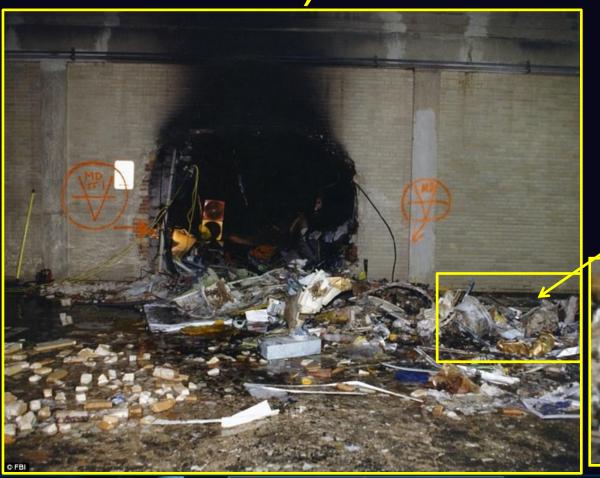
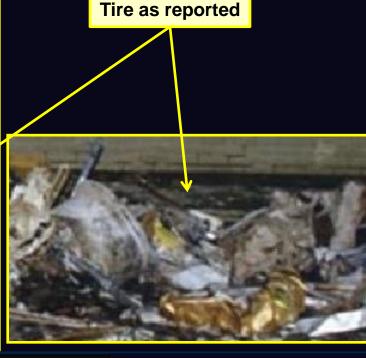
Large Parts (With Substantial Mass) Outside Exit Hole

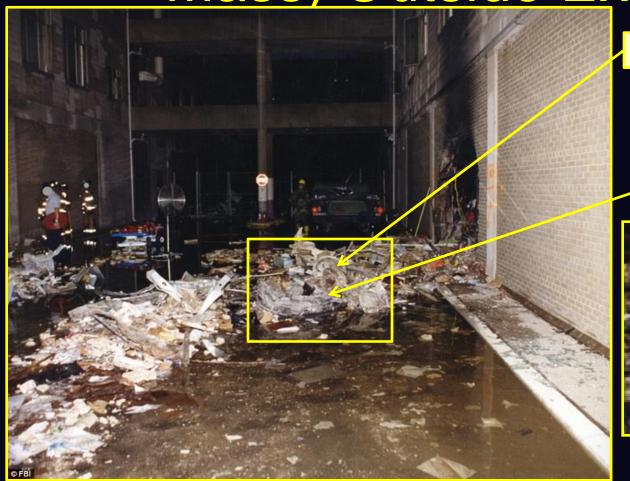
Large Parts (With Substantial Mass) Outside Exit Hole

Landing gear parts as reported

Tire as reported

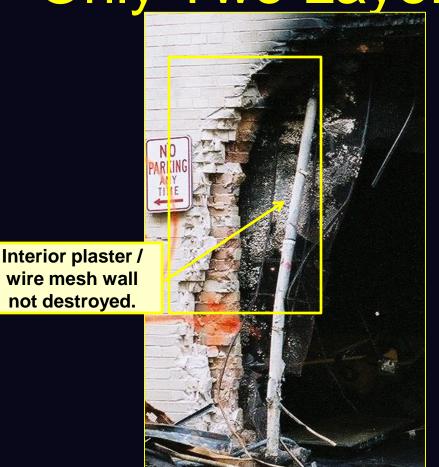
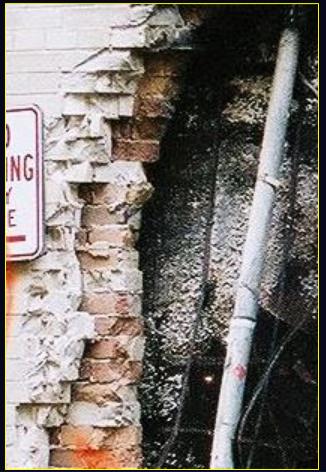
- "The first story at AE Drive is brick infilled in the concrete frame, with no windows." [Page 6]
- Columns on either side of the "C-Ring Exit Hole" are approximately 20 feet apart.
 - No significant intermediary support observed between the columns
 - Between column 5 'O' and 7 'O' in Wedge 2

Wall Appears to Be Only Two Layers of Bricks Thick

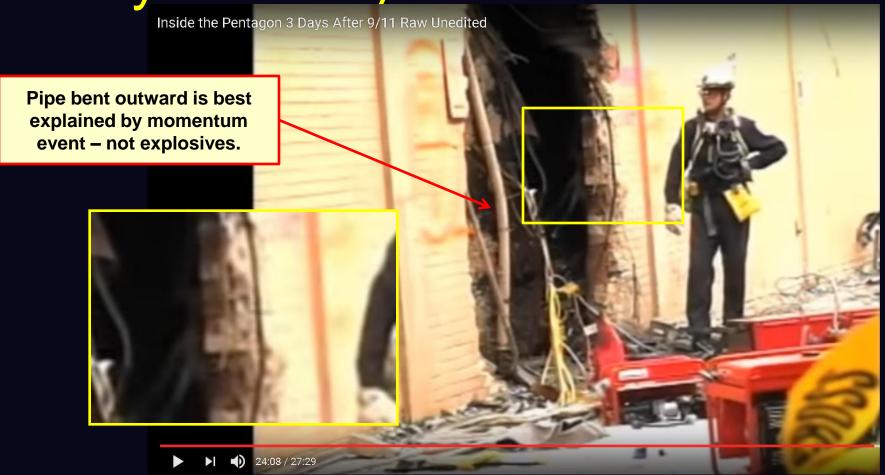
Wall Appears to Be Only Two Layers of Bricks Thick

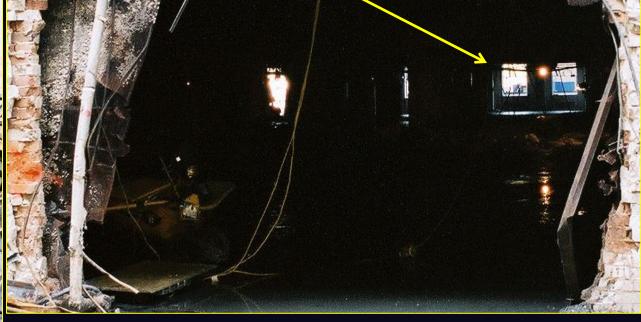
Windows in outer "E" Ring wall (Note: no intervening interior walls)

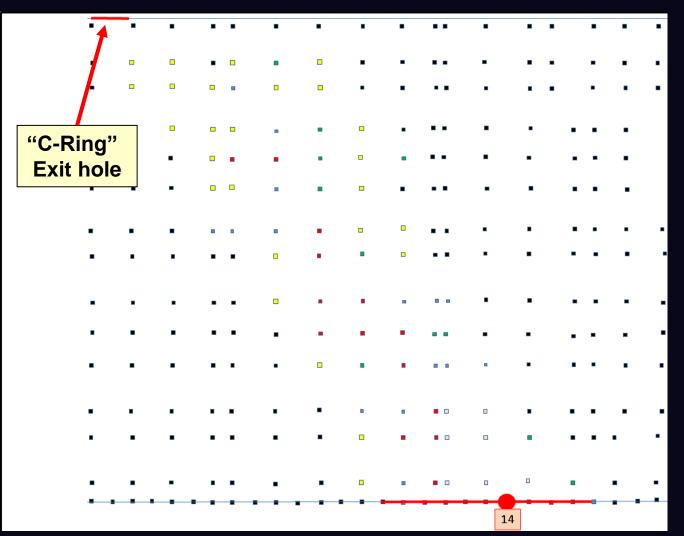
All Columns Shown

(with ASCE Colors)

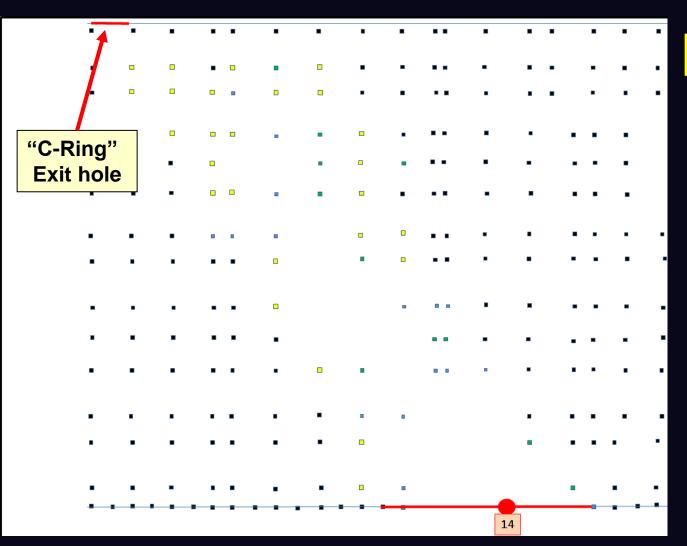
Destroyed Columns Removed

(Pink and Red)

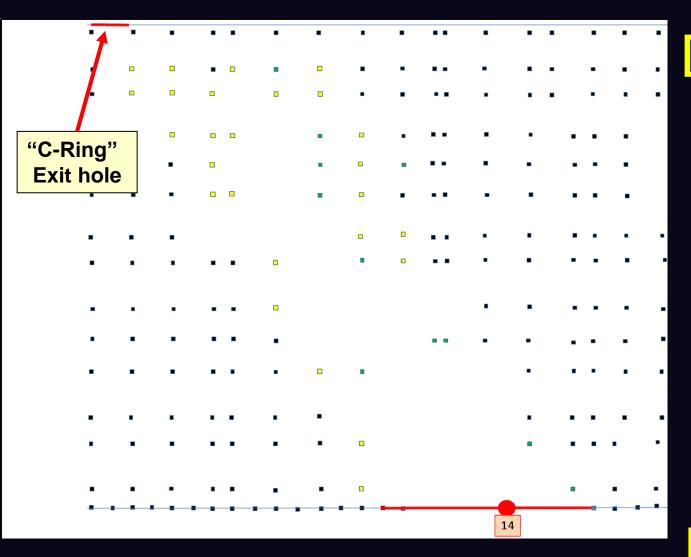
Destroyed and Impaired Columns Removed

(Pink, Red, Blue)

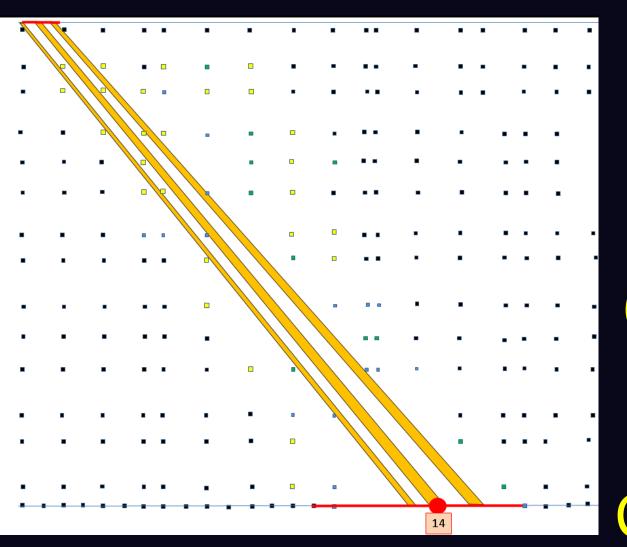
Paths Through Columns

(Includes Effect of Impaired Columns)

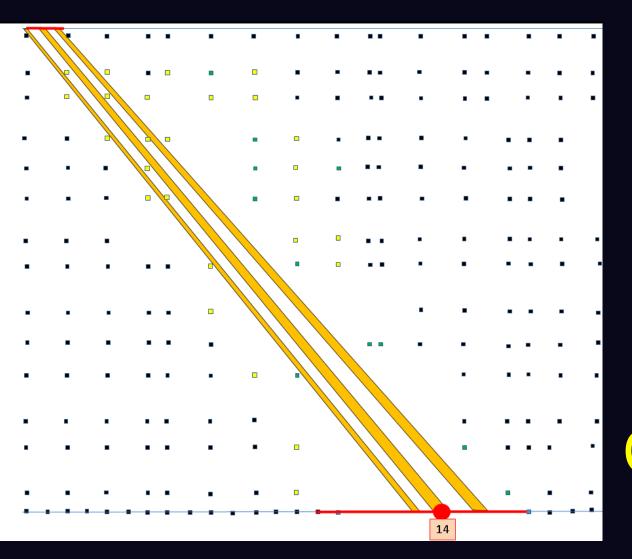
Paths Through Columns

(Without Impaired Columns)
