Analysis of Pentagon Plane Approach and Impact

Prepared for the October 25, 2017 9/11 and Other Deep State Crimes Teleconference

Wayne H. Coste, PE Truth Outreach, Inc.

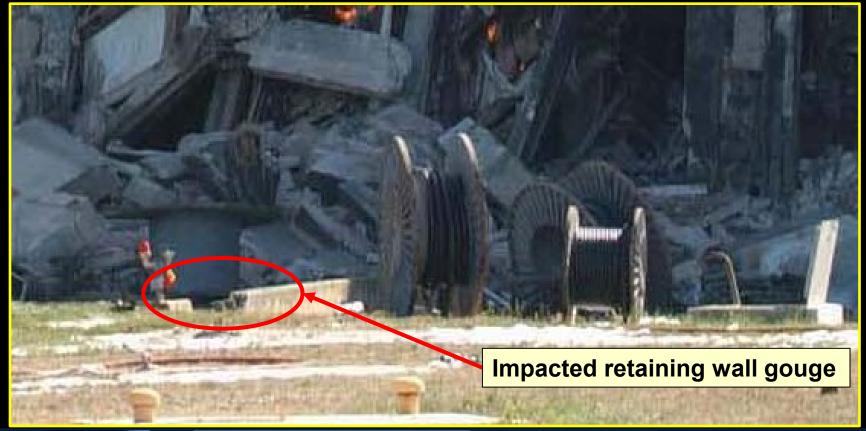
Photo Taken Approximately Perpendicular to Column 14

Retaining Wall Gouge

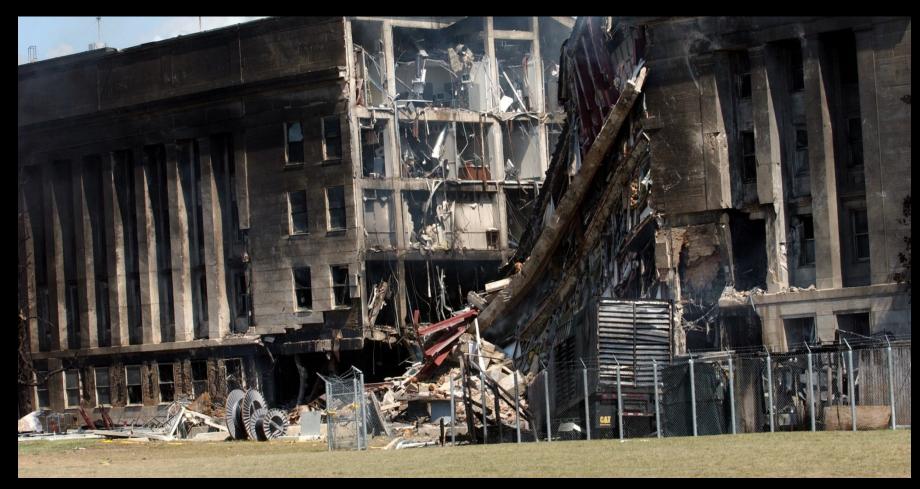
Three Spools Knocked Toward Wall

- The wire spools rolled
 - From their storage area between the generator trailer and the retaining wall
 - Rolled in the wake of the plane, or
 - Moved because of impact with the plane
 - They came to their final post-impact location after the plane had passed
- There is no photographic record showing two of the seven wire spools
 - Suggests their destruction upon impact, or
 - Rolling into the Pentagon opening in first floor

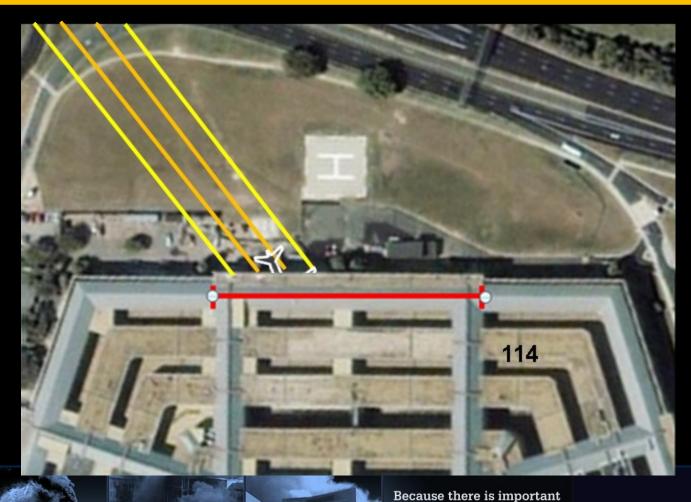
Left Wing Impacts Column 9AA

Column 9AA bowed, not severed, because energy in the wing spar dissipated by impact with Columns 10, 11 and 12

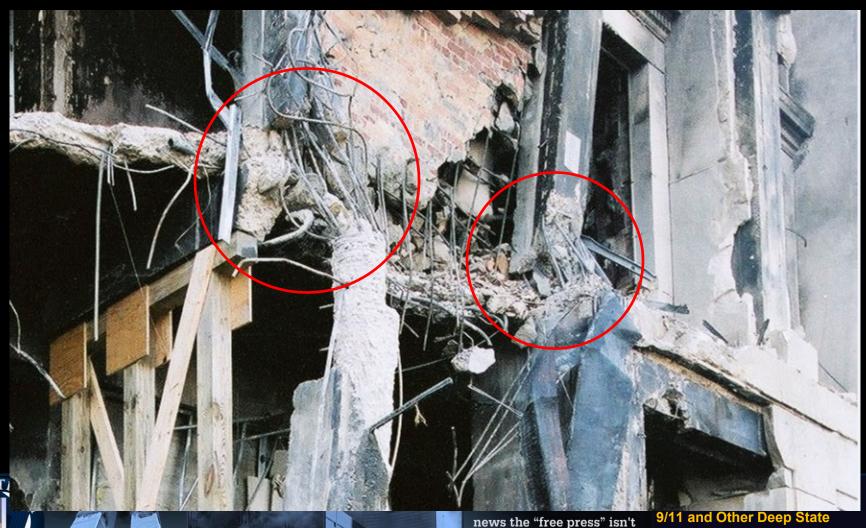
- Evidence of large momentum based impact event
- Consistent with large plane impact
- Cannot be explained by other hypotheses
 - e.g. Exterior explosives
 - e.g. Interior explosives
 - e.g. Cruise missile type event

Columns 18 and 19 Shown "Bashed" Inward

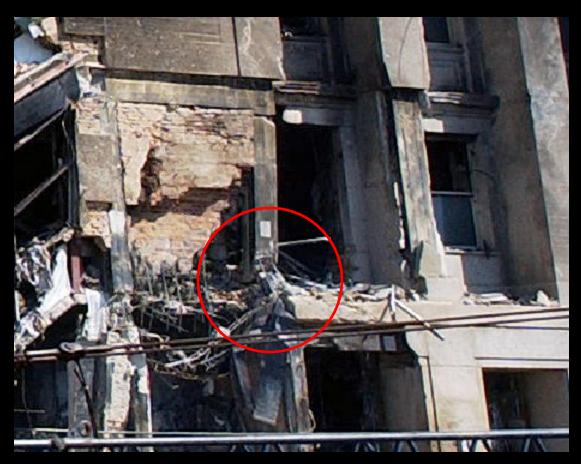
Column 19 "Bashed" Inward

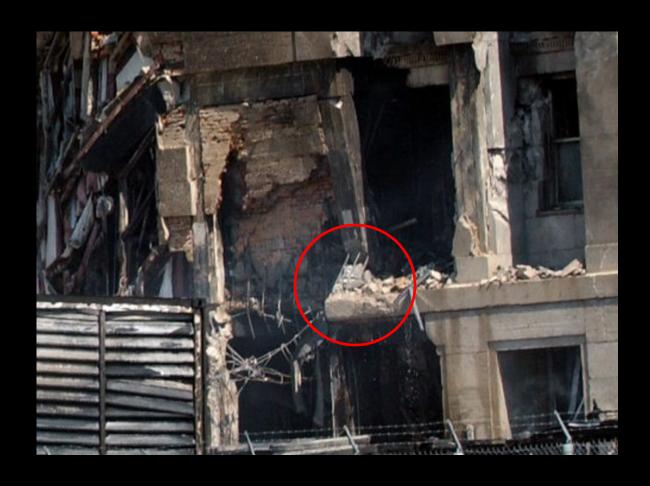
Column 19 "Bashed" Inward

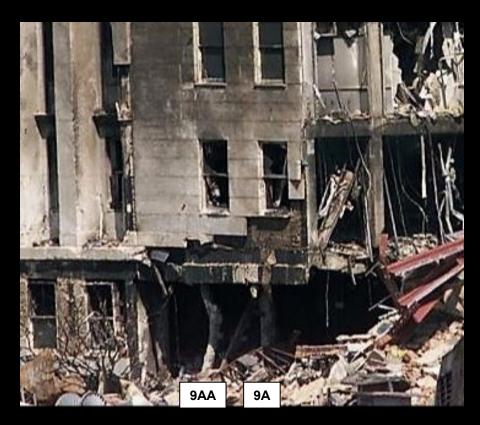
Column 9AA is Bowed Inward at North End from Wing Impact

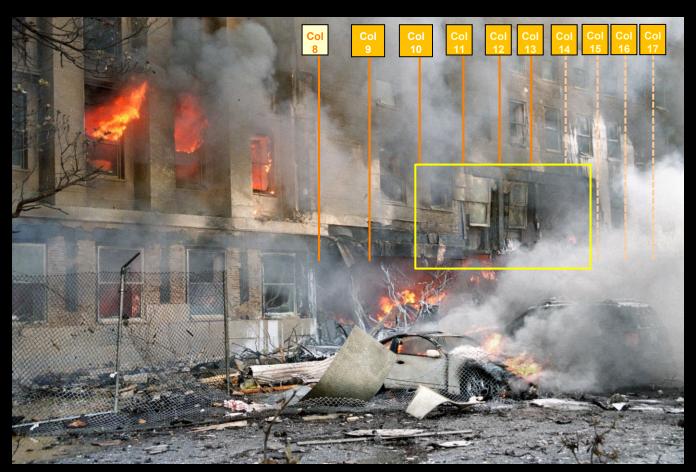
Damage at Column 12 Suggests Impacting Mass into Second Floor

- Right side engine
 - The right engine impacts the façade
 - To the left of column 17
 - Near the lower half of the window
 - Traveling horizontally (e.g. no impact into floor slab)
- Left side engine
 - Impacts into Column 12 well below second floor
- Damage to second floor at column 12 suggests tail impact

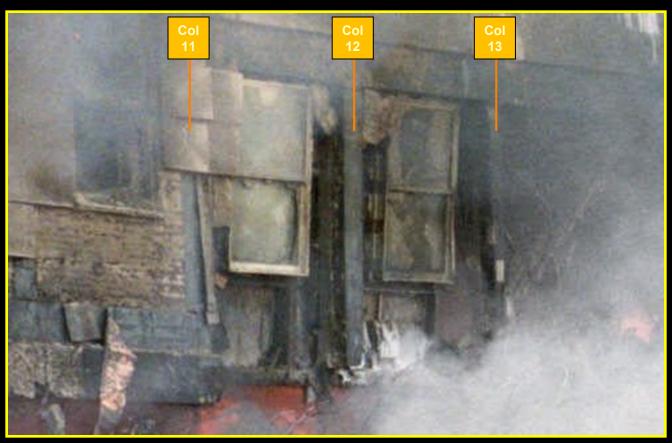
Second Floor Beam Missing Under Column 12

Wing and engine impact was significantly below the second floor beam, suggesting another mass damaged this area.

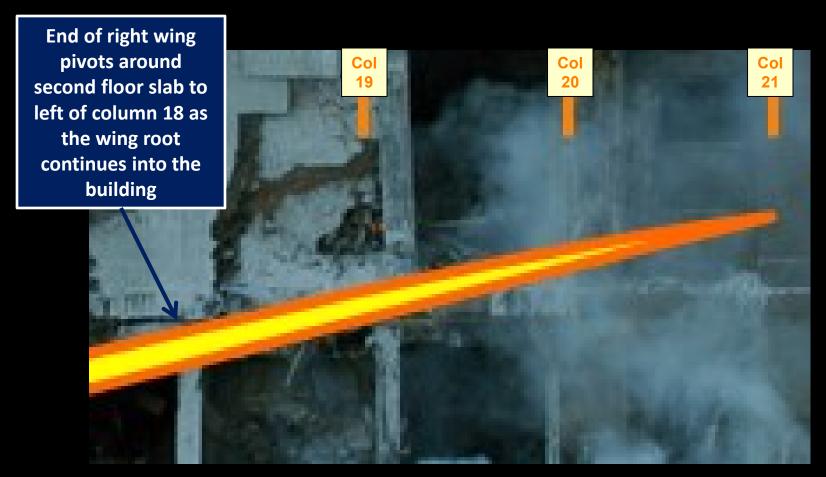
Right Wing Impacts and Damages Columns 18 and 19

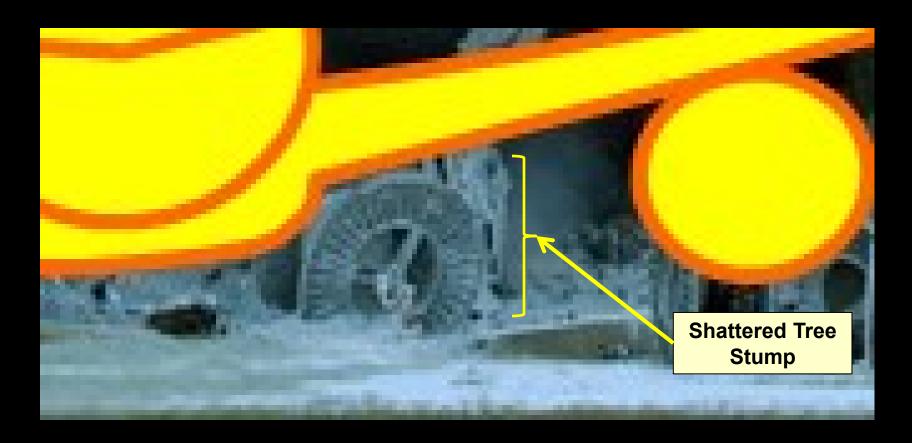
Projection Shows Tree Stump at Height of Wing Root / Wing Spar

- Aligning the key damage points positions the plane
 - Second floor wing impact at column 19 at about one foot above floor slab, places the right wing
 - First floor column 9AA bowed inward places the left wing location
 - Severed tree stump in front of column 16 establishes height of wing root near fuselage
