Supplemental Material For January 27  
9/11 Truth and Other Deep State  
Crimes Teleconference Debate

Conceptual Illustration of Plane Impact on the  
First Floor Pentagon Wall

Wayne Coste, 9/11 Truth Outreach

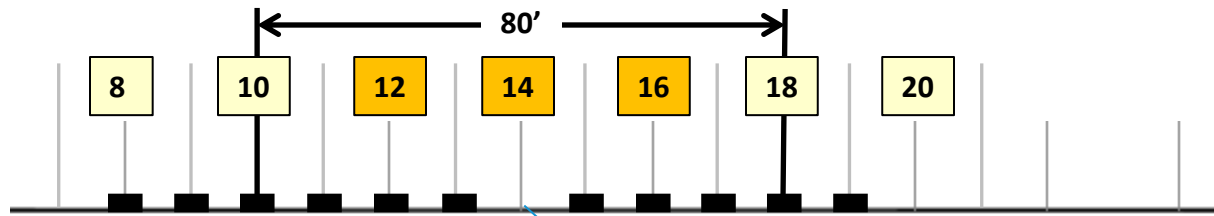
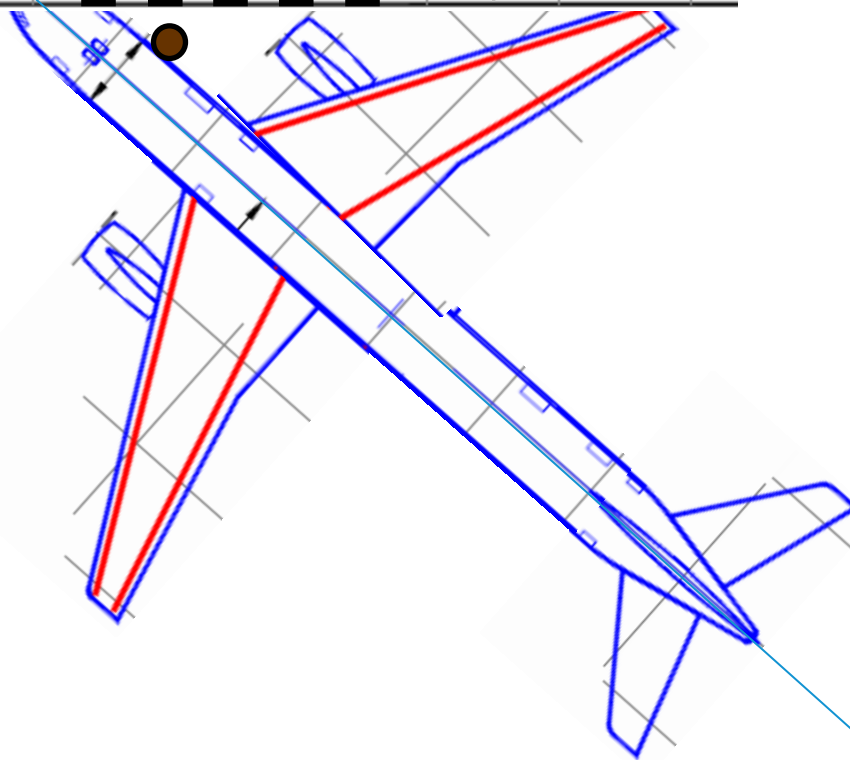
**Pre-Impact:**

Cockpit passes to left of tree  
at column 16

No plane rotation yet

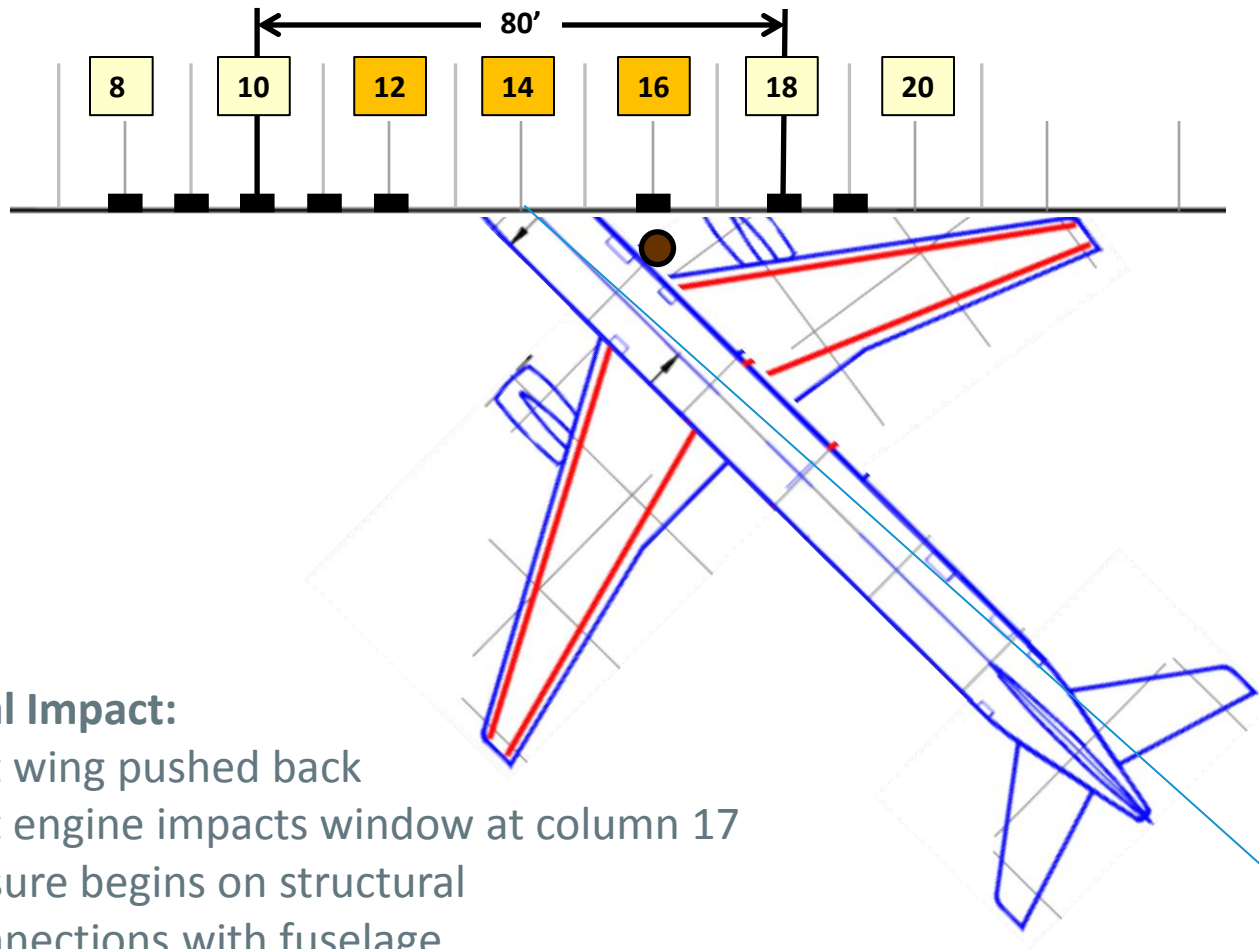
**Initial Contact:**

Right wing begins to be pushed back from end  
Pressure begins on structural connections with fuselage  
No plane rotation yet

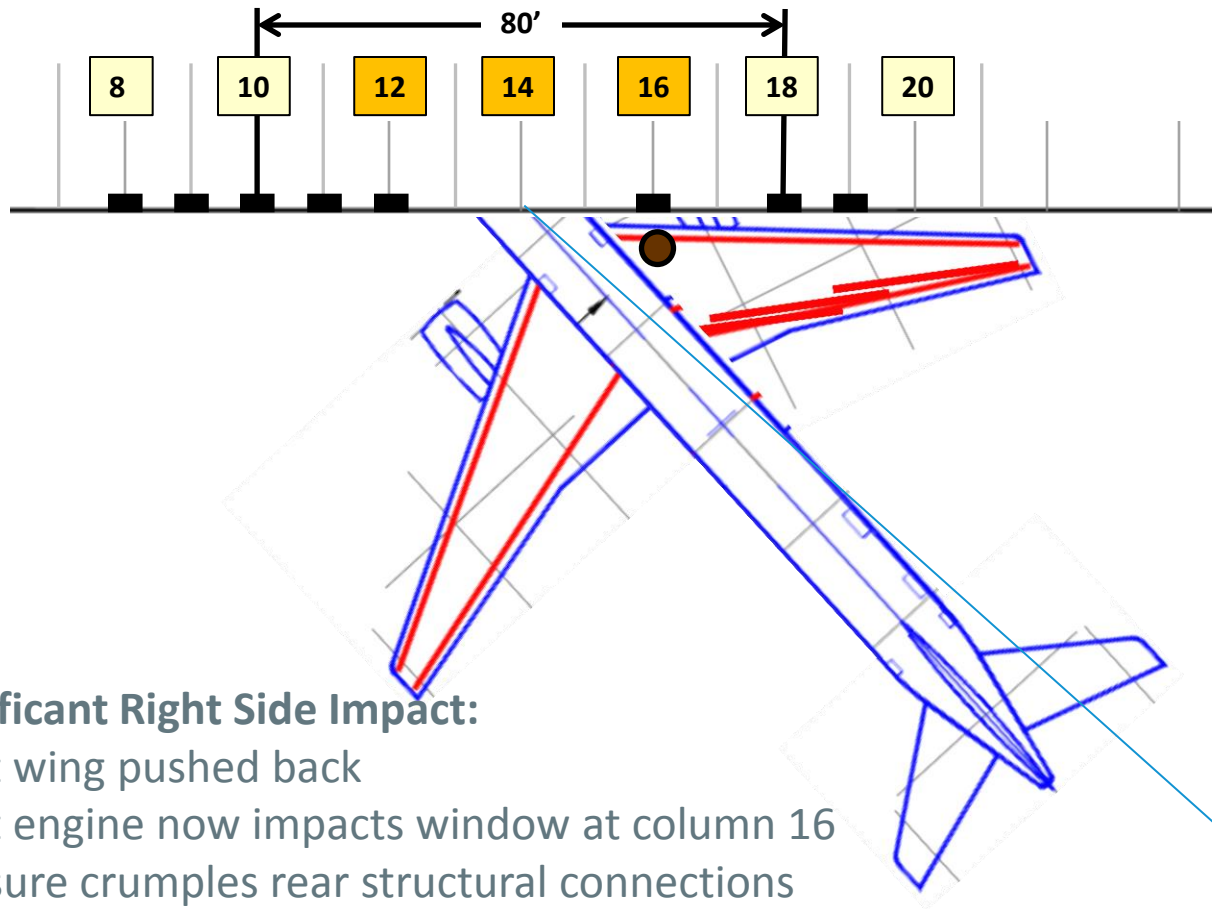
**Initial Impact:**

- Right wing pushed back
- Right engine impacts window at column 17
- Pressure begins on structural connections with fuselage
- Rear shift from assumed 3 degree rotation

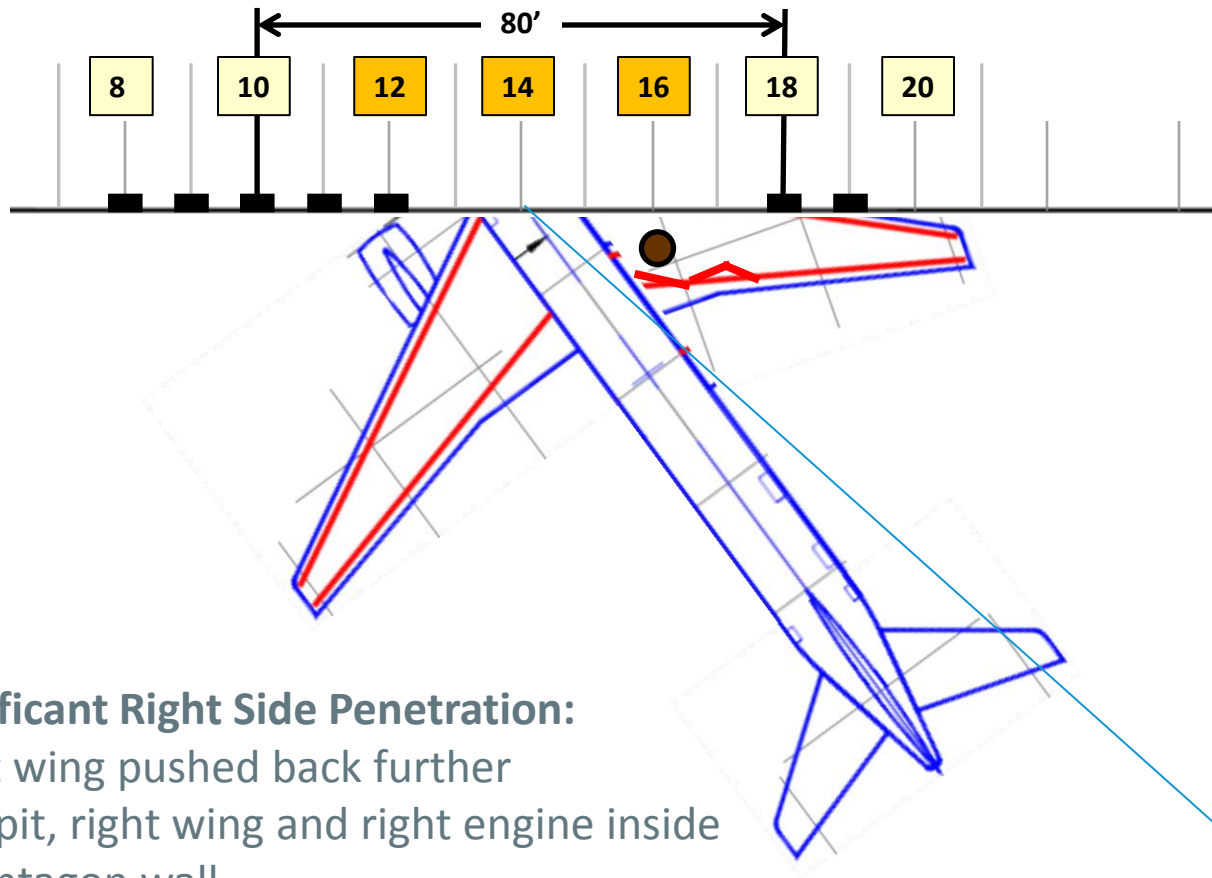
**Significant Right Side Impact:**

- Right wing pushed back
- Right engine now impacts window at column 16
- Pressure crumples rear structural connections with fuselage
- Rear shift from assumed 6 degree rotation

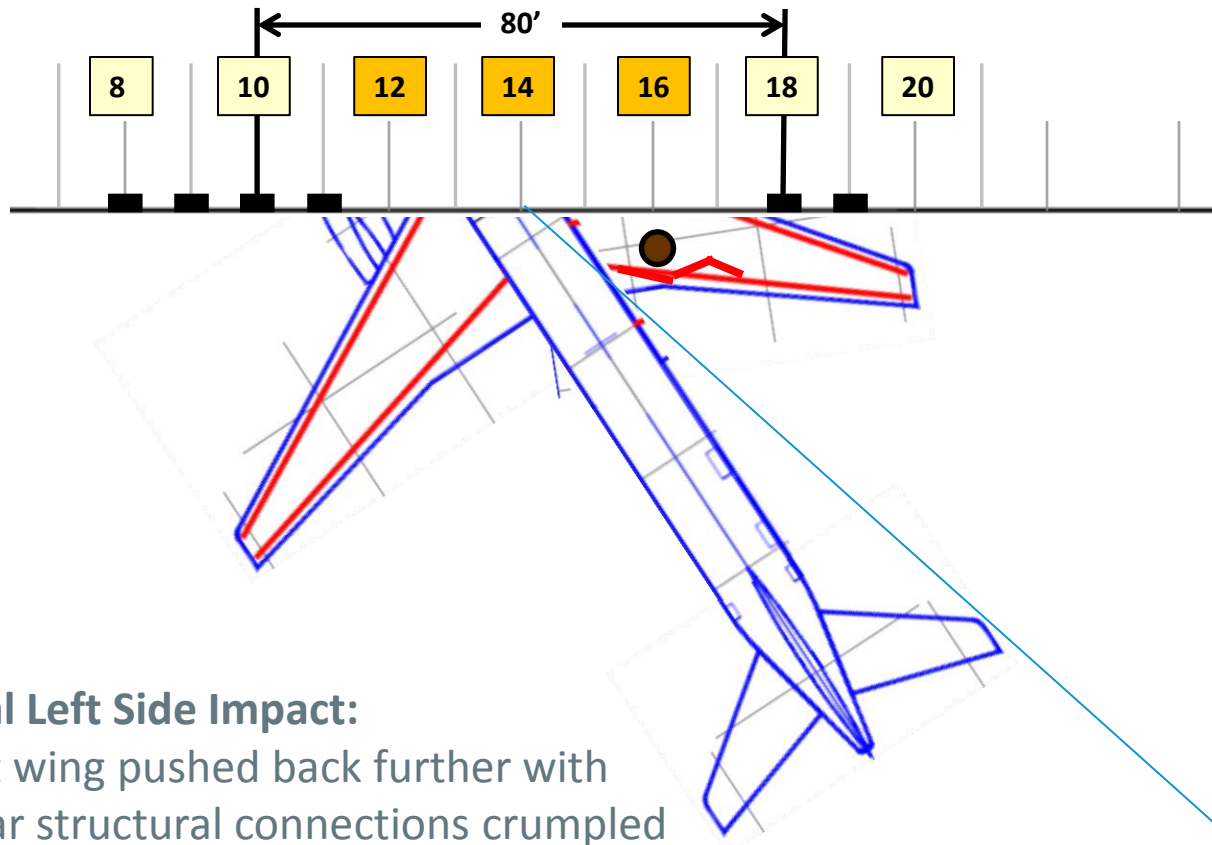
**Significant Right Side Penetration:**

Right wing pushed back further  
 Cockpit, right wing and right engine inside  
 Pentagon wall

Pressure crumples rear structural connections  
 with fuselage, wing rotates further front connection  
 remain

Rear shift from assumed 12 degree rotation

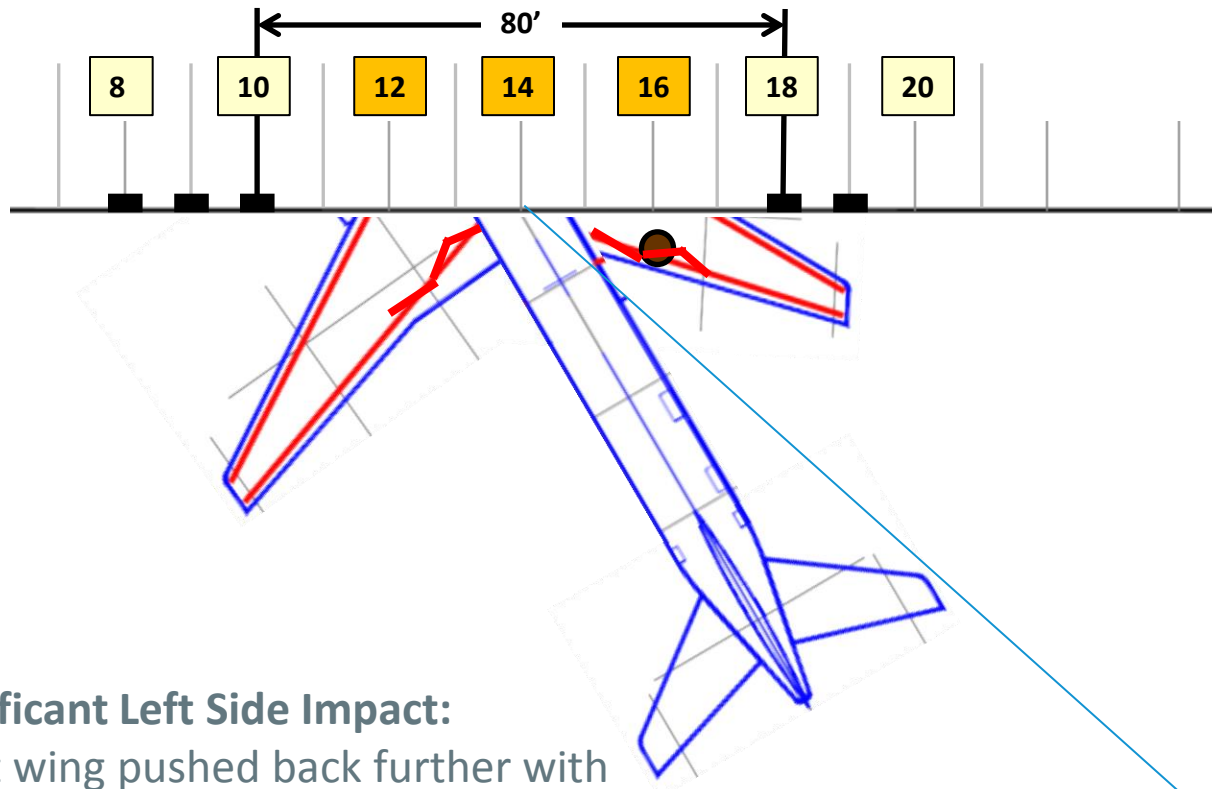
**Initial Left Side Impact:**

- Right wing pushed back further with rear structural connections crumpled
- Left engine impacts window at column 12
- Left wing begins to get pushed backward
- Rear shift from assumed 15 degree rotation

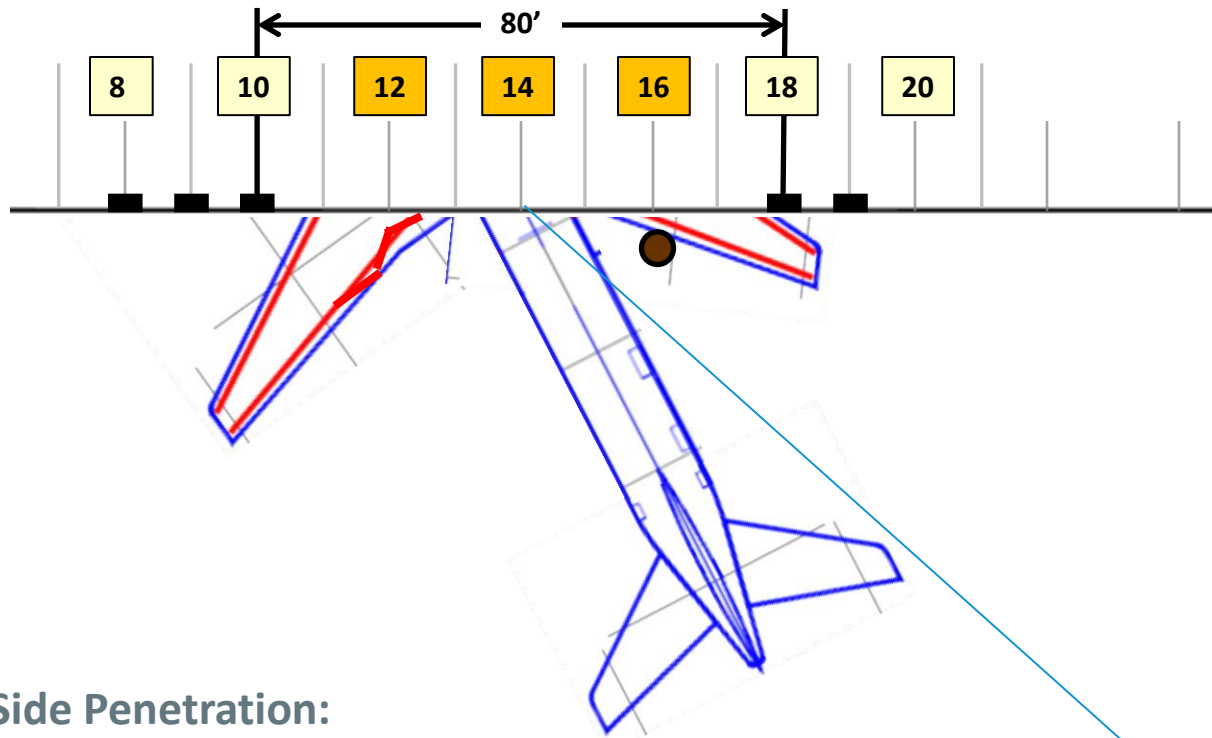
**Significant Left Side Impact:**

- Right wing pushed back further with rear structural connections crumpled
- Left engine impacts window at column 11
- Left wing rear structural connections crumpled
- Rear shift from assumed 18 degree rotation

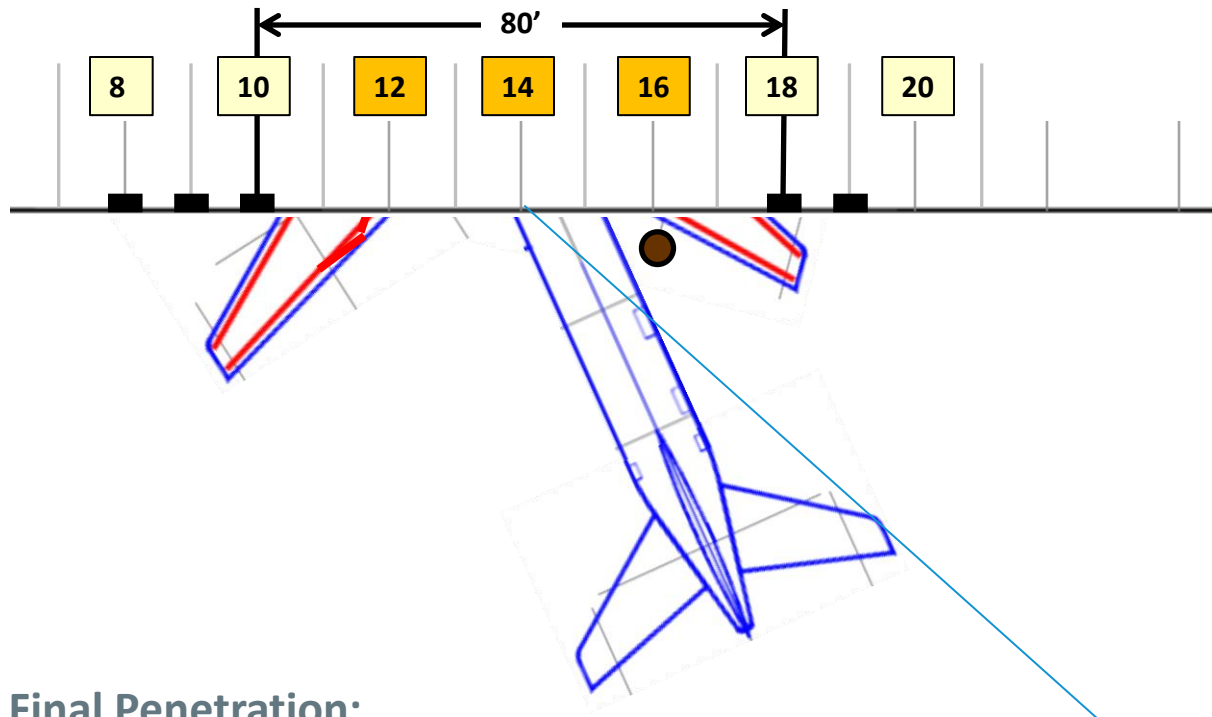
**Left Side Penetration:**

- Right wing pushed back further with rear structural connections crumpled
- Right engine impacts window at column 17
- Left wing rear structural connections crumpled
- Rear shift from assumed 18 degree rotation
