# Analysis of Column 14AA on the Second Floor

Wayne Coste, PE

# Column 14AA / Second Floor

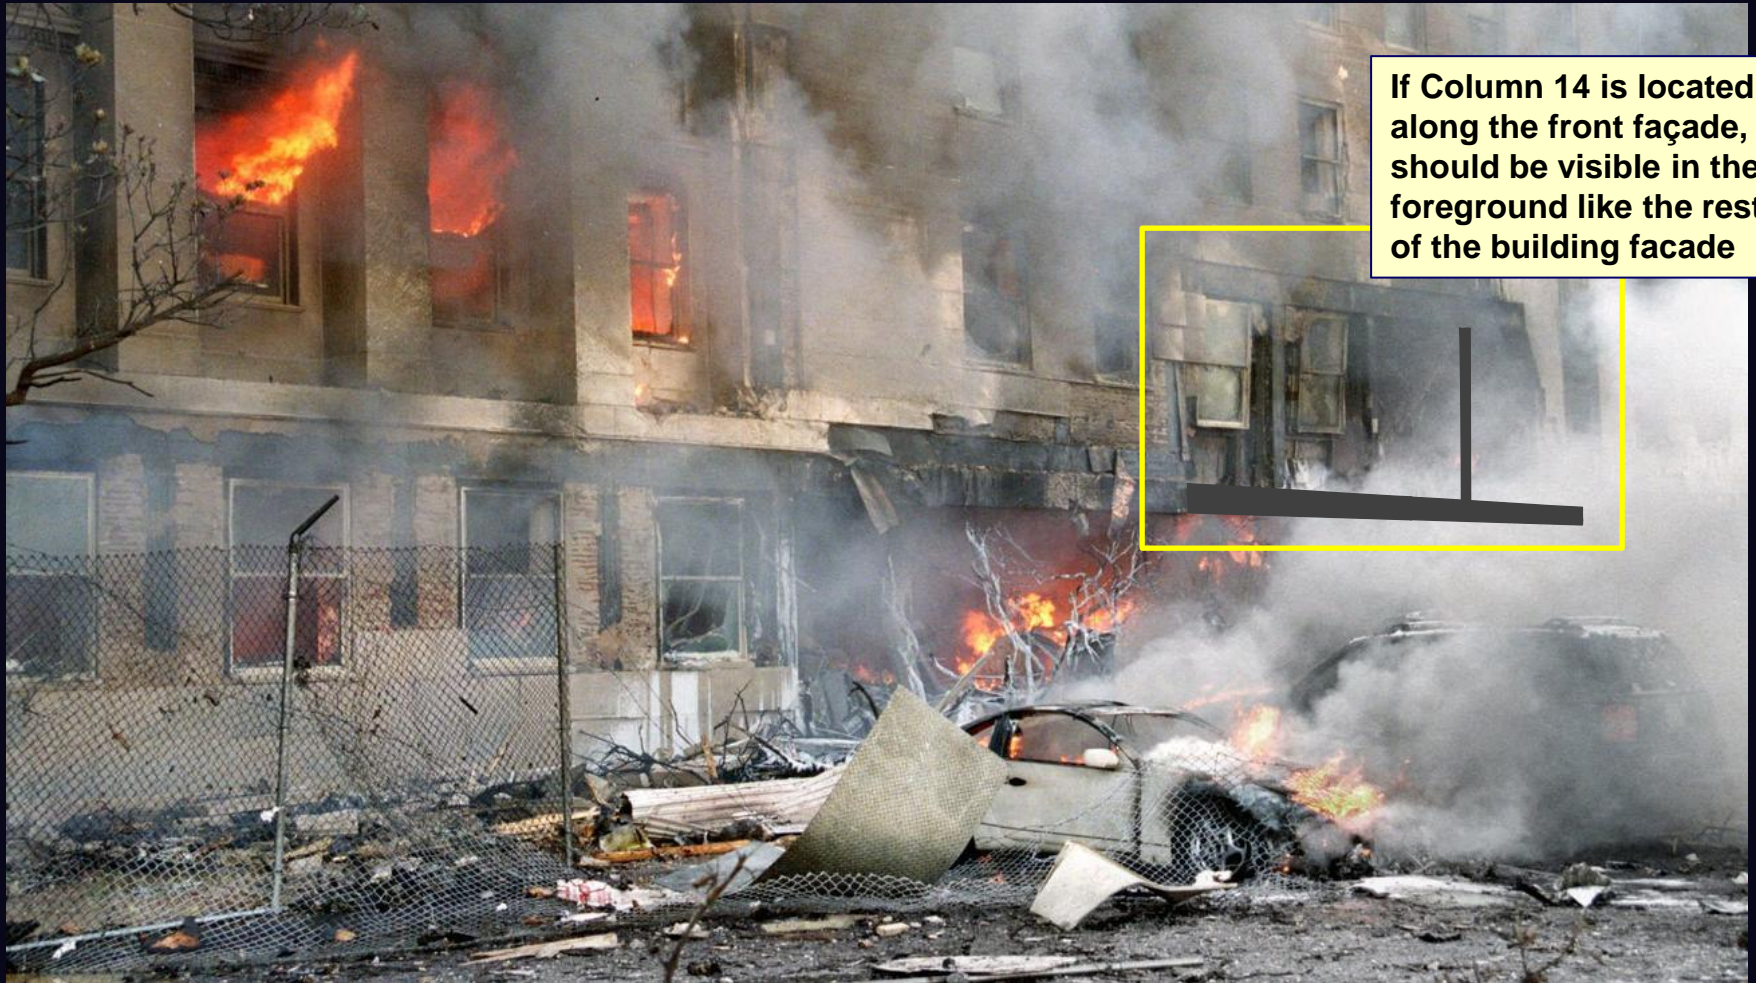
# Original Will Morris Photo

If Column 14 is located along the front façade, it should be visible in the foreground like the rest of the building facade

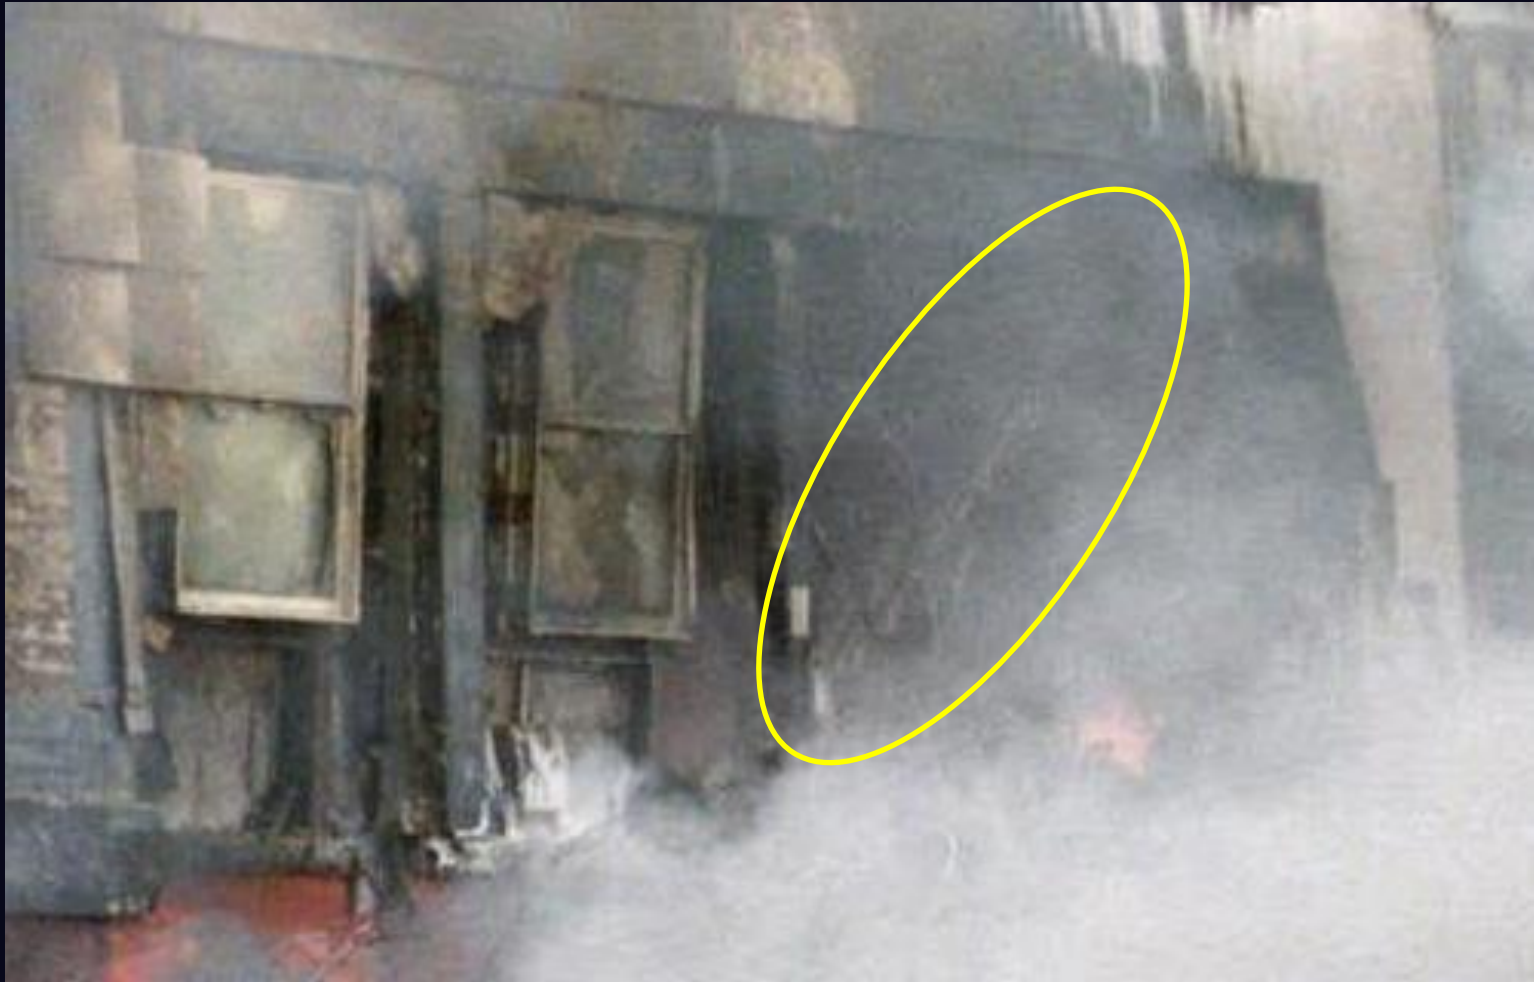
# Column 14AA<sub>2</sub> Will Morris Photo – From North

**As photographed and highlighted**

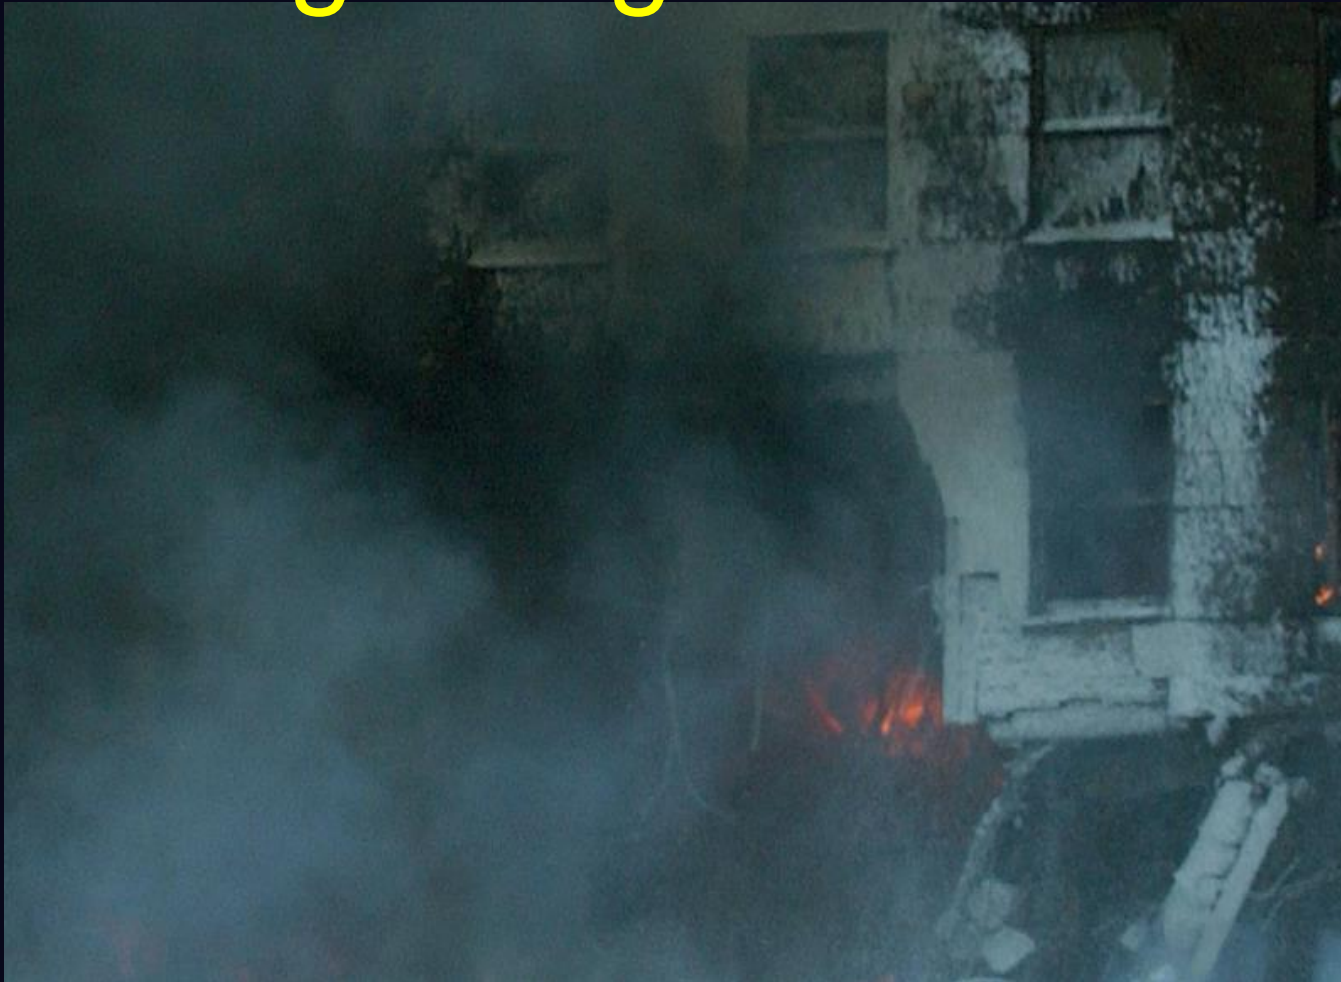
# Second Floor Slab Seems Missing in Ingersol Photo #1

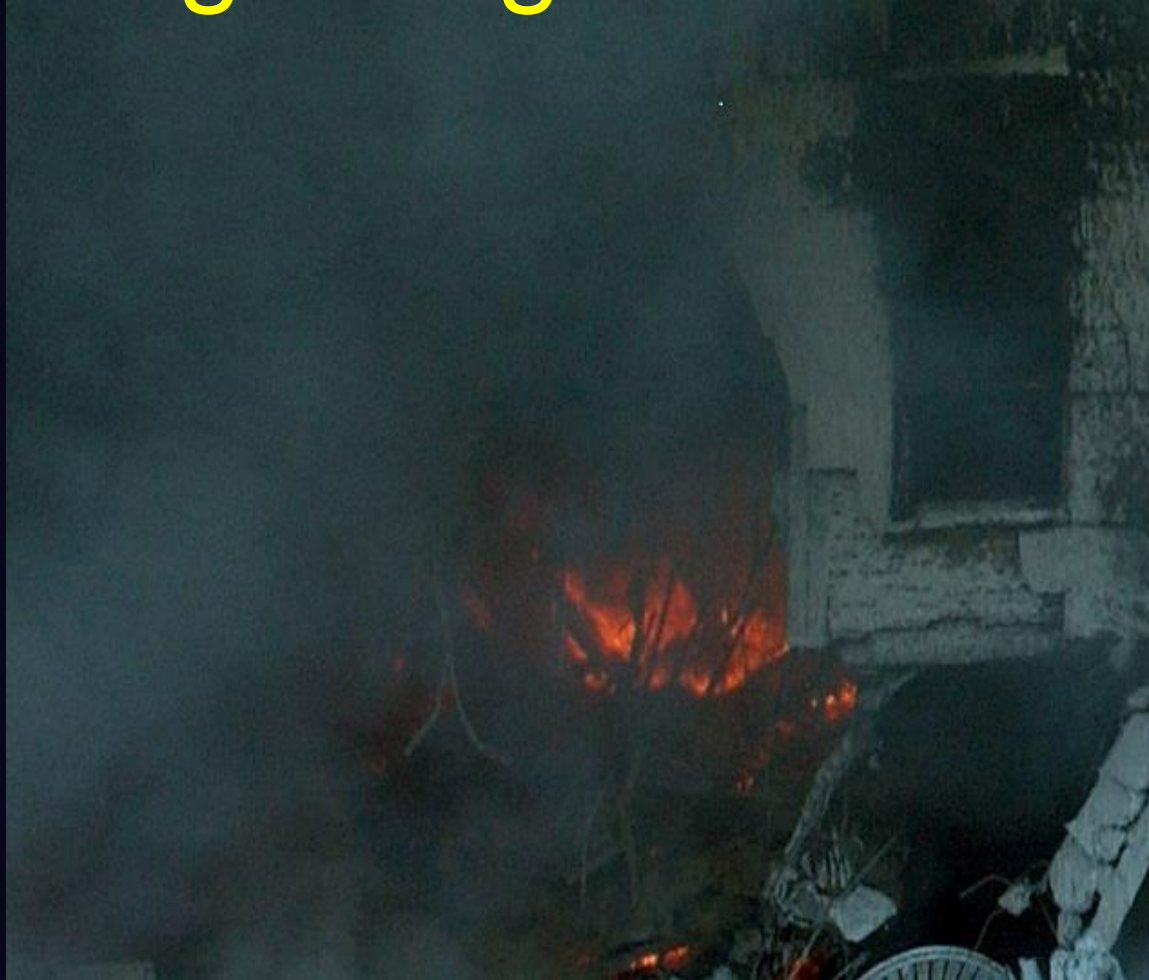
# Second Floor Slab Seems Missing in Ingersol Photo #2

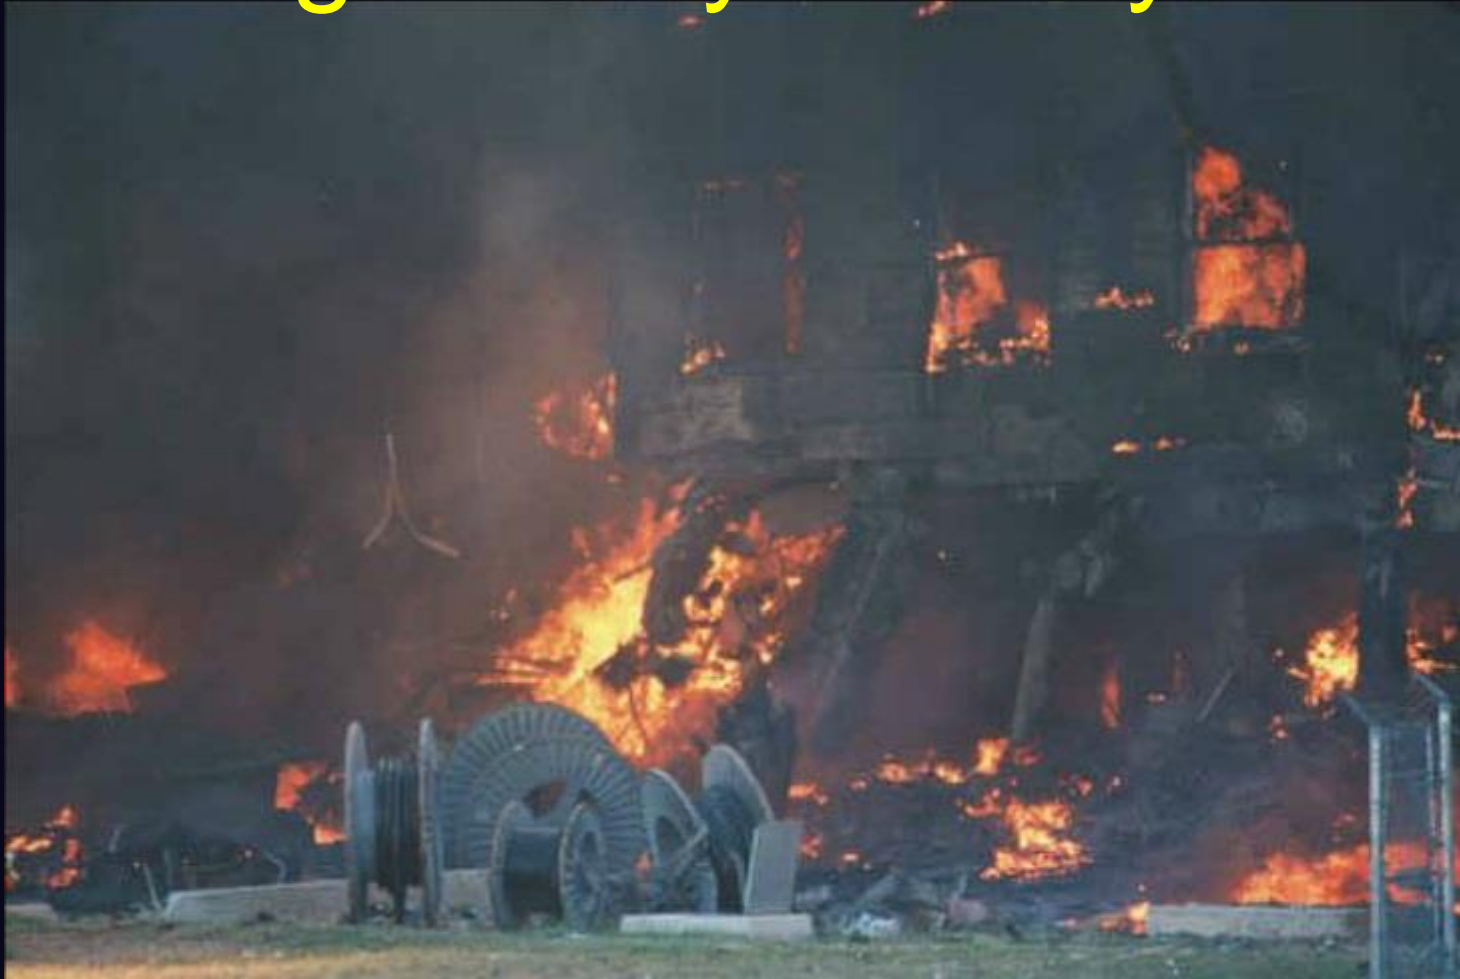
# Second Floor Slab Seems Missing in Daryl Donley Photo
