“Surfing” the Big Wave on 9/11

Analysis of a Large Perimeter Column Wall Section of the South Tower

By Wayne Coste, PE

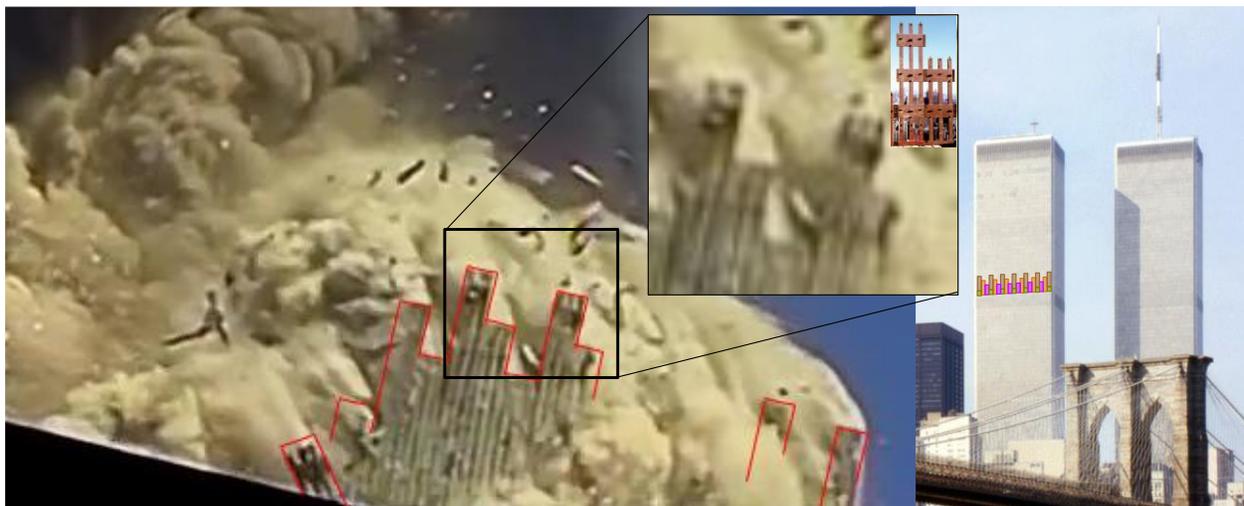
Figure 1: Eight or more contiguous perimeter column sections are seen propelled (left) from their initial location near the 80th floor (right). At this point, they have traveled over 200 feet from the South Tower wall.

Figure 1 (left) is a screenshot from the video known as, "[Skidmore, Owings & Merrill - from Dean Riviere²](#)," the shape of these perimeter columns with their connecting horizontal spandrels is clearly seen. By the time these columns emerge from the cloud of dust, debris and smoke they have been propelled nearly 200 feet away from the east face of the South Tower.

In the analysis discussed later, when these perimeter columns were first seen, they had been accelerated horizontally to a velocity of approximately 80 ft per sec (54 mph). The analysis shows that these perimeter columns originated from near the 80th floor (Figure 1, right) and had traveled approximately 2.27 seconds before they "out-ran" the cloud of propellant, fine dust and debris and emerged from the cloud. Additionally, the trajectory of these perimeter columns shows there was no initial component of velocity in the vertical direction (e.g., no initial velocity in the direction of gravity).

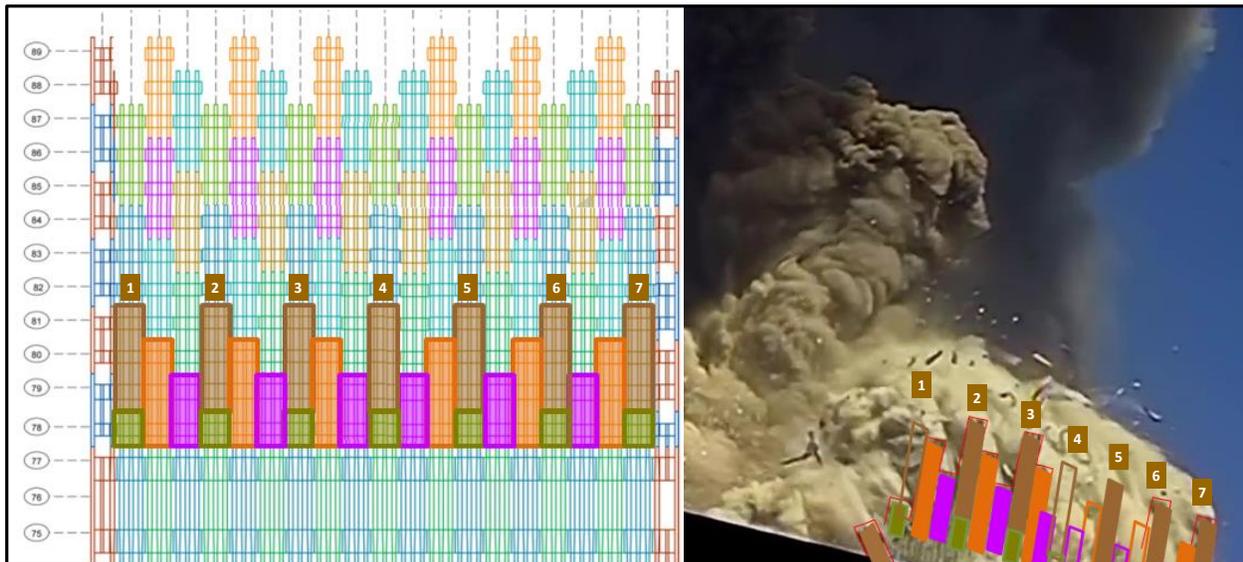
Figure 2: Initial location of expelled perimeter column sections in the east face of the South Tower (left) and estimated identification as they were propelled (right). Solid colors indicate columns that were observed in the video while outlined columns were not clearly seen.

Figure 2 shows a portion of the east face of the South Tower, and identifies the configuration of the perimeter column sections. Their corresponding arrangement while "surfing" fits the design pattern.

Additionally, because of the chaotic nature of the dust and debris cloud, and the numerous perimeter columns forming a line behind each other from the camera's viewpoint, it is also probable that a taller perimeter column section emerged from the dust and its top was the final object measured. A difference in measurement of only 10 feet over the 1.33 seconds would account for the difference between the observed acceleration and the expected vertical acceleration. For reference, the difference in height between adjacent perimeter column sections is 12 feet (e.g., the difference in height of a 'brown' column section and an 'orange' column section in Figure 2).

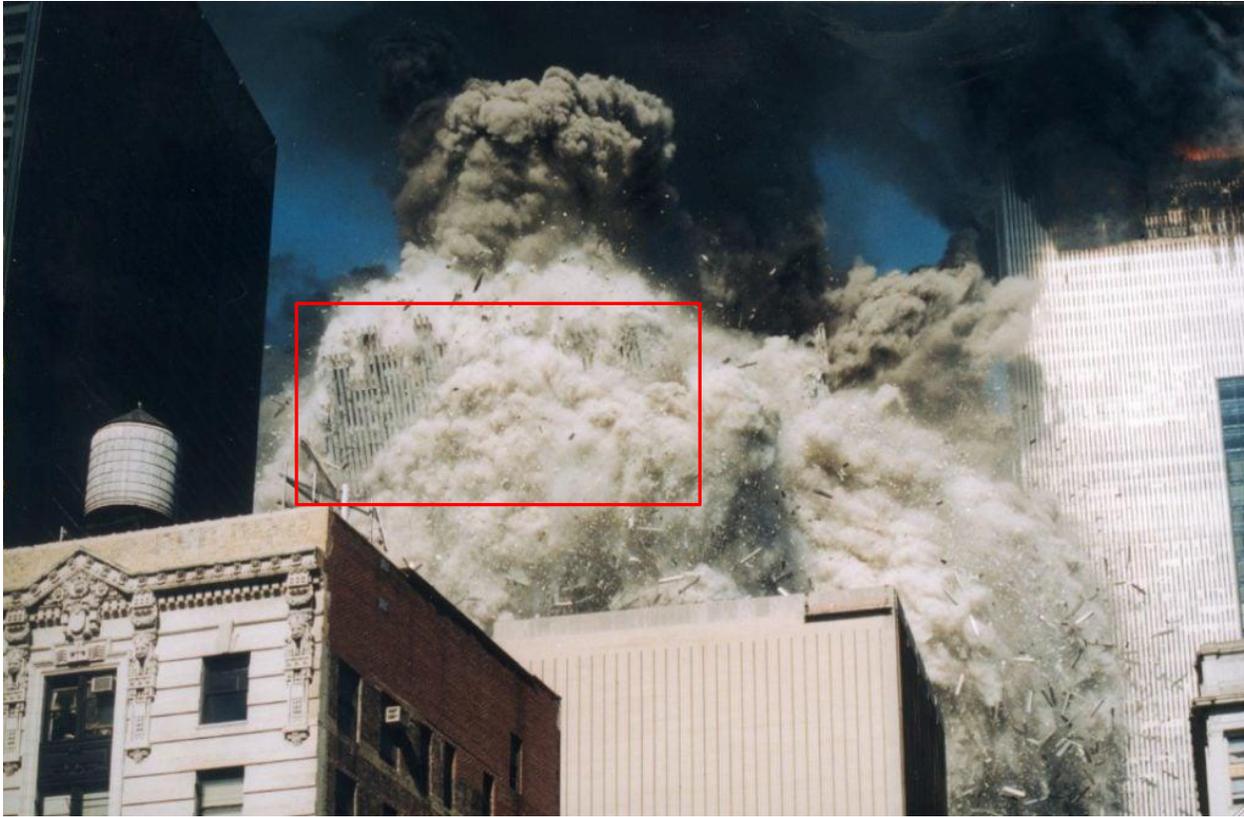
Figure 3: View of the “surfing” perimeter columns, taken nearly perpendicular to its trajectory, shows the width of the wall section which has been ejected as a relatively coherent whole.

These "surfing" perimeter columns were also captured in other photo and video records. A photo by Mark Stetler³ (Figure 3) provides an alternative view of the width of the ejected wall section. This perimeter column section can be seen to be a relatively coherent whole that extends for many floors.

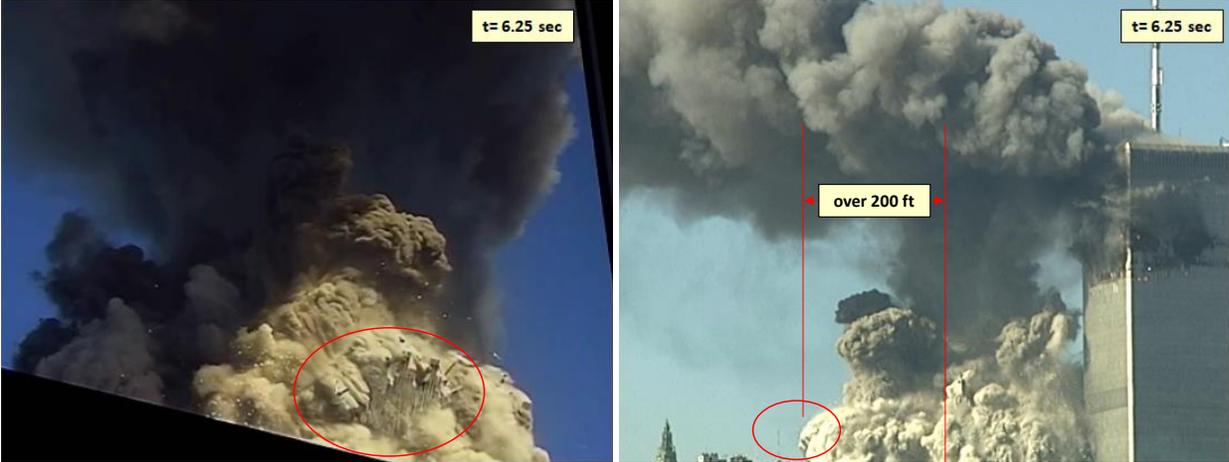
Figure 4: Location of the “surfing” columns from the southeast (left) and the northeast (right) at 6.25 second after the hinging motion begins.

Figure 4 shows these “surfing” perimeter columns from two perspectives that are approximately 90 degrees apart. Time-stamped photos in the Appendix to this paper show the movement of these perimeter columns from three perspectives (northeast, southeast and directly south).

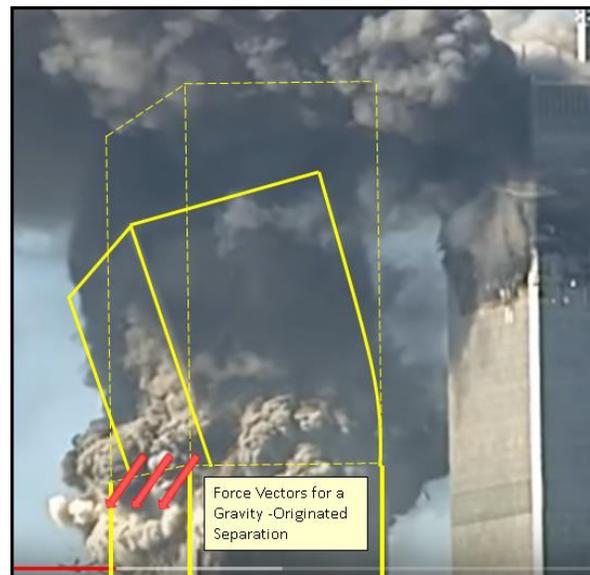
Figure 5: Any mechanical ejection due to gravity would impart an initial downward velocity component. None was observed.

- **Mechanical ejection** of these columns would not be possible because there was no mechanism to create the forces that would have been necessary to accelerate these perimeter columns to a horizontal velocity of 80 ft/sec (54 mph). As shown in Figure 5 any eastward mechanical ejection of the perimeter columns as a result of gravitational effects would also have imparted them with a significant initial downward velocity – which was not observed. In order for the observed perimeter column sections to travel as a mostly coherent whole in adjacent trajectories while remaining relatively intact, the ejecting forces would need to be uniform across the width of the Tower. A downward focused gravity-only collapse, as NIST implied happened once conditions for “...collapse initiation were reached and [a gravity driven] collapse became inevitable⁵,” cannot produce forces orthogonal to the effect of gravity.

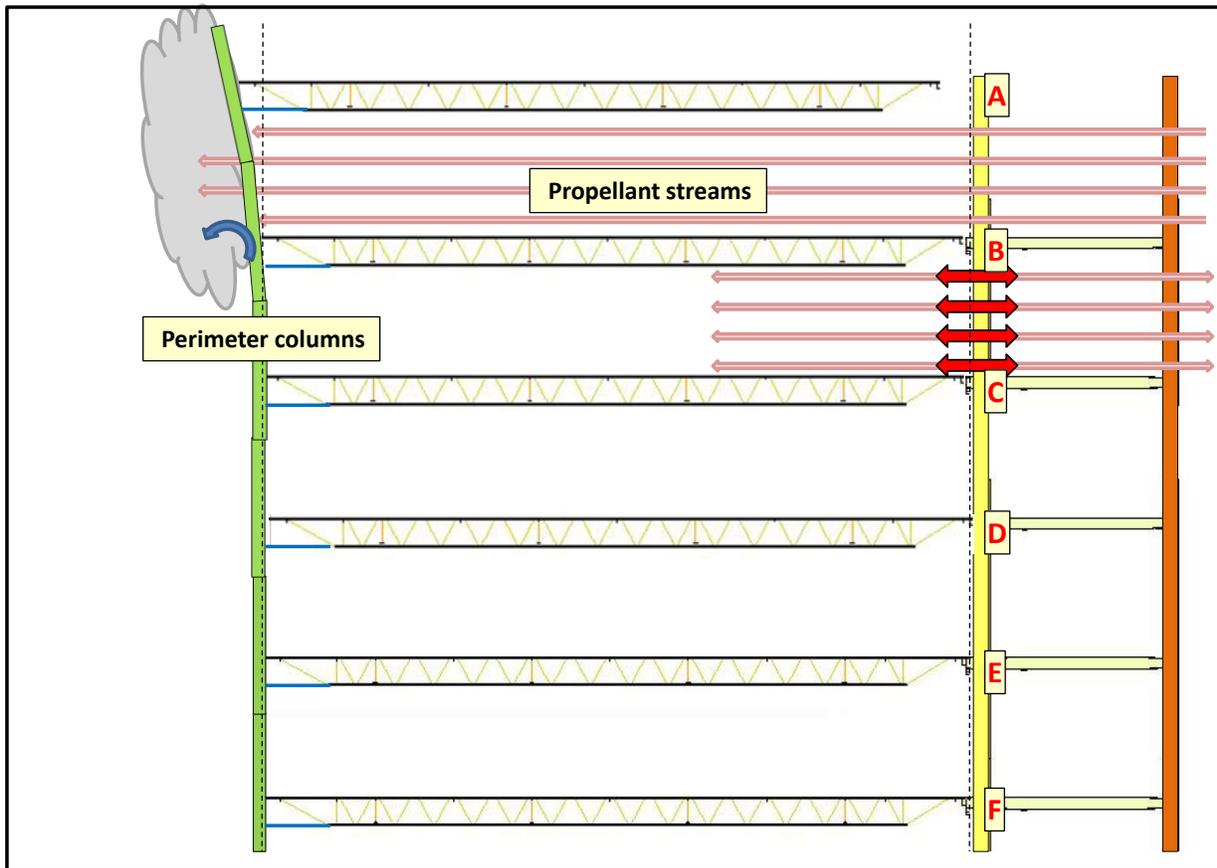
Figure 6: Propellant forces (pink), originating around the core, pushed groups of entire perimeter column sections (green) outward in a horizontal direction

As described in the Propelled Demolition paper and shown in Figure 6, the activation of this propellant would create forces that would have traveled across the office areas from the core to the perimeter columns in a very fast, very high temperature thermal stream. This thermal stream would have been hot enough to contain molten iron which would later cool into the tiny iron spheres that characterized the World Trade Center dust. The effect of the passage of such an energetic stream on office contents would be to dissociate virtually everything encountered from human bodies to asbestos fireproofing. The propellant derived forces also would have accelerated the office furnishings and even floor truss components toward the perimeter column sections, creating immense simultaneous outward impact forces in all four directions, which the building was not designed to withstand. These forces would have resulted in the separation of the structure at its weakest point, which would have been the interior bolted connections between the floor trusses and the steel "channels" along the core.

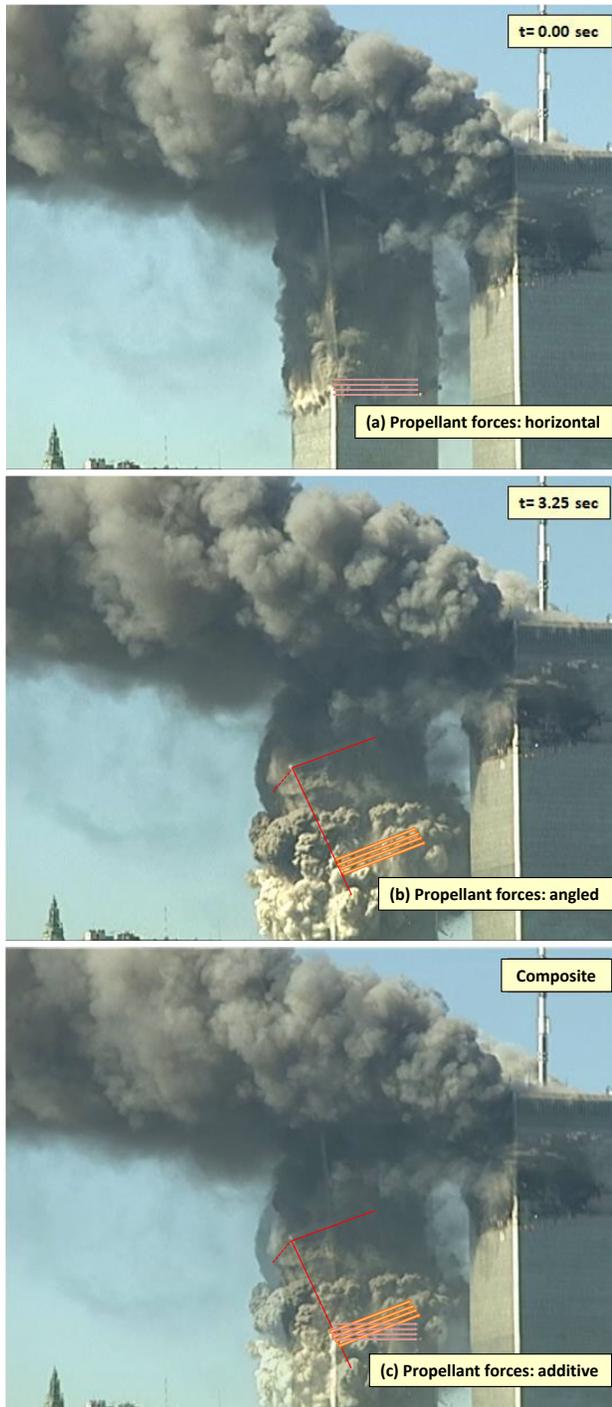
Figure 7: Horizontal forces from the stationary lower part of the Tower (a) and the forces from the angled top block (b) add together to create a propelling force that would have been much greater than at any other part of the Towers (c).

The “surfing” perimeter column wall section originated from the top of the stationary lower section of the South Tower, and not the bottom row of the hinging top block. This is because approximately four seconds after the hinging motion began, the east perimeter columns of the top block would have hinged inside the lower part of the South Tower. From this interior location, any propellant forces that were destroying the top block would also have been angled slightly downward and would have combined with the propellant forces directed horizontally at the wall section on the 80th floor (see Figure 7). This geometry-based confluence of propellant forces makes this location unique in the demolition of either Tower.

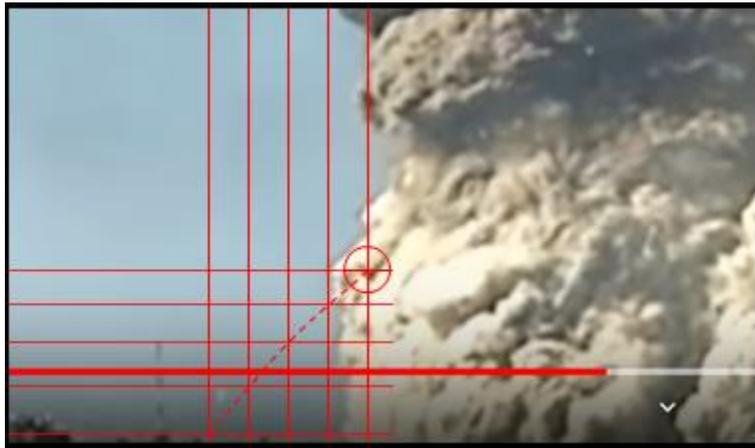
Figure 8: First observed location of the perimeter wall section

The location of the top of these perimeter columns is first seen in Figure 8 as denoted by the round circle. Figure 9 shows the location 1/3 of a second later. Figure 10 shows continued constant horizontal motion while acceleration due to gravity is observed in the vertical direction. Figure 11 and Figure 12 illustrate the continuation of these horizontal and vertical movement trends.

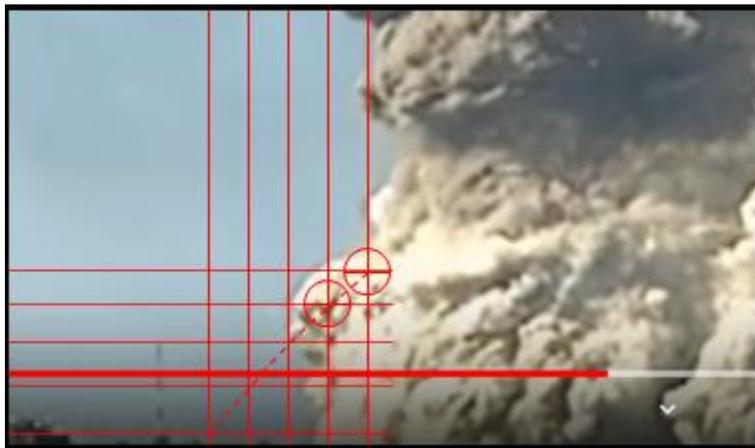
Figure 9: Location of the perimeter wall section after 0.33 sec

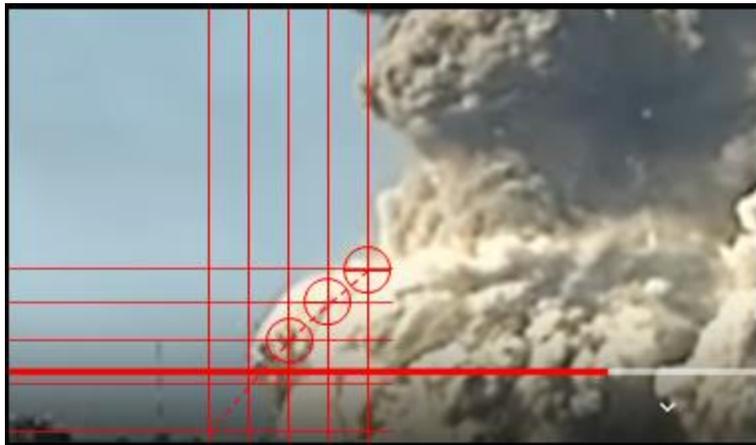
Figure 10: Location of the perimeter wall section after 0.67 sec

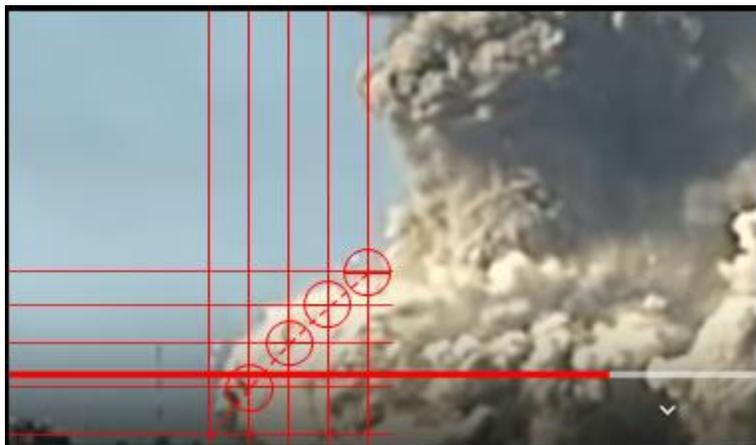
Figure 11: Location of the perimeter wall section after 1.00 sec

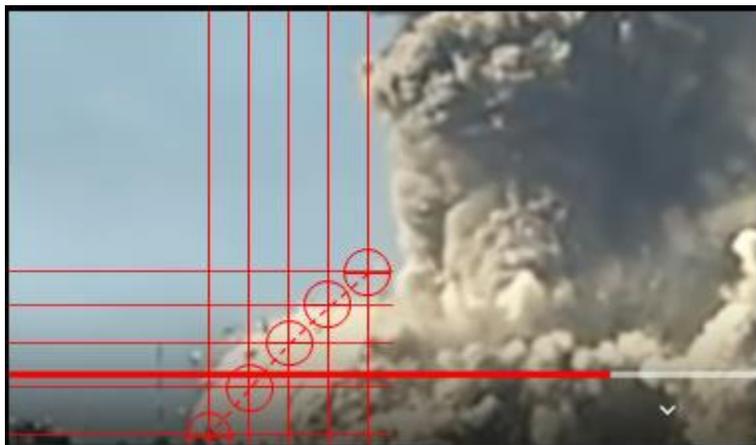
Figure 12: Location of the perimeter wall section after 1.33 sec

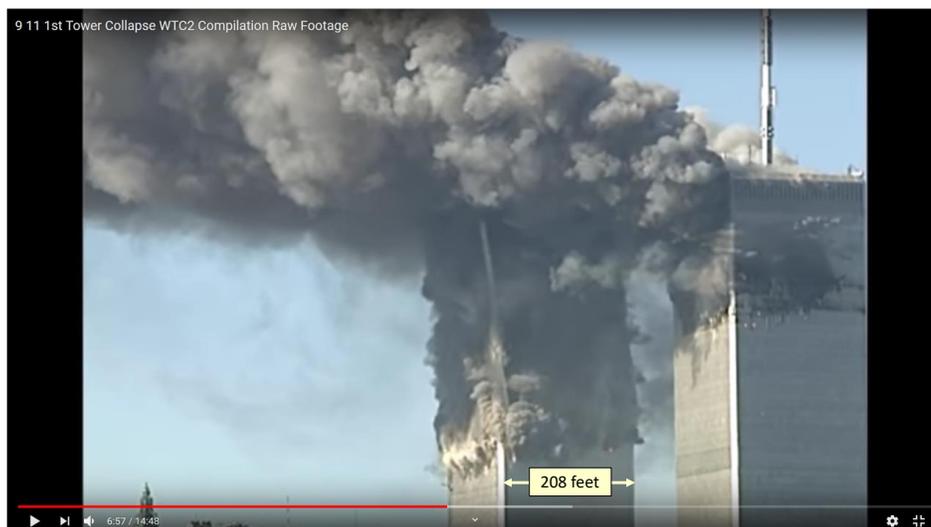
Figure 13: Full screen capture of DeJong video shows the basis for measuring distances.

Adjusting for the camera's perspectives of approximately 24 degrees, the 208-foot width of the South Tower can be used as a reference for the dimensions (Figure 13). Assuming that the vertical and horizontal aspect ratios of the video are equal, the vertical acceleration can be estimated.

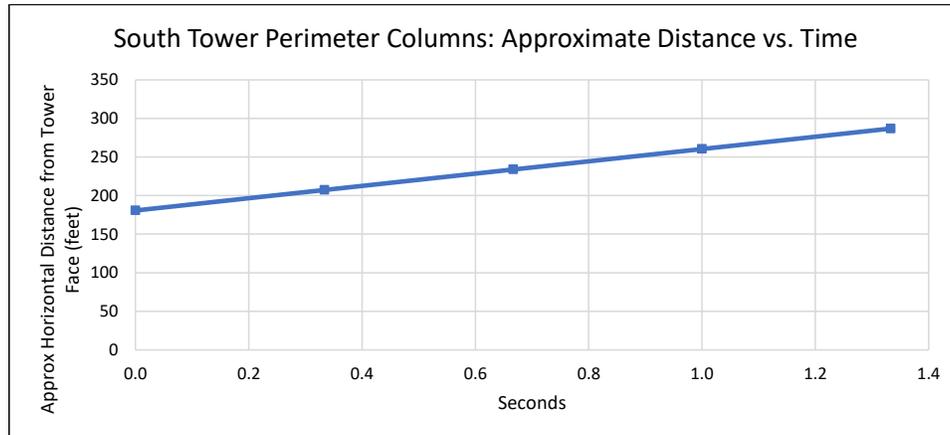
Figure 14: Observed horizontal distance from the South Tower Face

Figure 14 shows the approximate location of these perimeter columns relative to the Tower face. Figure 15 shows the change in position over time, which is the horizontal velocity. This horizontal velocity is observed to be constant.

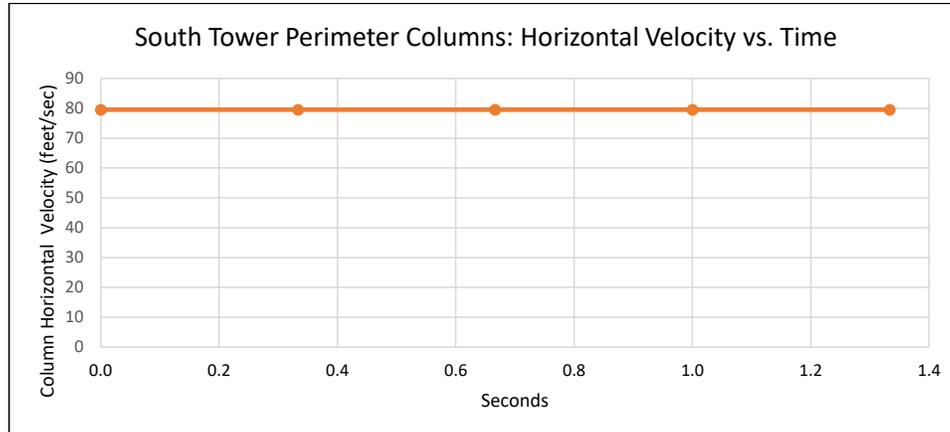
Figure 15: Observed horizontal velocity

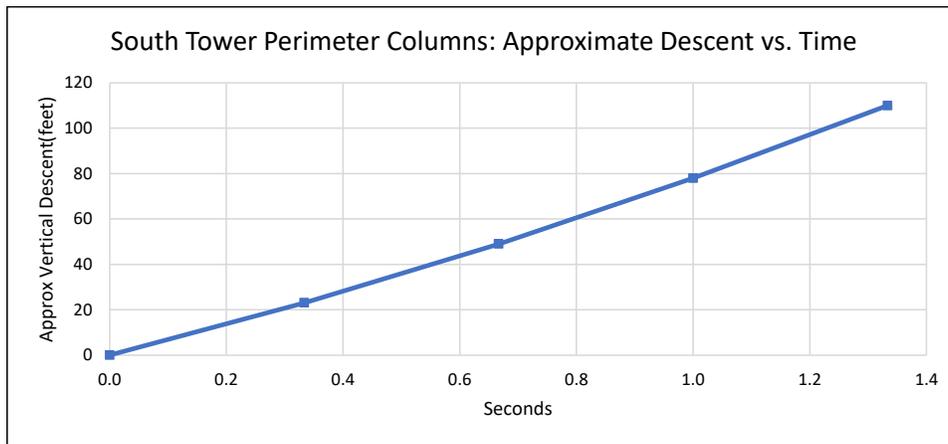
Figure 16: Observed vertical position relative to first observation

Figure 16 shows the vertical locations relative to the first observation. From these locations the velocities can be calculated as shown in Figure 17. There is a slight change in vertical velocity during this 1.33 second interval. Calculating the change in velocity during this period, the observed acceleration is estimated to be in the range of 26.8-27.5 ft/sec², which is approximately 85 percent of the value for objects experiencing freefall acceleration. The calculated acceleration is shown in Figure 18. The difference in the value for acceleration vs. the expected 32.2 ft/sec² can be attributed to the problems with measurements of three-dimensional movement from a series of two-dimensional images where perspective, parallax effects and even the exact object being measured can only be approximated.

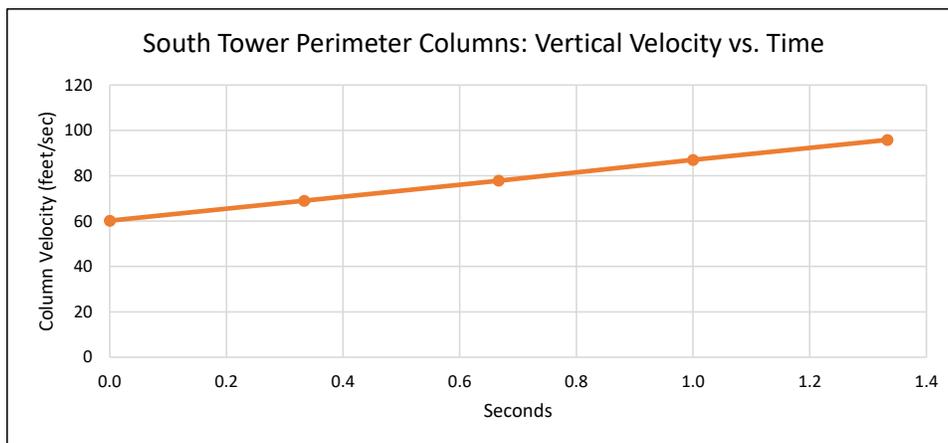
Figure 17: Observed velocity

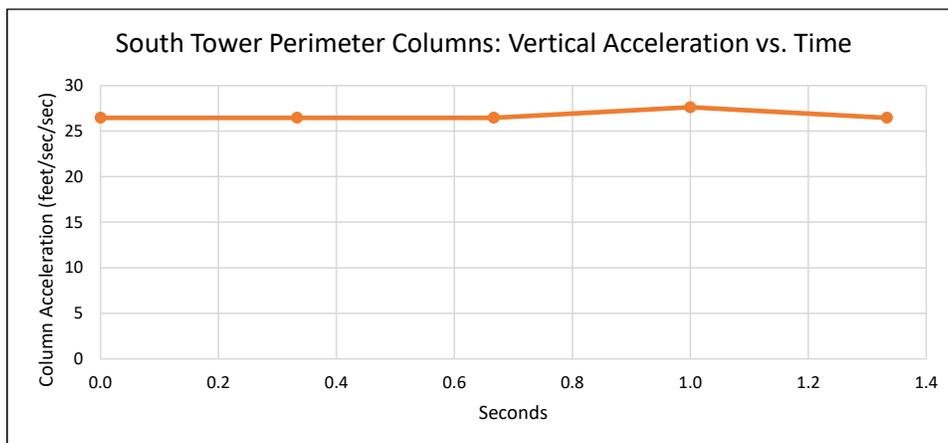
Figure 18: Observed acceleration of columns experiencing freefall acceleration (measurement error is low by approximately 17 percent)

Based on the measurements, the observed vertical acceleration is estimated at only 27 ft/sec² – which is about 85 percent of the actual 32.2 ft/sec² freefall acceleration due to gravity. Because the perimeter columns are moving in three-dimensional space accurate quantification may not be possible from two-dimensional images.

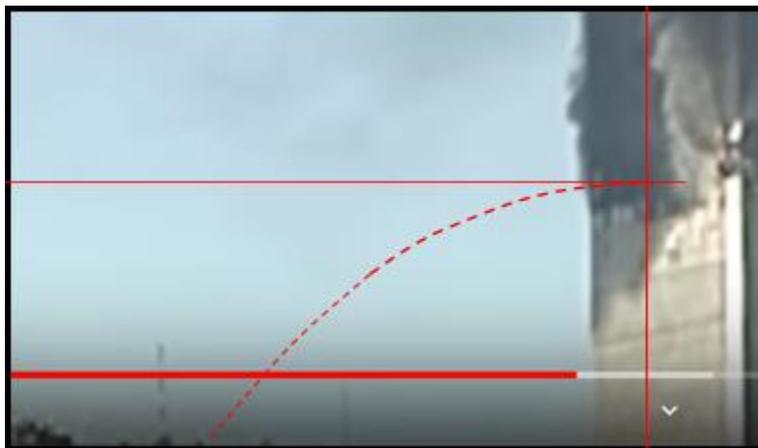
Figure 19: Starting location of the perimeter column wall section at the 80th floor of the east face as imputed from the horizontal and vertical velocities and accelerations.

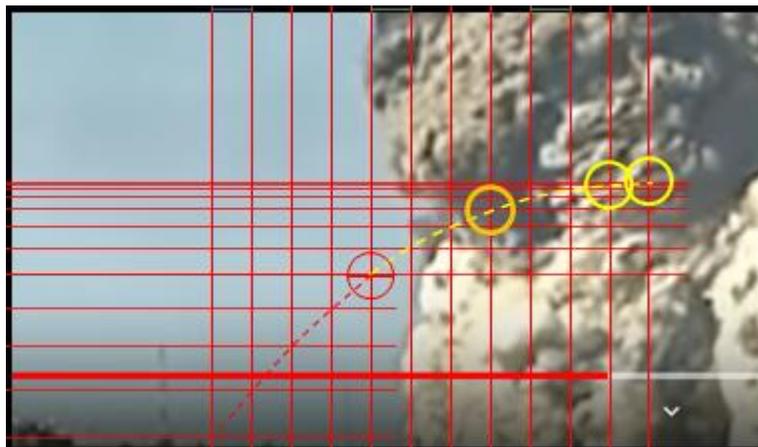
Figure 20: Implied location 1.00 second before initial observation (red circle is the location of the initial observation; orange circle is the imputed location 1.00 second earlier).

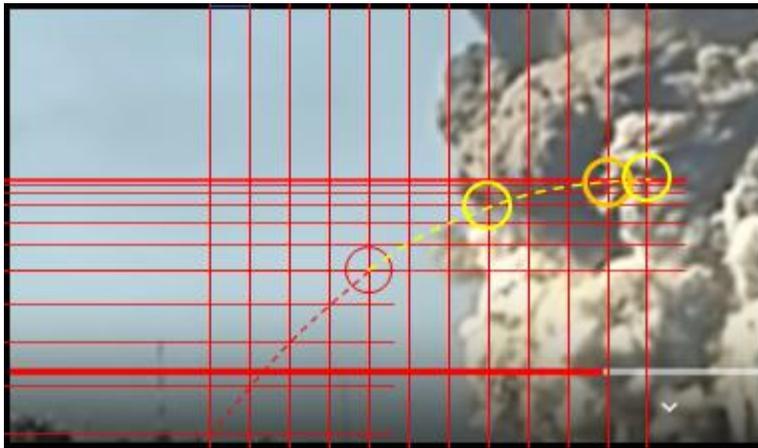
Figure 21: Implied location 2.00 second before initial observation (red circle is the location of the initial observation: orange circle is the imputed location 2.00 second earlier).

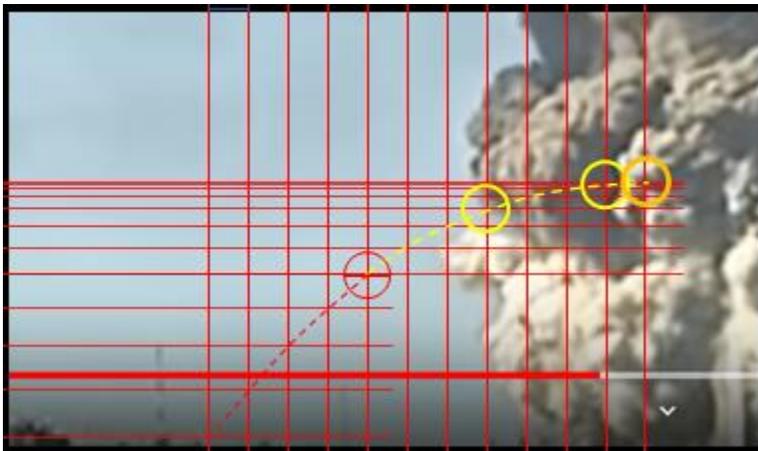
Figure 22: Implied location 2.27 seconds before initial observation is at the 80th floor (red circle is the location of the initial observation: orange circle is the imputed location 2.27 second earlier).

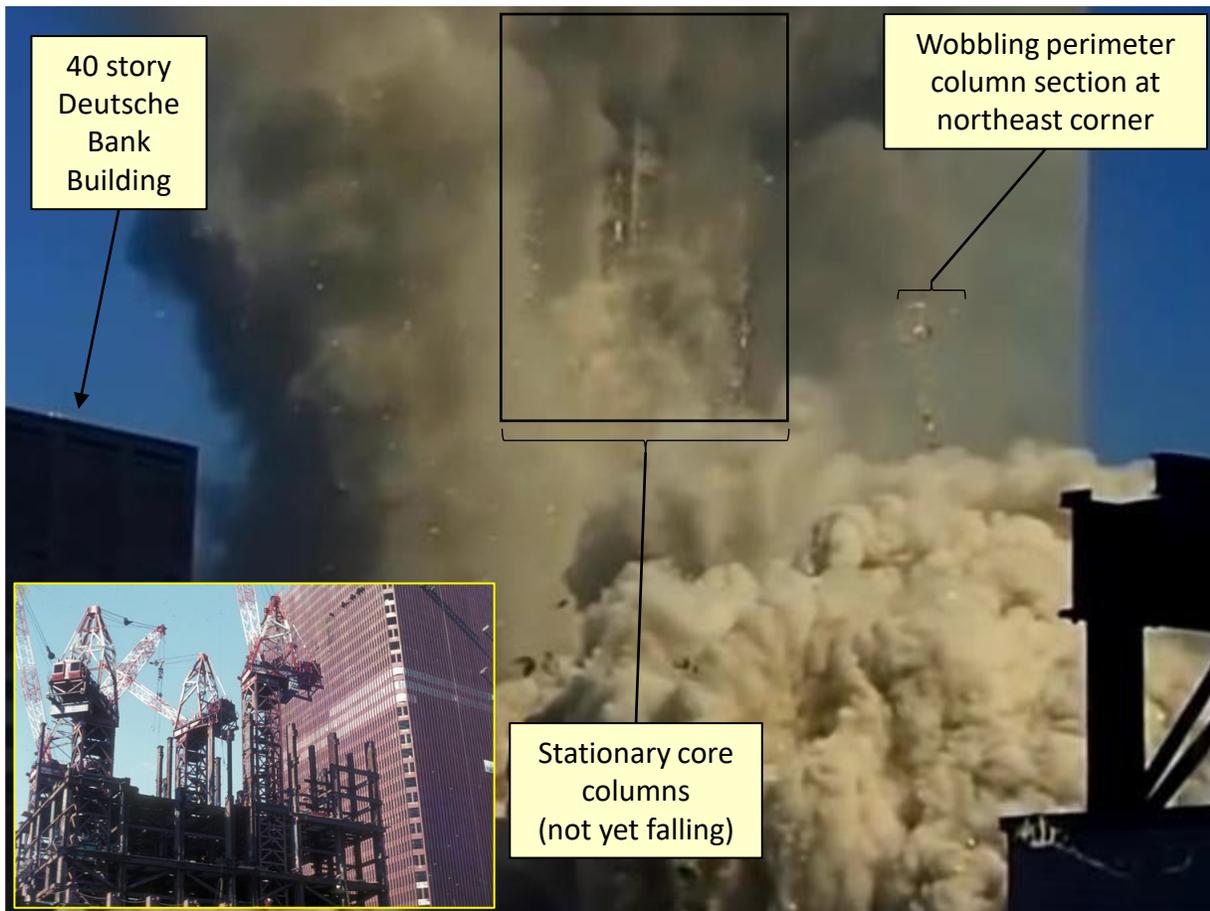
Figure 23: Details of the stationary core columns are seen in the Reviere video once the outer perimeter columns and floor trusses have been propelled away. Inset photo shows the South Tower core during construction from a similar perspective.

One of the remarkable details captured in the [“Skidmore, Owings & Merrill - from Dean Reviere” \(“Reviere”\)¹⁴](#) video is a three second segment where the core columns of the South Tower are clearly seen standing stationary once the outer perimeter columns and office areas were propelled away. The presence of these stationary core columns disproves any core column failure in the lower 2/3 of the South Tower much the same as the standing core of the North Tower, (e.g., “the ghost spire”) disproves core column failure in the North Tower, and supports the hypothesis that externally directed horizontal forces violently propelled the outer perimeter columns and office areas outward in all directions.

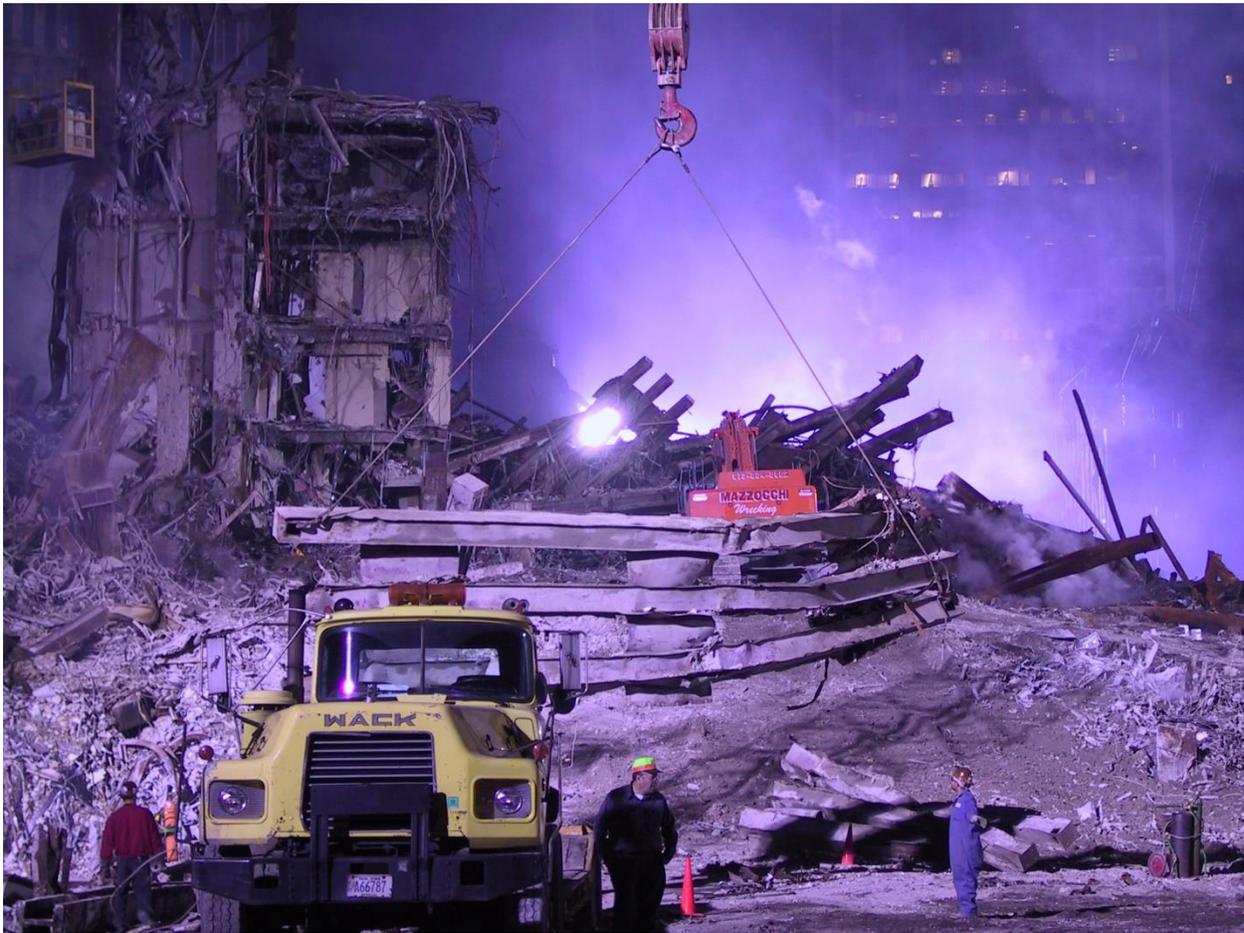
Figure 24: Wall boards surround the stairway where 13 survivors of the North Tower demolition were located suggesting horizontal propellant forces were absent at this location and falling debris did not dislodge wall board material.

It can also be observed that no drywall or other wall material is present separating the office area from the core. It would be expected that in a gravity only collapse, some portions of the wall would have been protected from falling debris as occurred in the atrium area of the North Tower¹⁵ as shown in Figure 24.

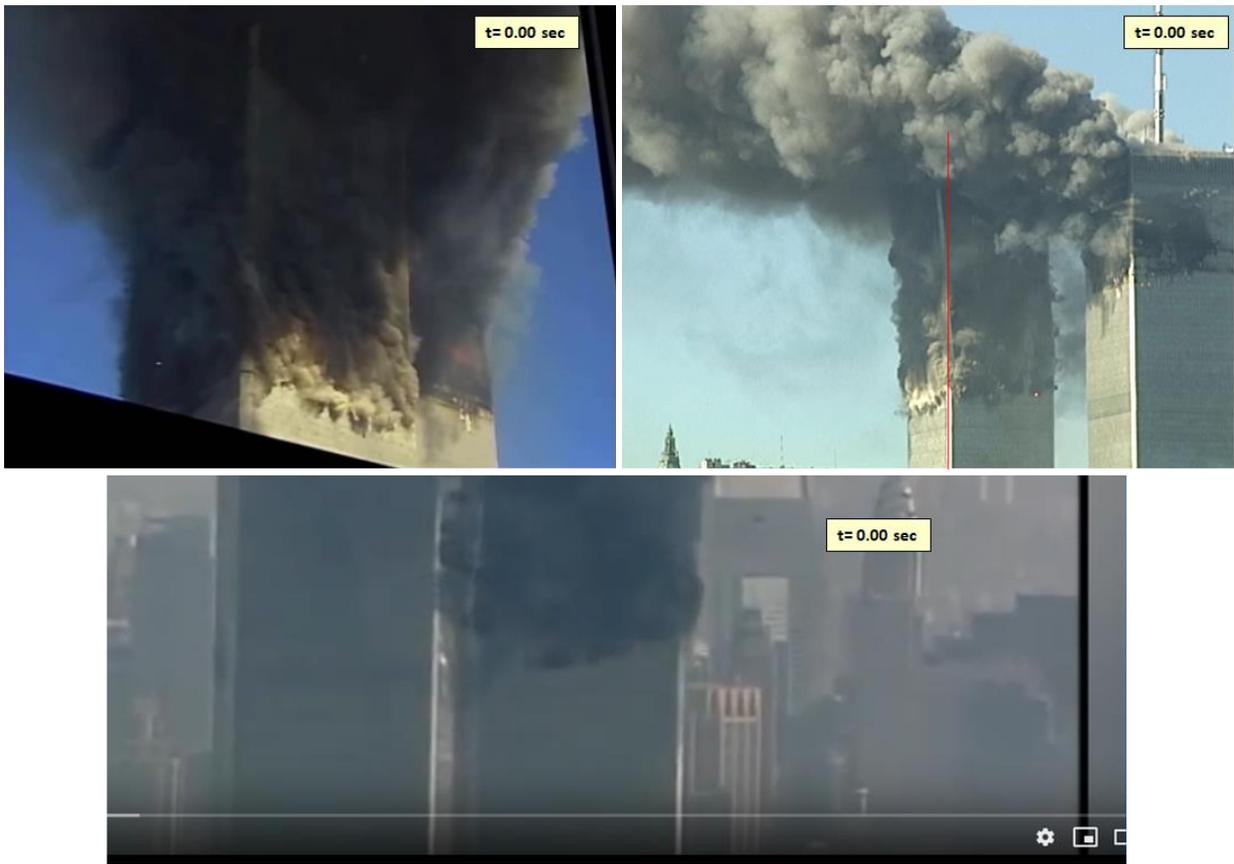
Figure Appendix 1: At t=0.00 sec – White clouds of dust and debris begin to be ejected horizontally from approximately the 80th floor as the top is seen hinging to the east. A vertical red line shows the continuation of the corner and will be used as a reference in several subsequent images.

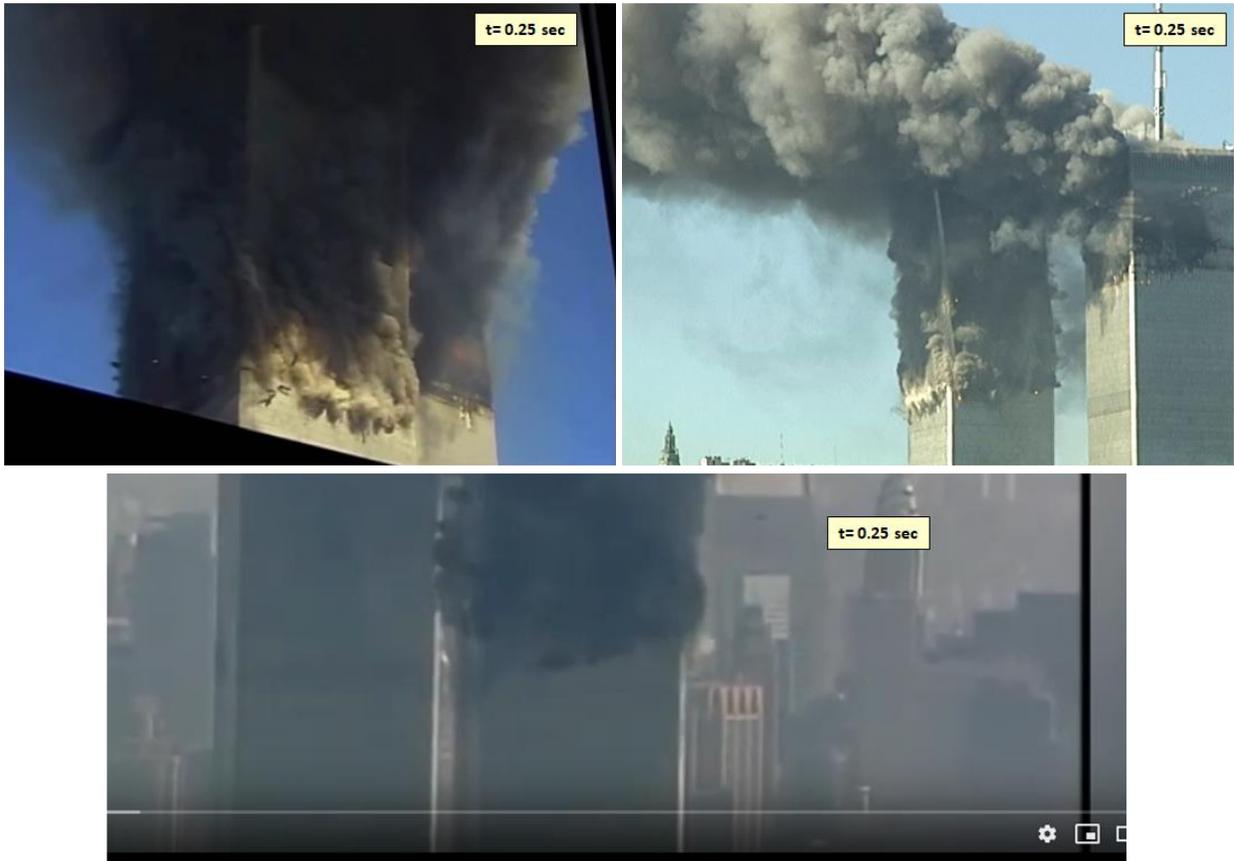
Figure Appendix 2: At $t=0.25$ sec – Horizontal forces push the cloud of dust and debris further from the wall.

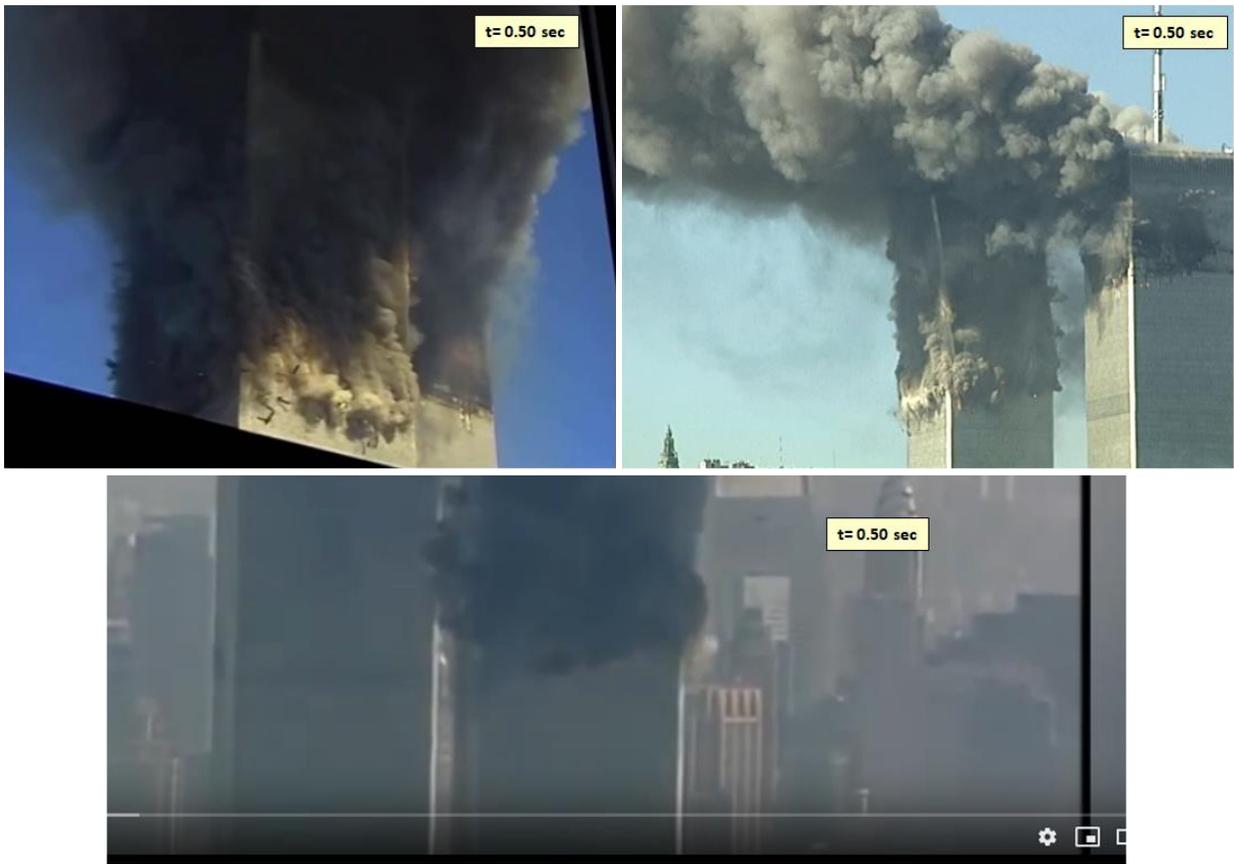
Figure Appendix 3:: At $t=0.50$ – The east and north sides of the top of the South Tower are visible in the “Reviere” and “DeJong” videos, respectively.

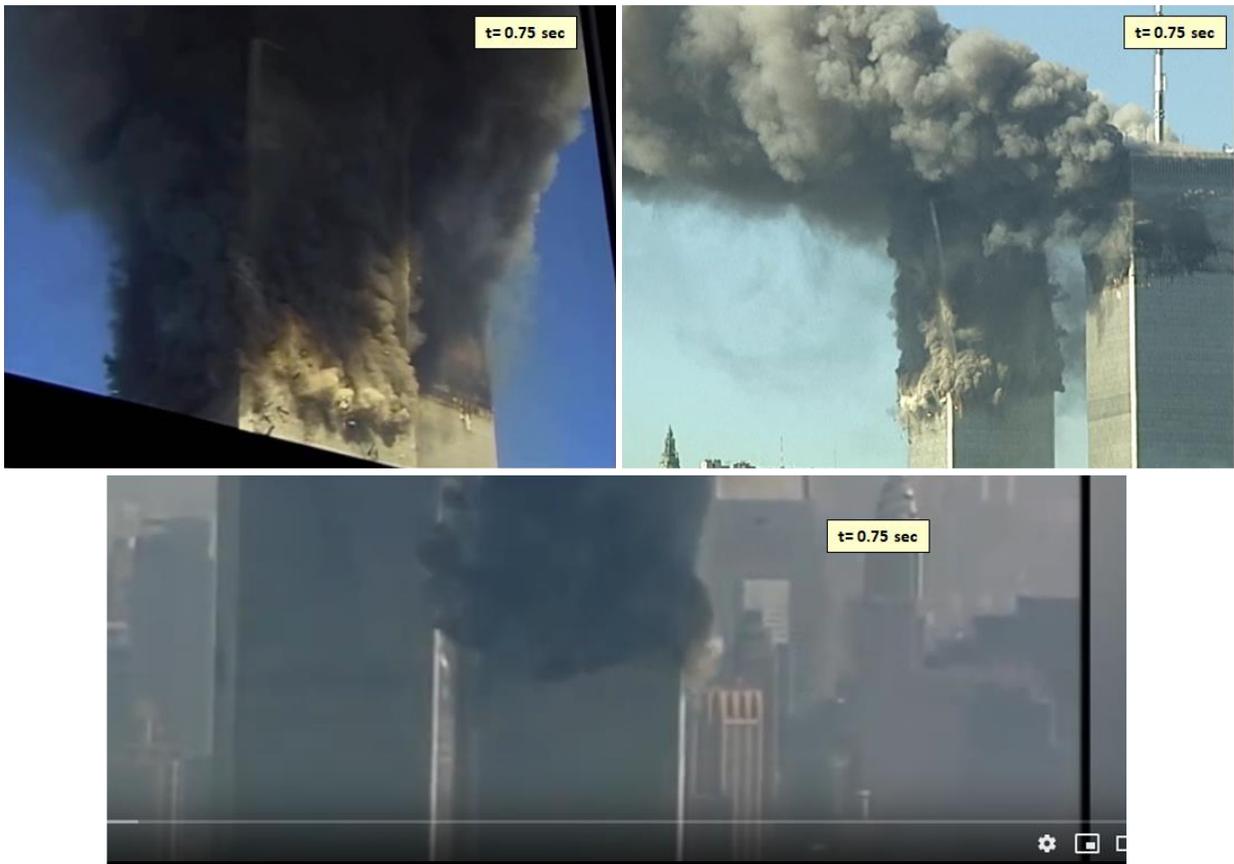
Figure Appendix 4: At $t=0.75$ – The east and north sides of the top of the South Tower are visible in the “Reviere” and “DeJong” videos, respectively. Increased hinging eastward of the Tower is observed in both videos.

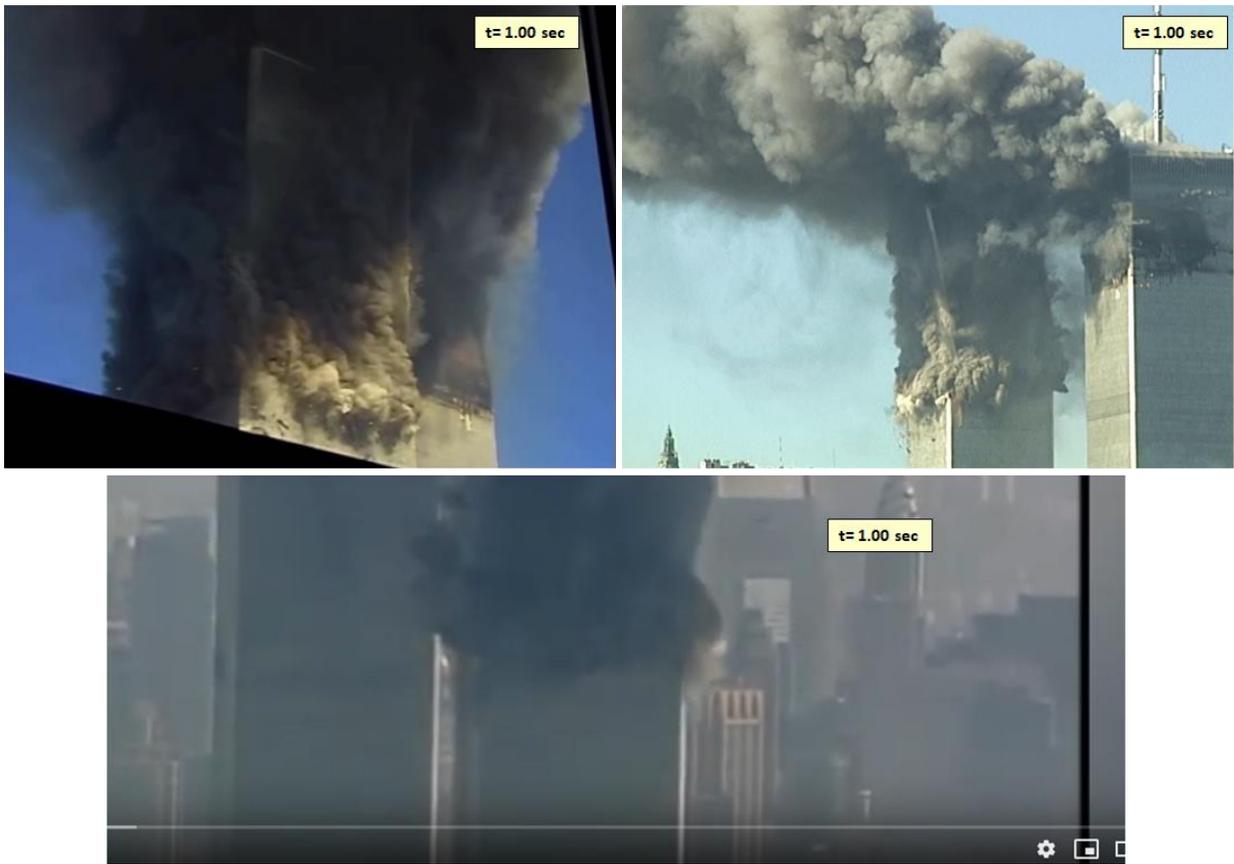
Figure Appendix 5: At $t=1.00$ sec – The east and north sides of the top of the South Tower remain visible in the “Reviere” and “DeJong” videos, respectively. Increased hinging eastward of the Tower is observed in both videos.

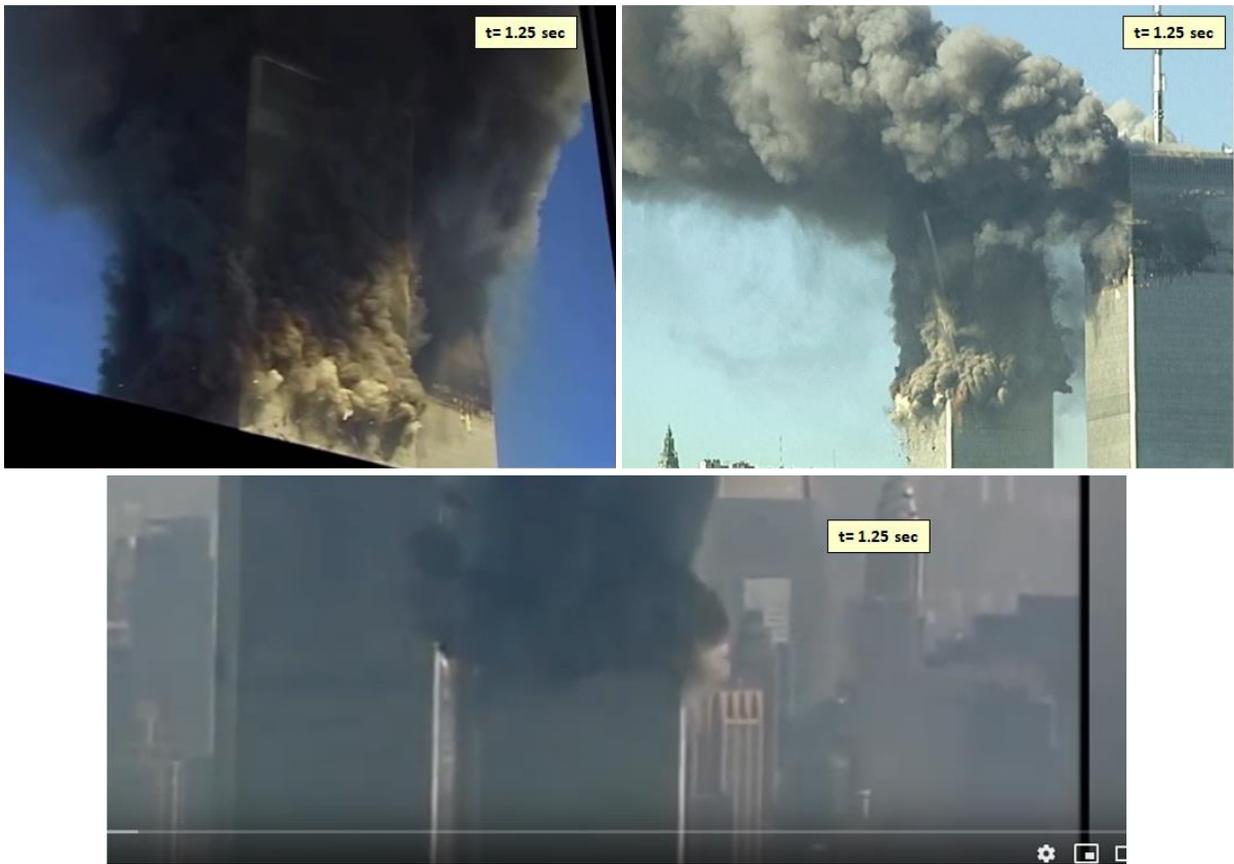
Figure Appendix 6: At $t=1.25$ – Increased hinging eastward of the Tower is observed in both videos, large pieces of the façade are seen falling in both videos.
