“Surfing” the Big Wave on 9/11

Analysis of a Large Perimeter Column Wall Section of the South Tower

By Wayne Coste, PE

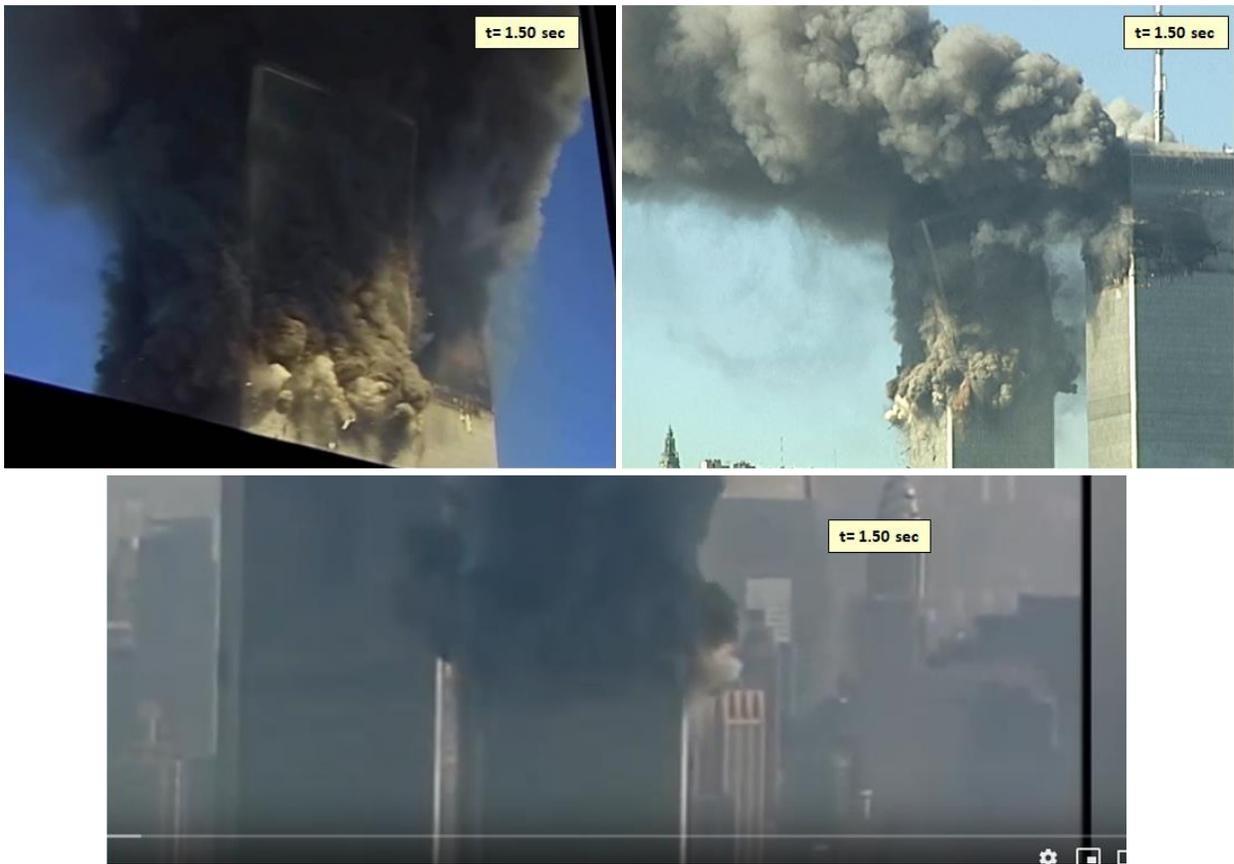
Figure Appendix 7: At $t=1.50$ – Increased hinging eastward of the Tower is observed in both videos, large pieces of the façade are seen falling in both videos.

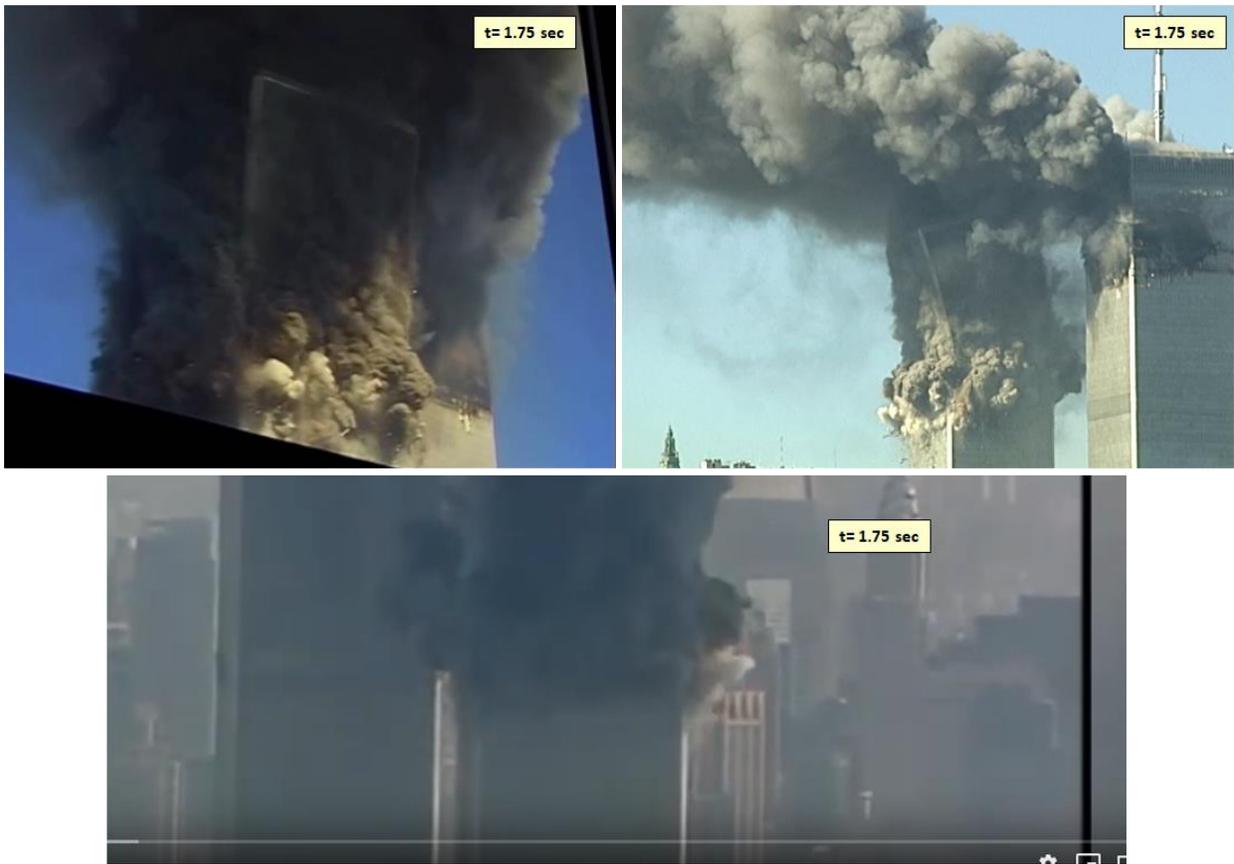
Figure Appendix 8: At $t=1.75$ – The east and north sides of the top of the South Tower are visible in the “Reviere” and “DeJong” videos, respectively. The hinging motion is clearly seen in the “DeJong” video as the top corner descends and the west side (top and bottom) is deflected westward.

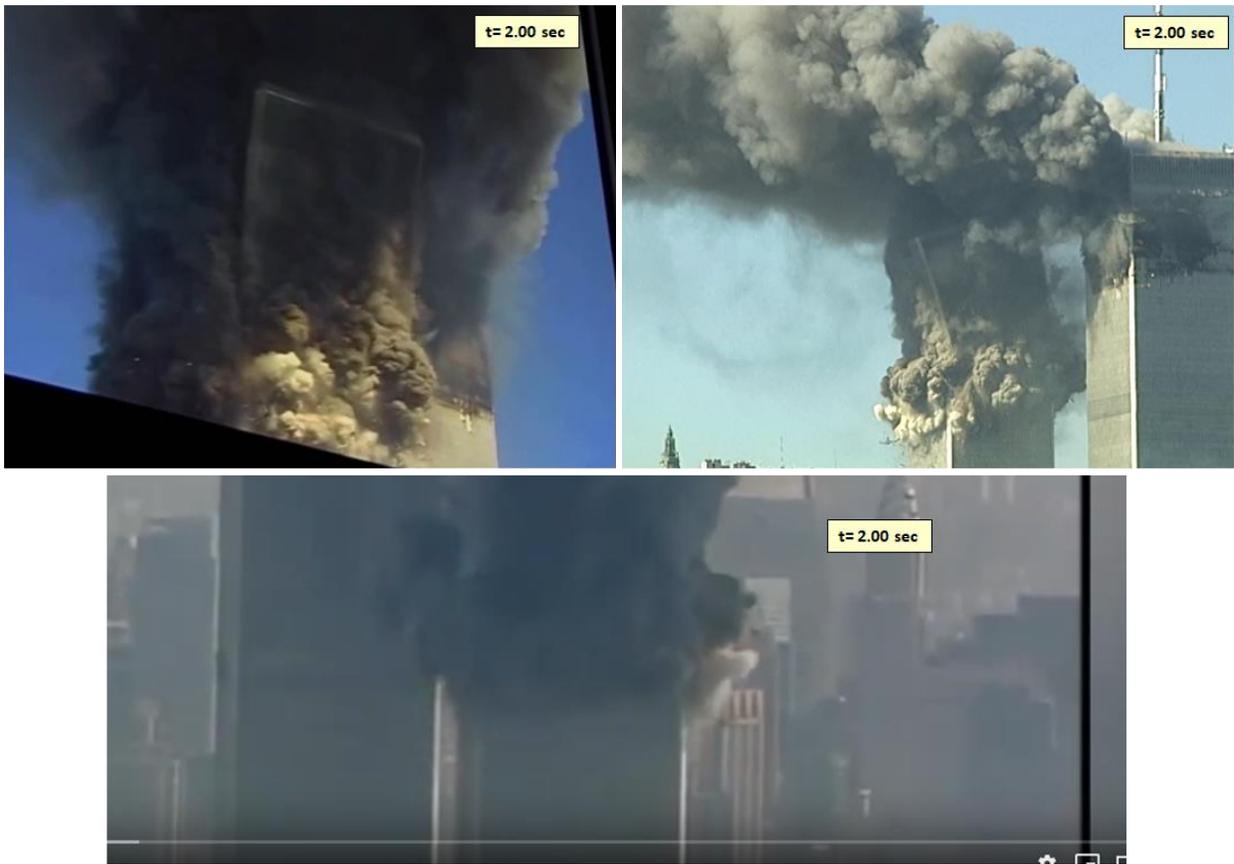
Figure Appendix 9: At $t=2.00$ – The east and north sides of the top of the South Tower are visible in the “Reviere” and “DeJong” videos, respectively.

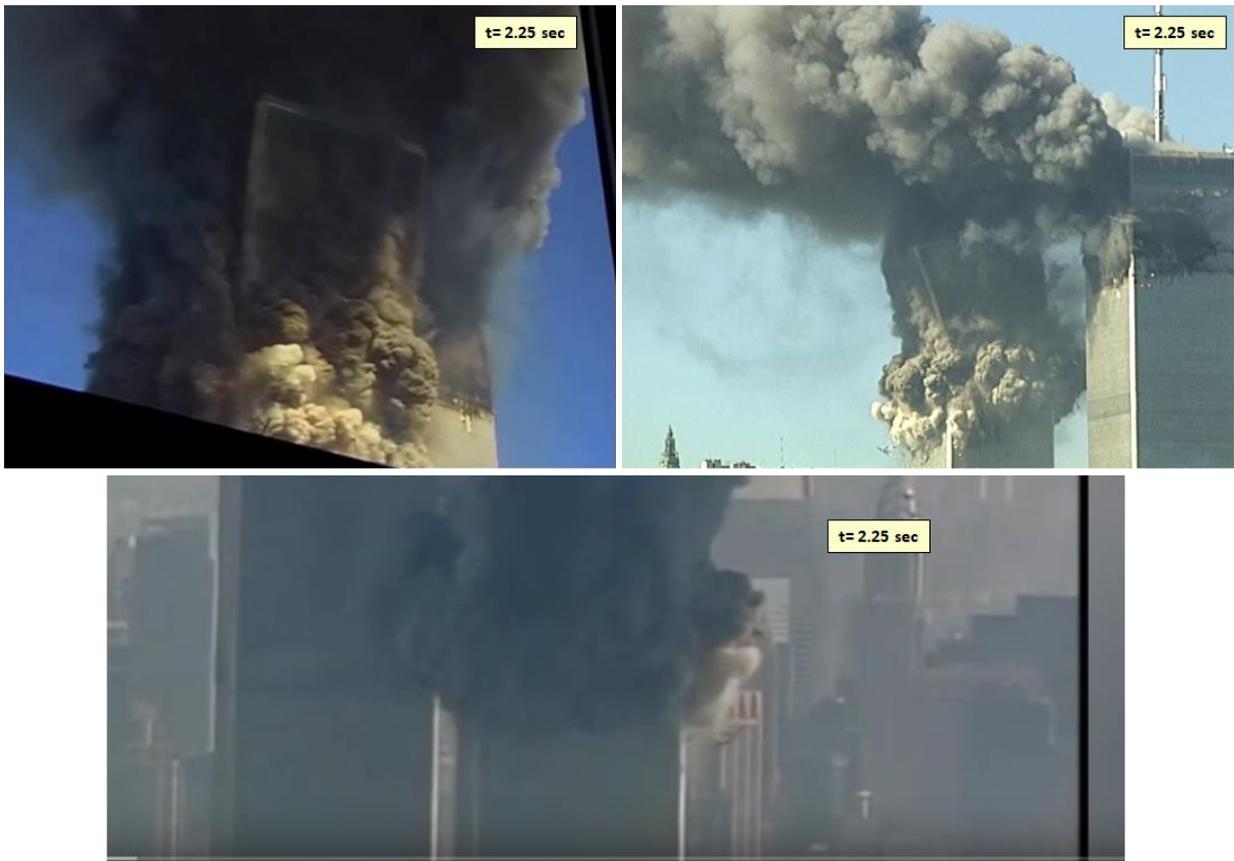
Figure Appendix 10: At $t=2.25$ – The east and north sides of the top of the South Tower are visible in the “Reviere” and “DeJong” videos, respectively.

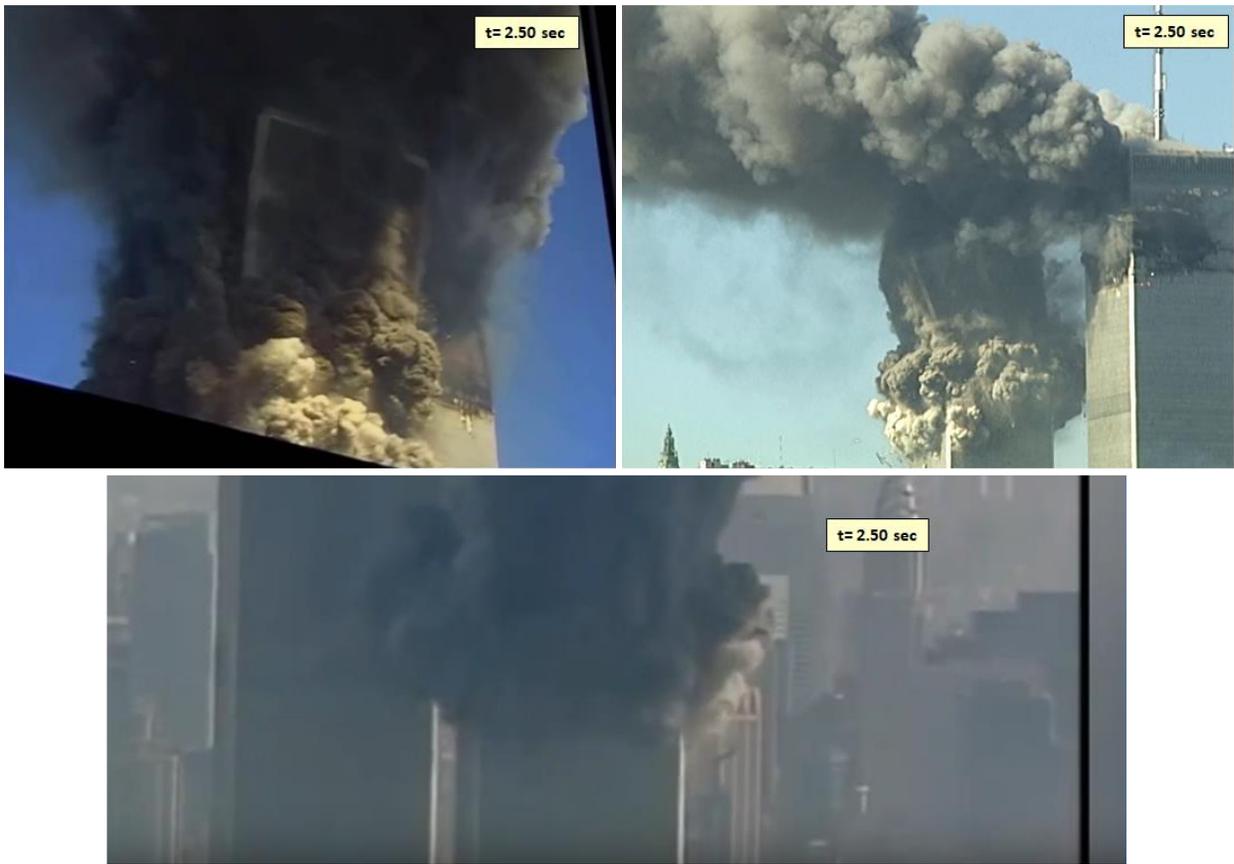
Figure Appendix 11: At $t=2.50$ – The east and north sides of the top of the South Tower are visible in the “Reviere” and “DeJong” videos, respectively.

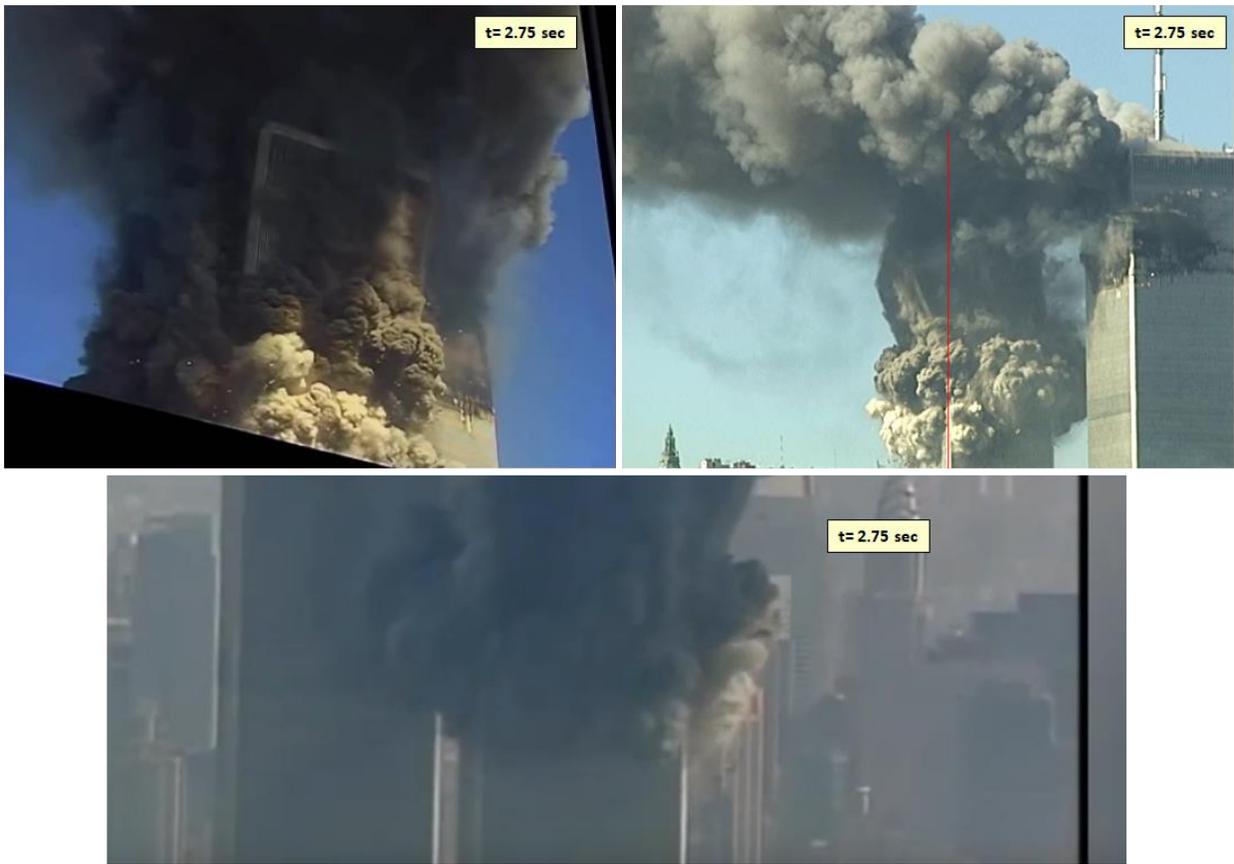
Figure Appendix 12: At $t=2.75$ – The east and north sides of the top of the South Tower are visible in the “Reviere” and “DeJong” videos, respectively.

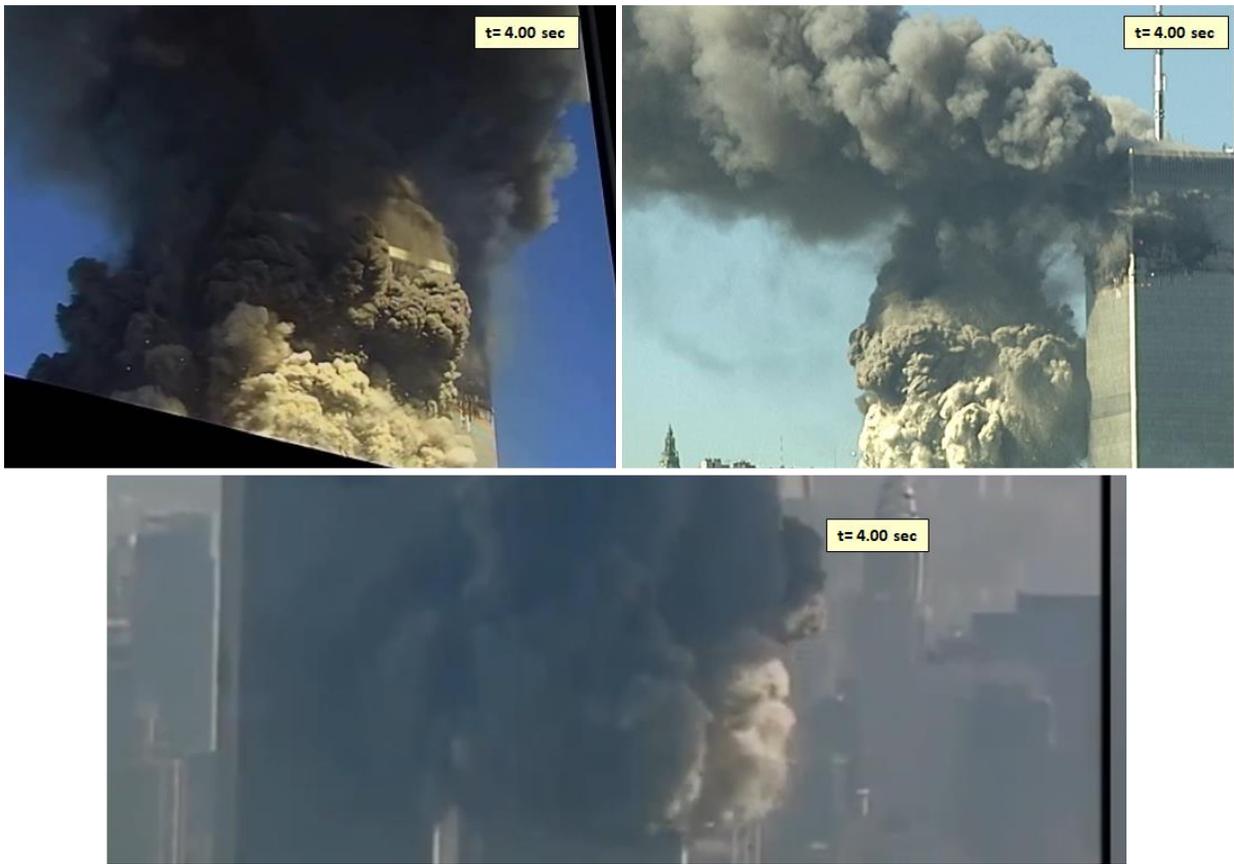
Figure Appendix 17: At $t=4.00$ – The east side of the top of the South Tower in the “Reviere” video, while the north side is barely visible in the “DeJong” video.

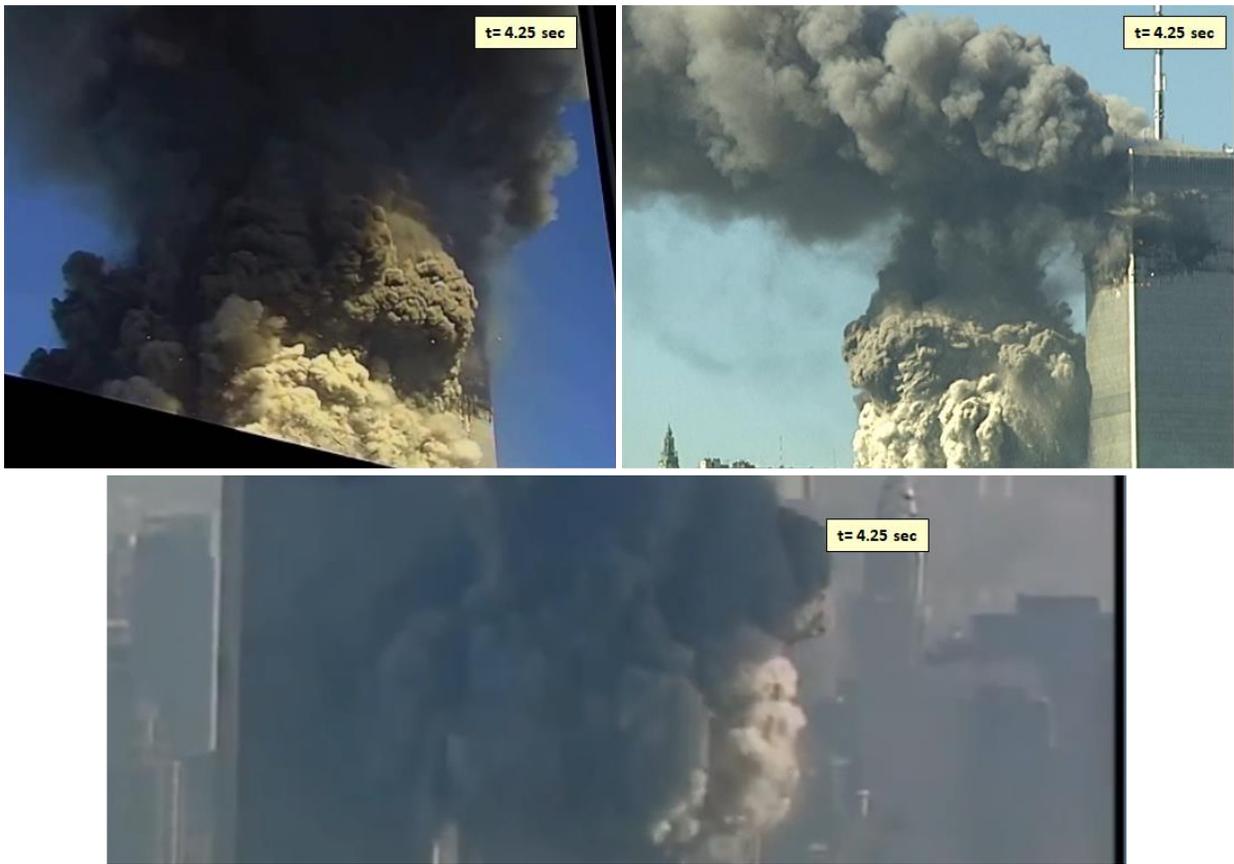
Figure Appendix 18: At t=4.25 – The top descends behind black smoke in the “Reviere” video, and is completely obscured in both videos.

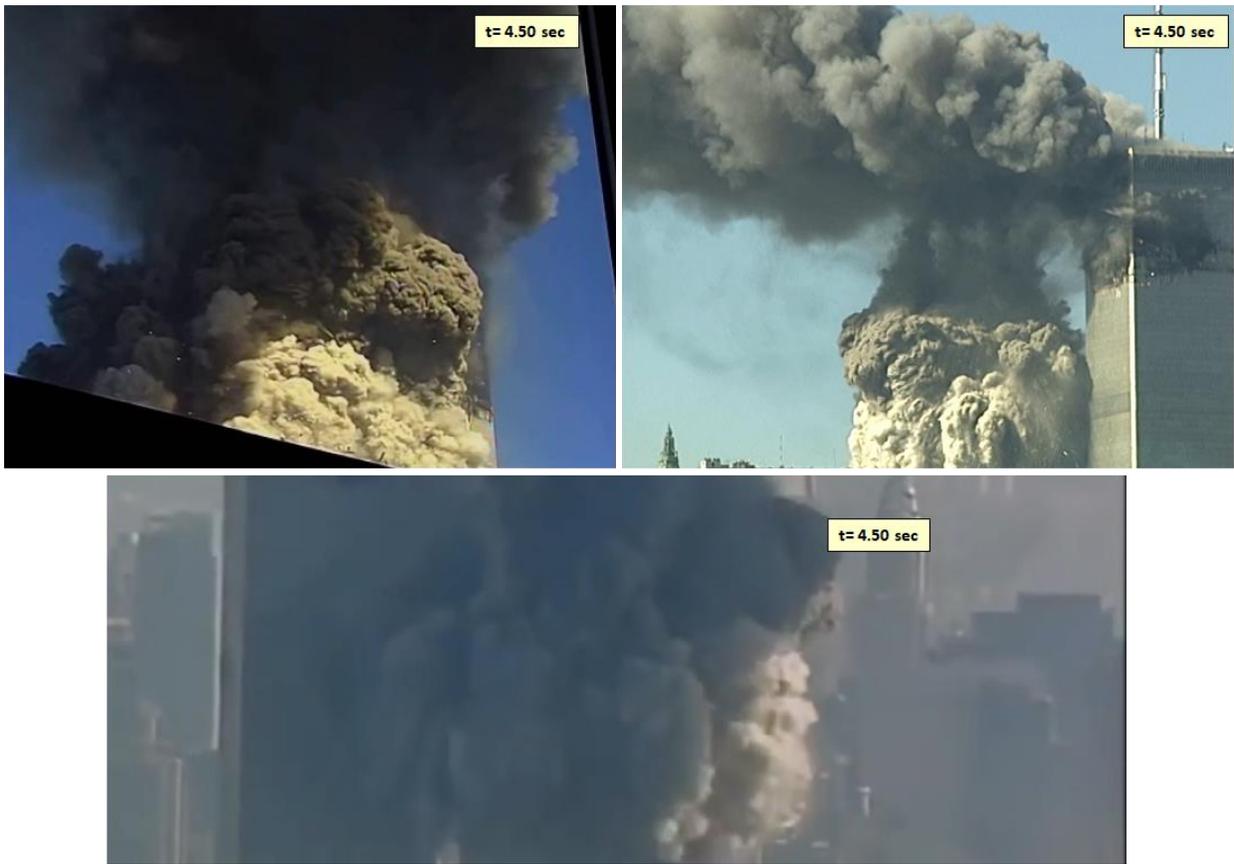
Figure Appendix 19: At t=4.50– The cloud of dust and debris expands with no structure clearly discernable.

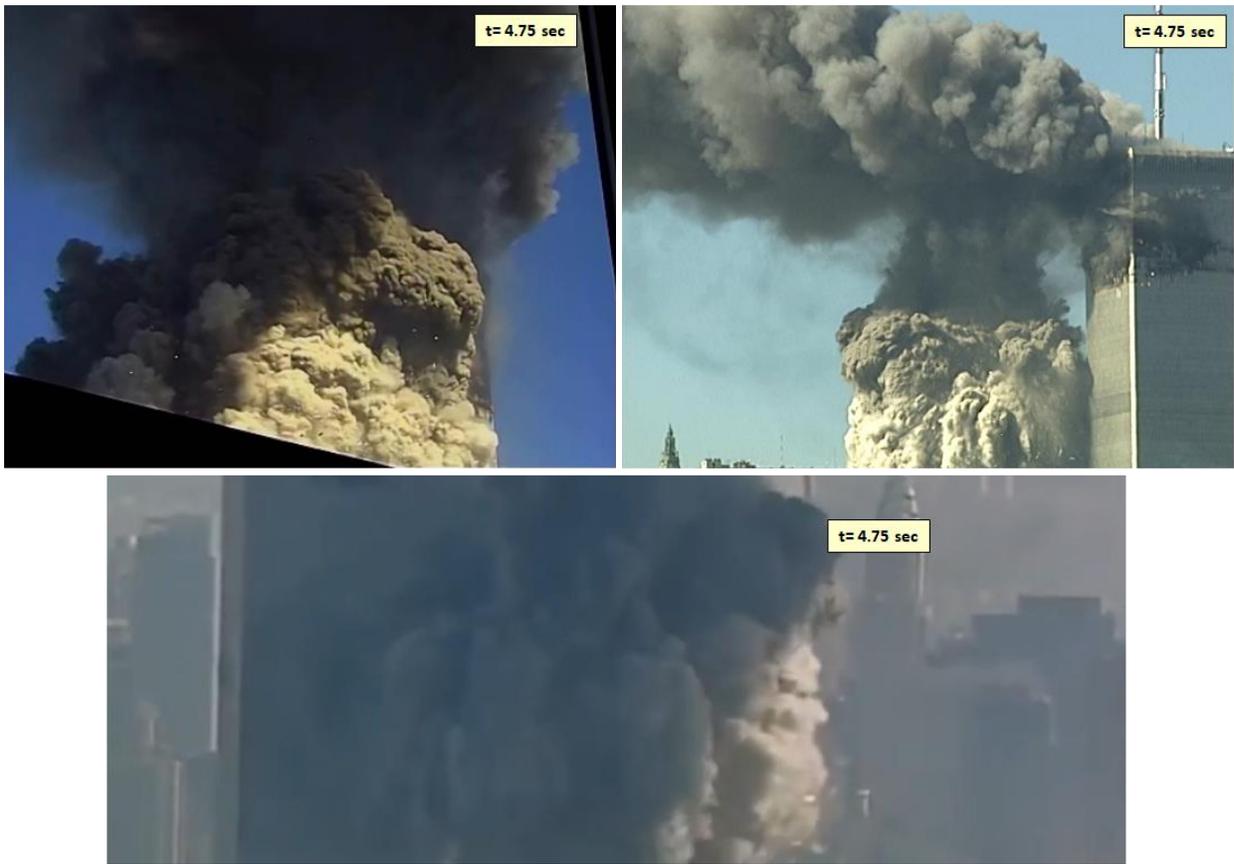
Figure Appendix 20: At $t=4.75$ sec – Outlines of perimeter columns are seen in “Reviere” video, but not identifiable in either the “DeJong” or “unnamed” video.

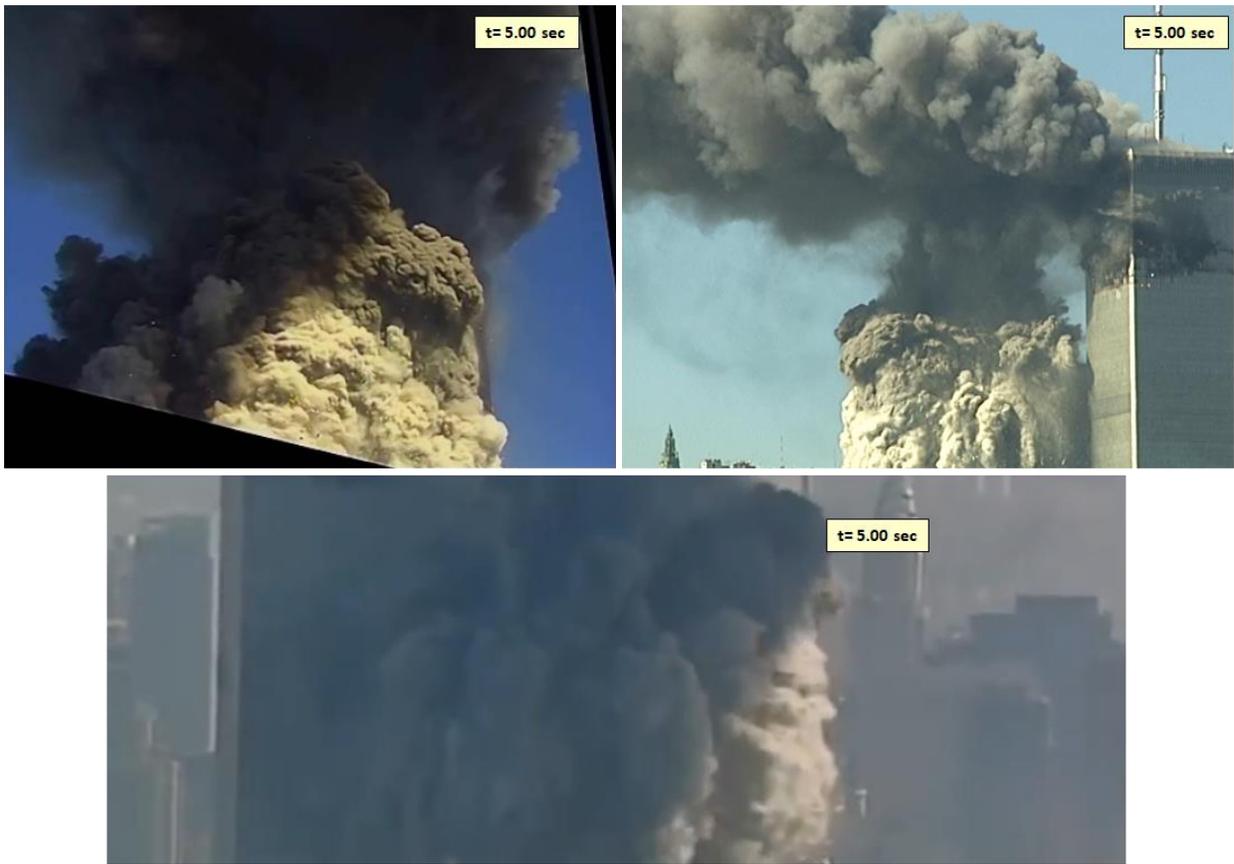
Figure Appendix 21: At $t=5.00$ sec – Outlines of perimeter columns are seen in “Reviere” video, but not identifiable in the “DeJong” or “unnamed” video.

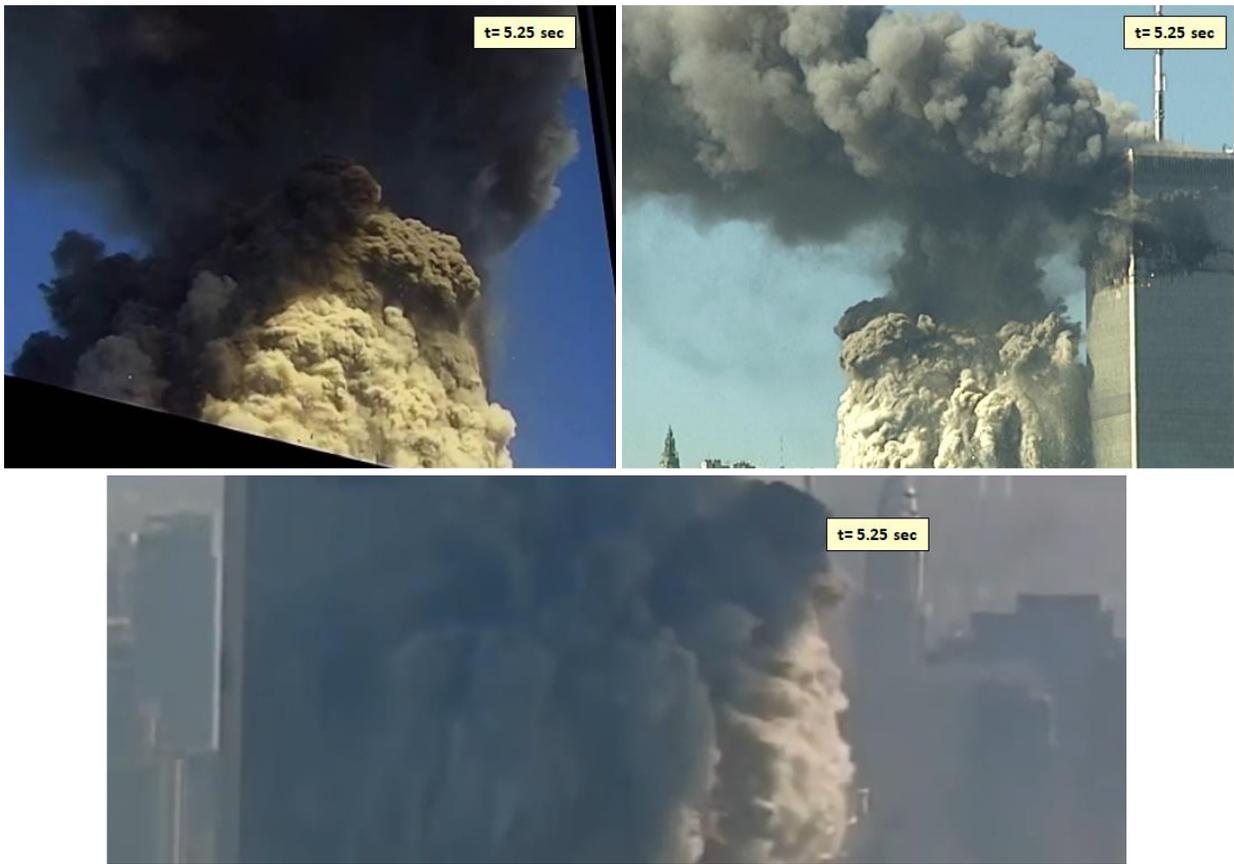
Figure Appendix 22: At t=5.25 sec – Outlines of the perimeter columns are seen in the “Reviere” video, but are not identifiable in the “DeJong” or “unnamed” video. They begin to emerge in the “unnamed” video.

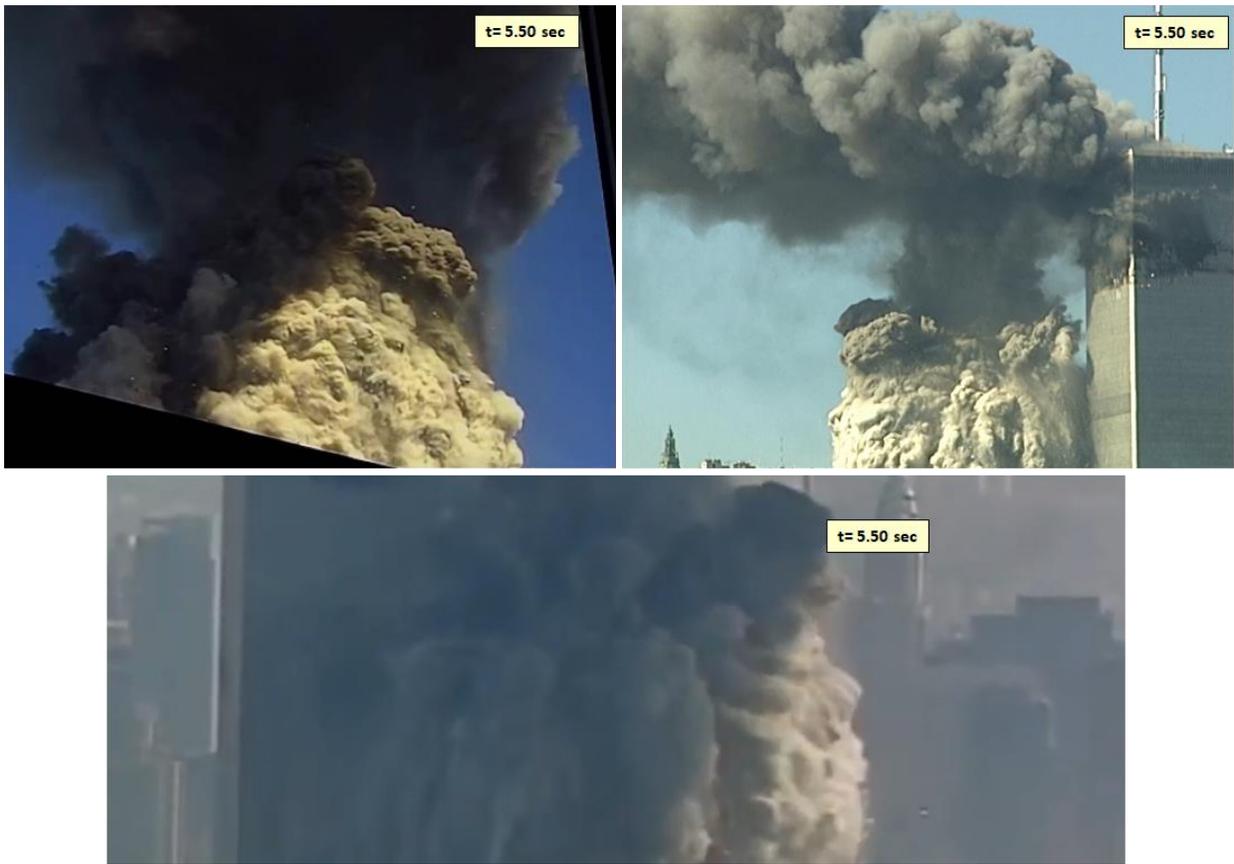
Figure Appendix 23: At t=5.50 sec – Perimeter columns begin to emerge in the “Reviere” video and begin to emerge in the “DeJong” video. They are clearly visible in the “unnamed” video.

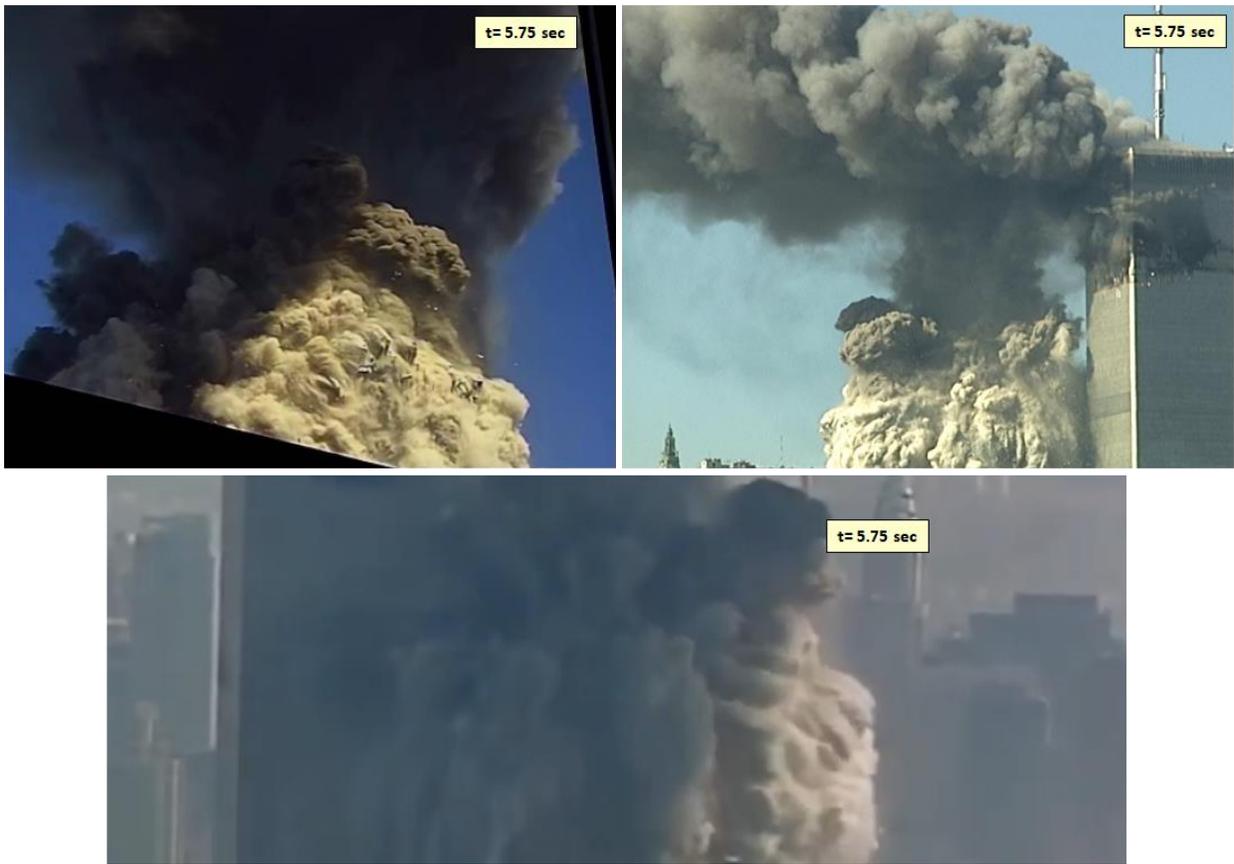
Figure Appendix 24: At t=5.75 sec – Perimeter columns continue to emerge in the “Reviere” video and are clearly seen in the “DeJong” and “unnamed” video.

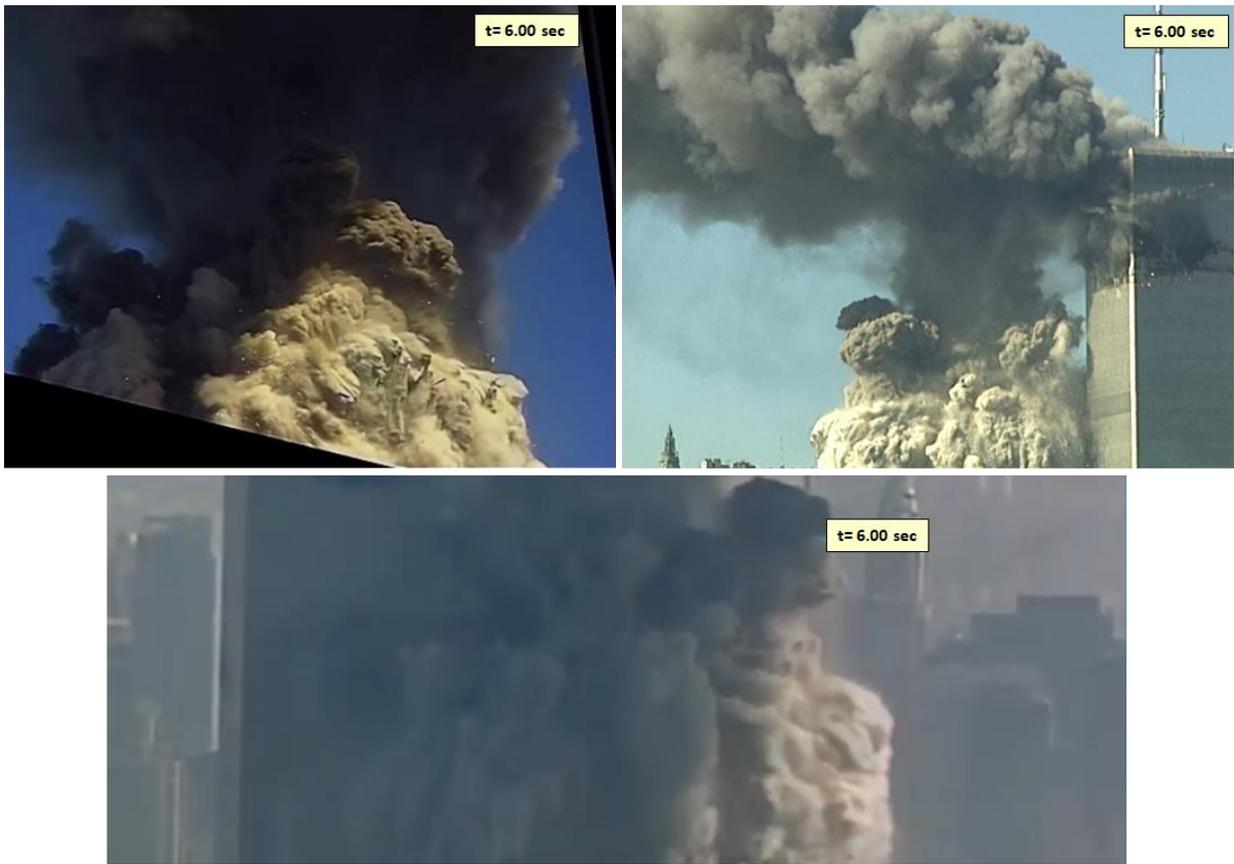
Figure Appendix 25: At t=6.00 – Perimeter columns are clearly seen in the “Reviere,” “DeJong” and “unnamed” video.

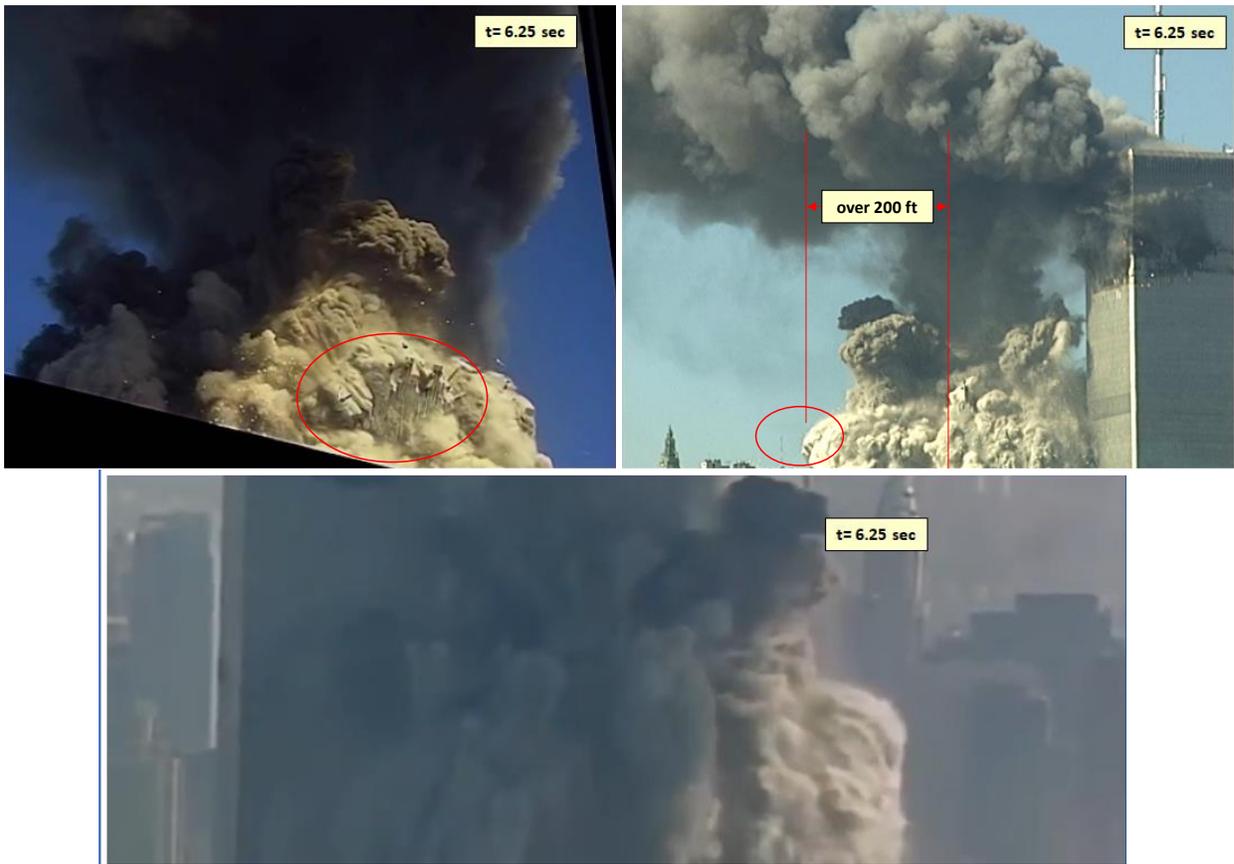
Figure Appendix 26: At t=6.25 sec – Perimeter columns are clearly seen in the “Reviere,” “DeJong” and “unnamed” video. At this point they are over 200 feet from the east side of the Tower.

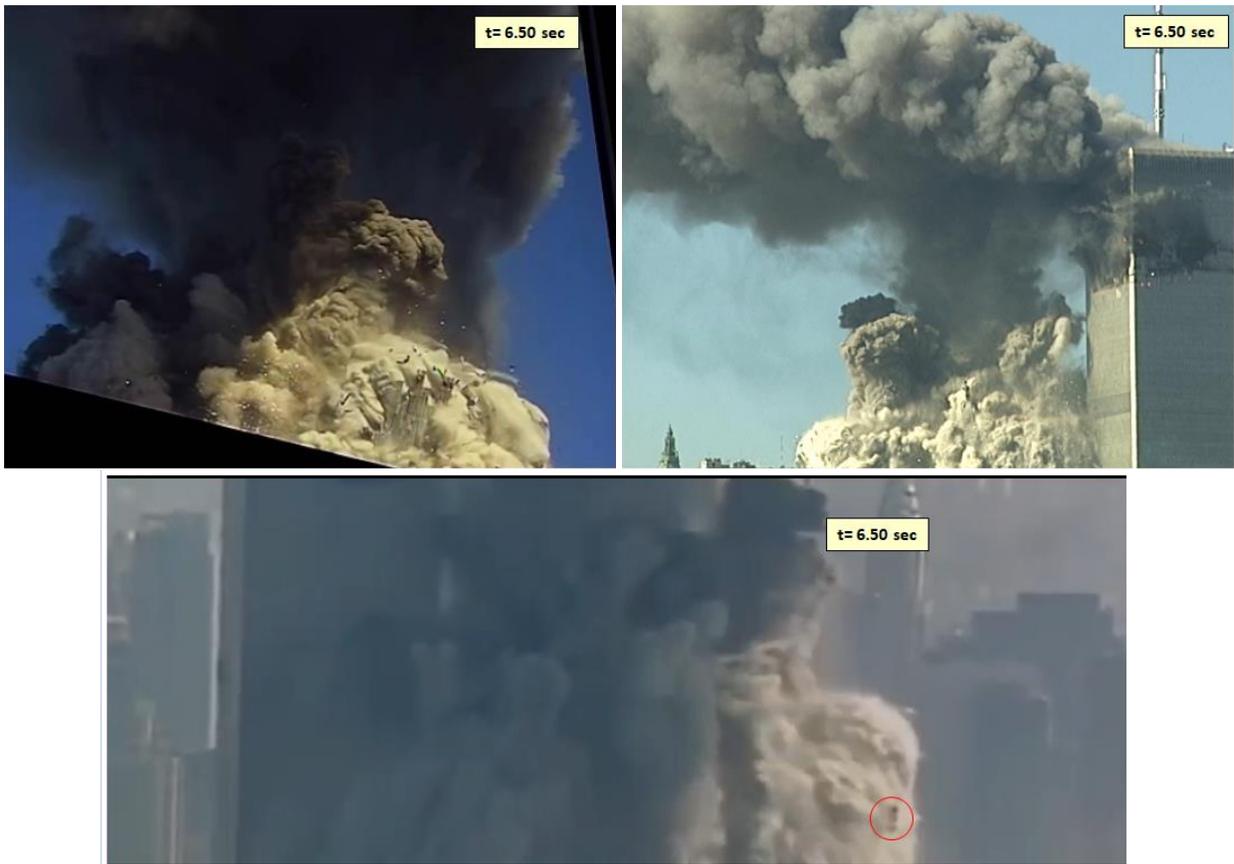
Figure Appendix 27: At t=6.50 – Perimeter columns are clearly seen in the “Reviere” video and in the “DeJong” video. These perimeter column sections are captured in the “unnamed” video.

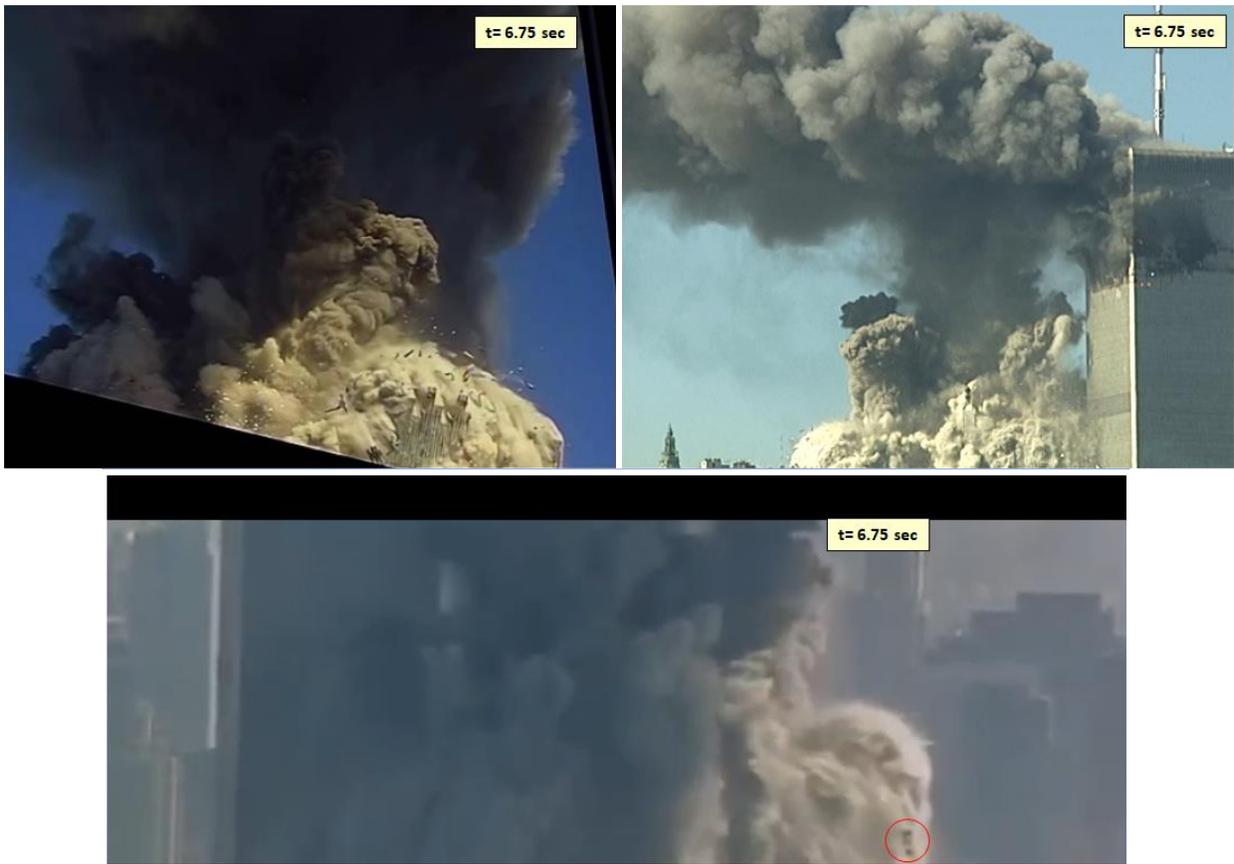
Figure Appendix 28: At t=6.75 – Perimeter columns are clearly seen in the “Reviere” video and top of the columns remains visible in the “DeJong” video. These perimeter column sections are captured in the “unnamed” video.

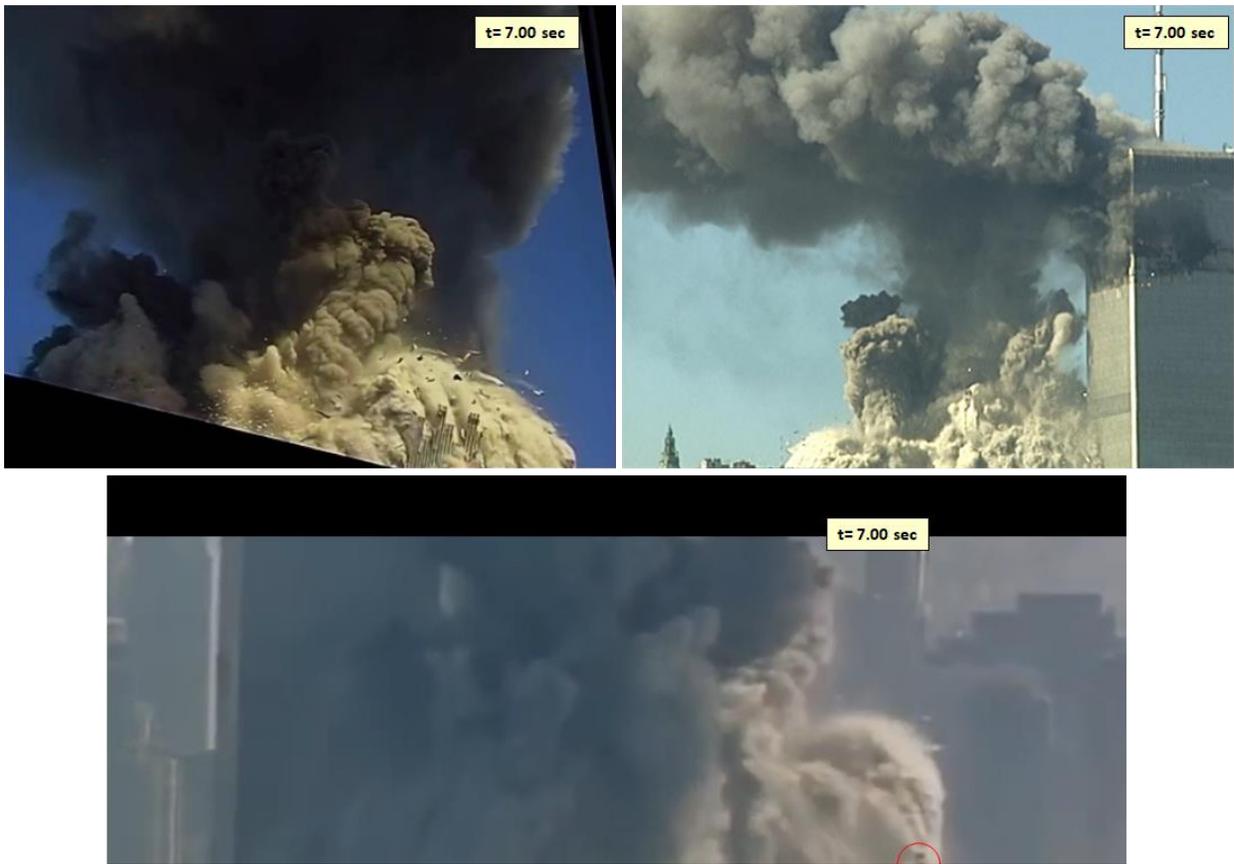
Figure Appendix 29: At t=7.00 – Perimeter columns are clearly seen in the “Reviere” video and descend out-of-sight in the “DeJong” video. These perimeter column sections are captured in the “unnamed” video.

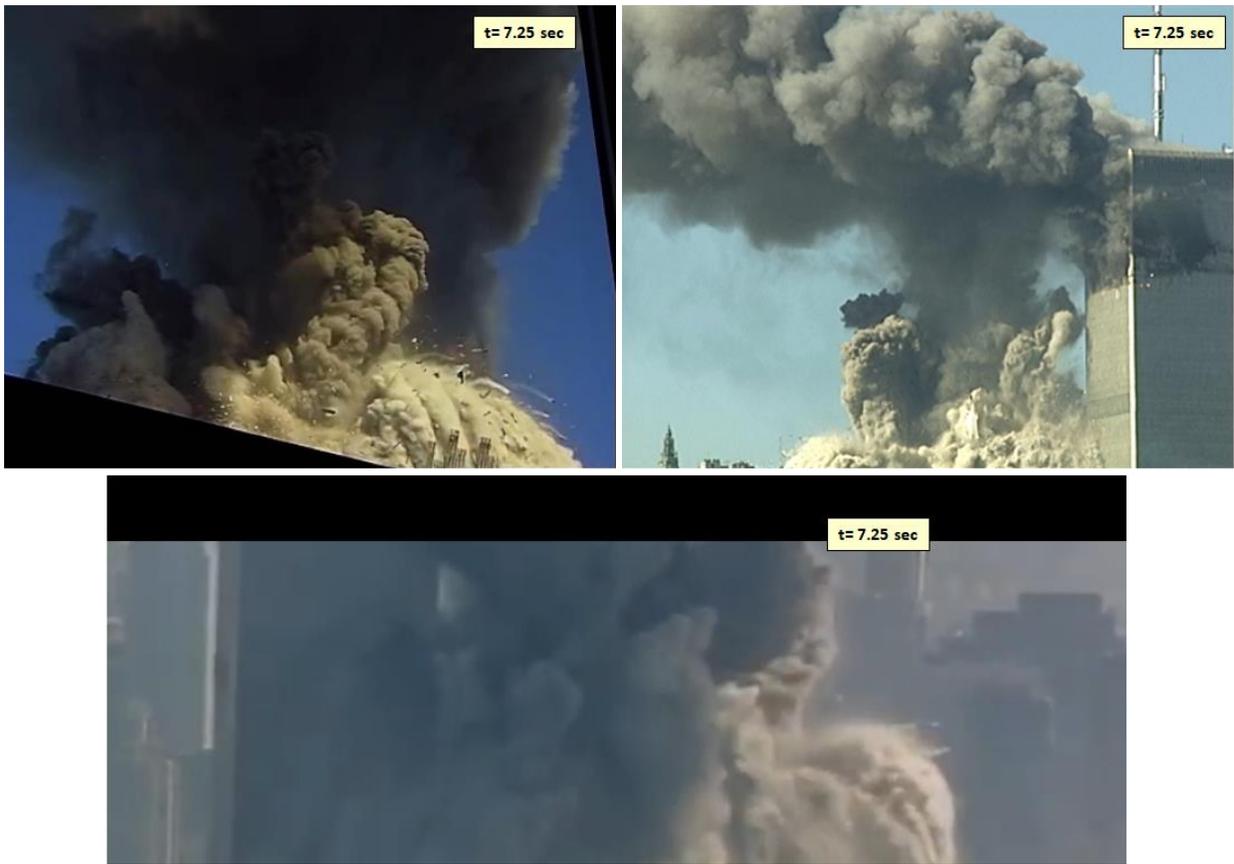
Figure Appendix 30: At t=7.25 sec – Perimeter columns continue to be seen clearly in the “Revire” video.

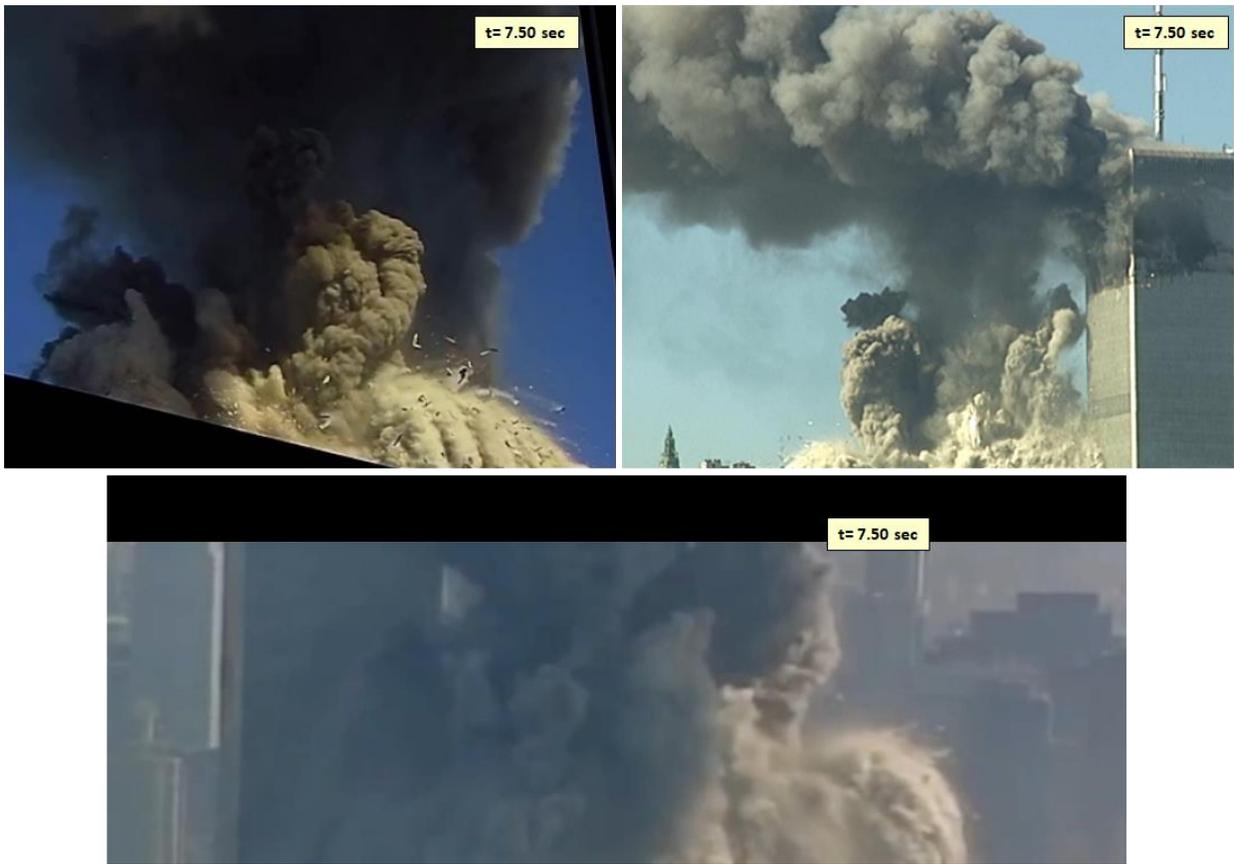
Figure Appendix 31: At t=7.50 sec – Top of the perimeter columns continue to be seen in the “Revire” video.
