“Surfing” the Big Wave on 9/11

Analysis of a Large Perimeter Column Wall Section of the South Tower

By Wayne Coste, PE

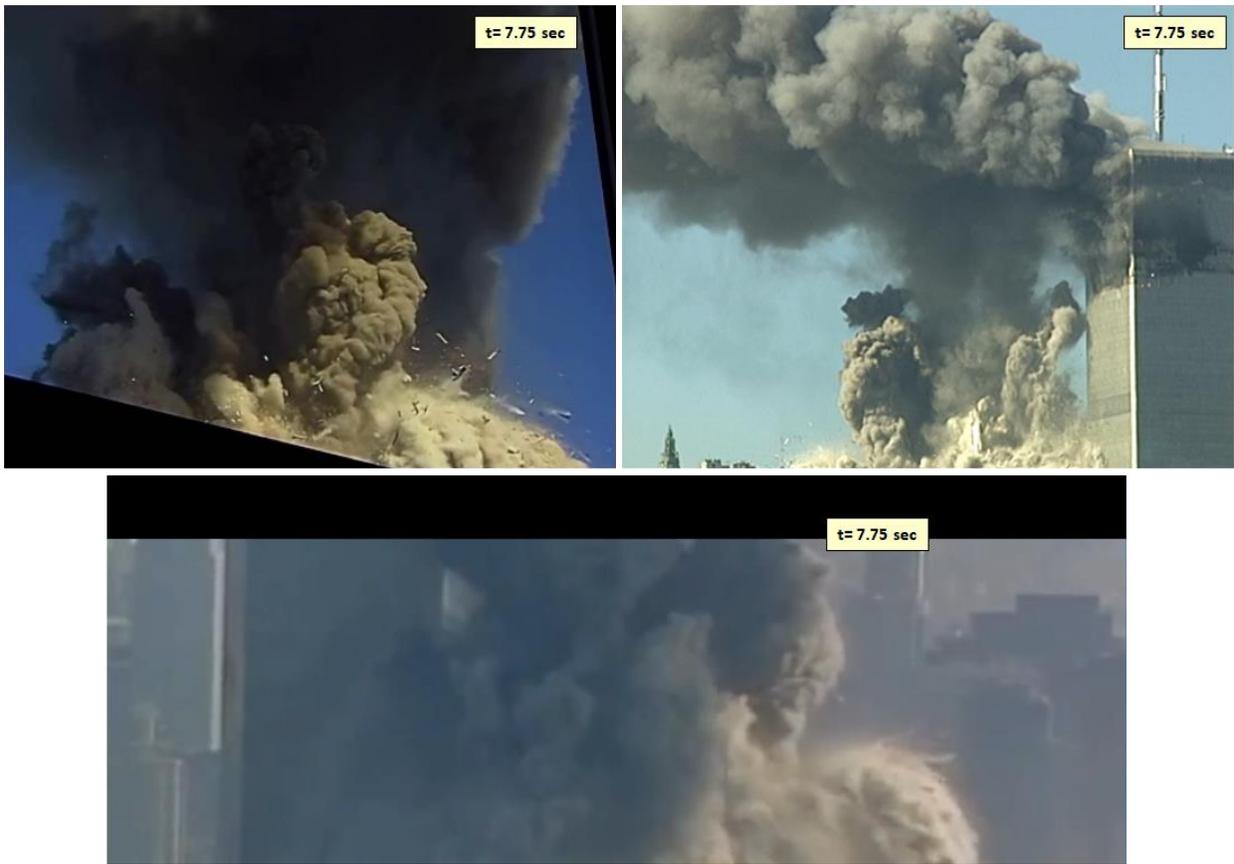
Figure Appendix 32: At $t=7.25$ sec – Only the path of some of the columns through the dust cloud remains visible in the “Reviere” video.
