# Retrofitted Pentagon Walls: Review of Design, Construction and Destruction

Prepared for the June 28, 2017  
9/11 Truth and Other Deep State Crimes Teleconference

Wayne H. Coste, PE  
Truth Outreach, Inc.

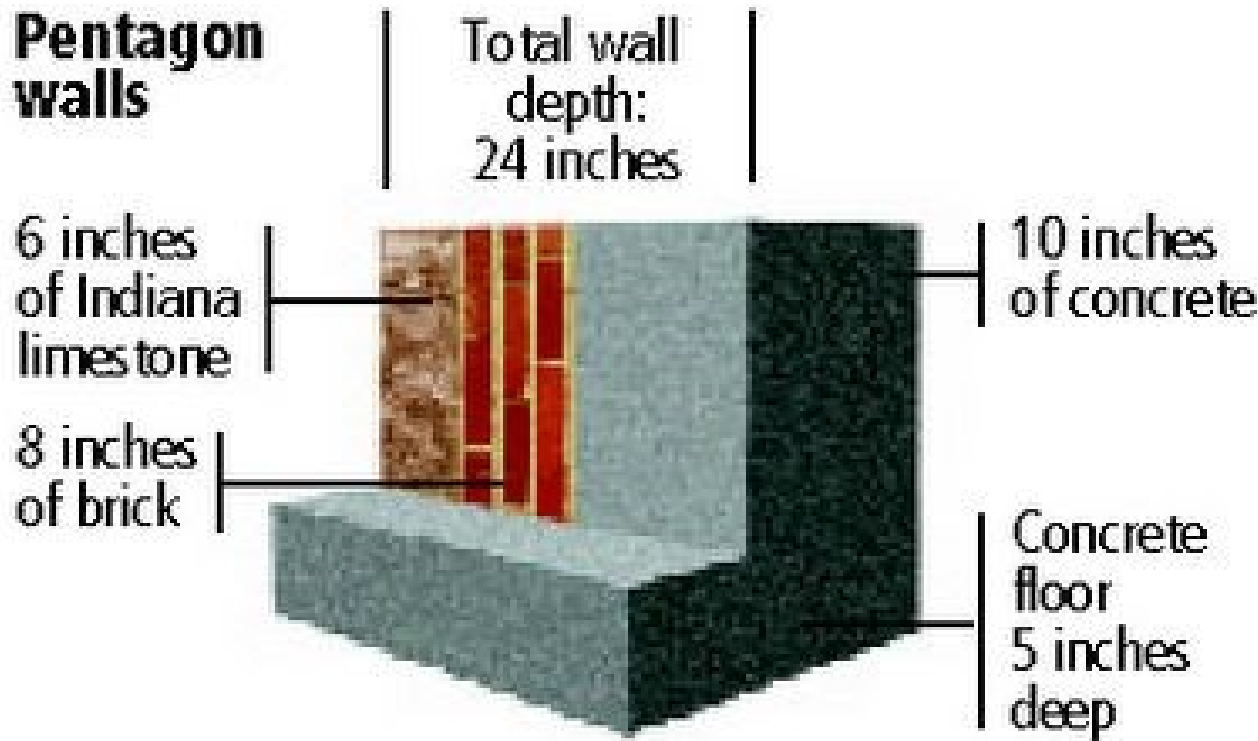
Wedge One's outer wall frequently characterized as solid, massive, limestone, brick and reinforced concrete wall

**Two-foot thick wall without windows**

**Protect occupants from blast and flying glass / bricks**

**NOTE: Sections with windows replace concrete with steel and Kevlar window frame**

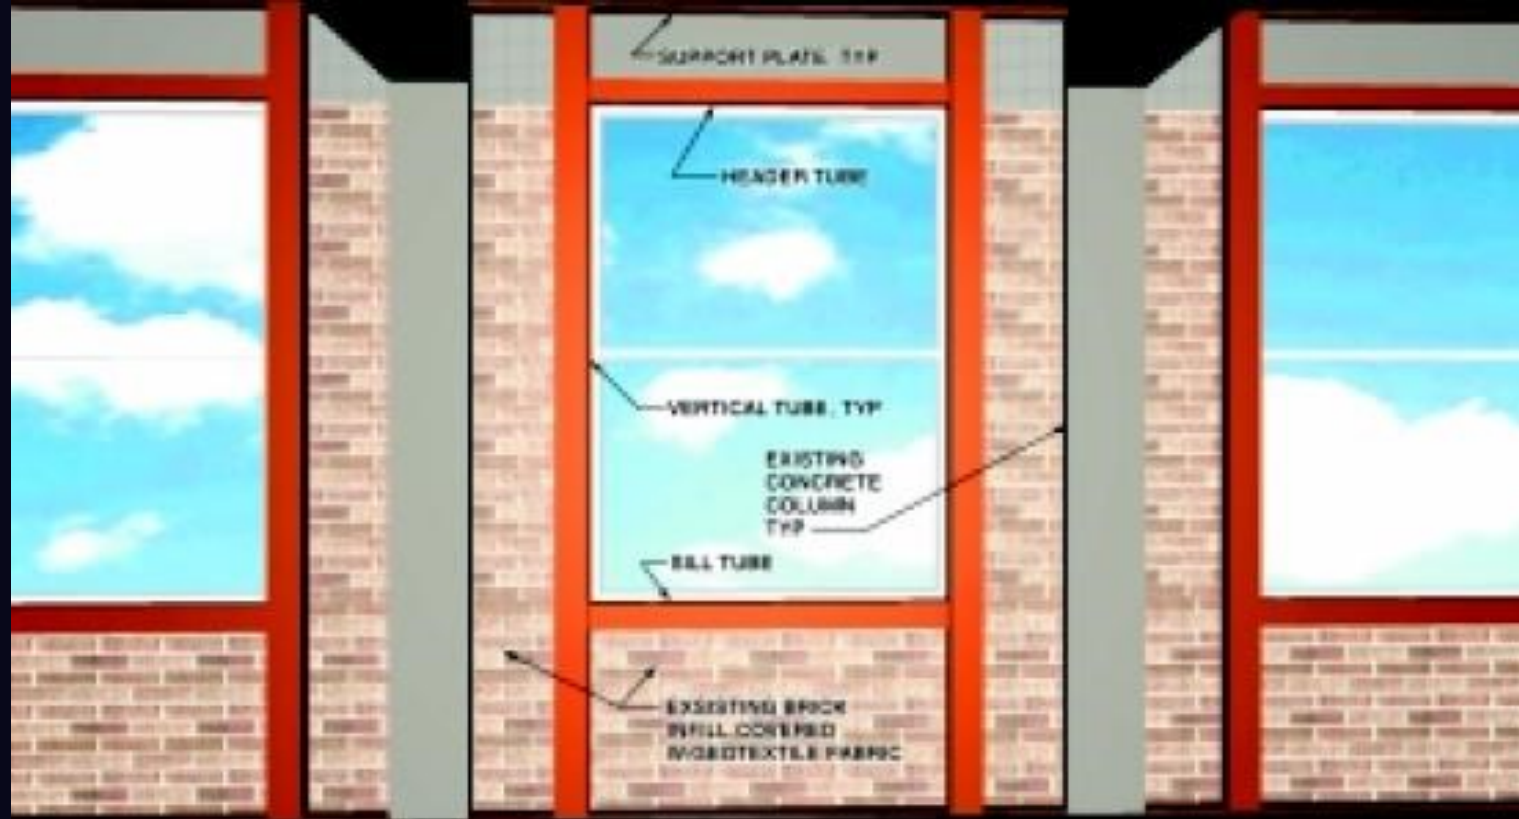
Wedge One's outer wall reconstructed with blast resistant windows to withstand a terrorist attack specifically from bomb blasts and high-force lateral impacts

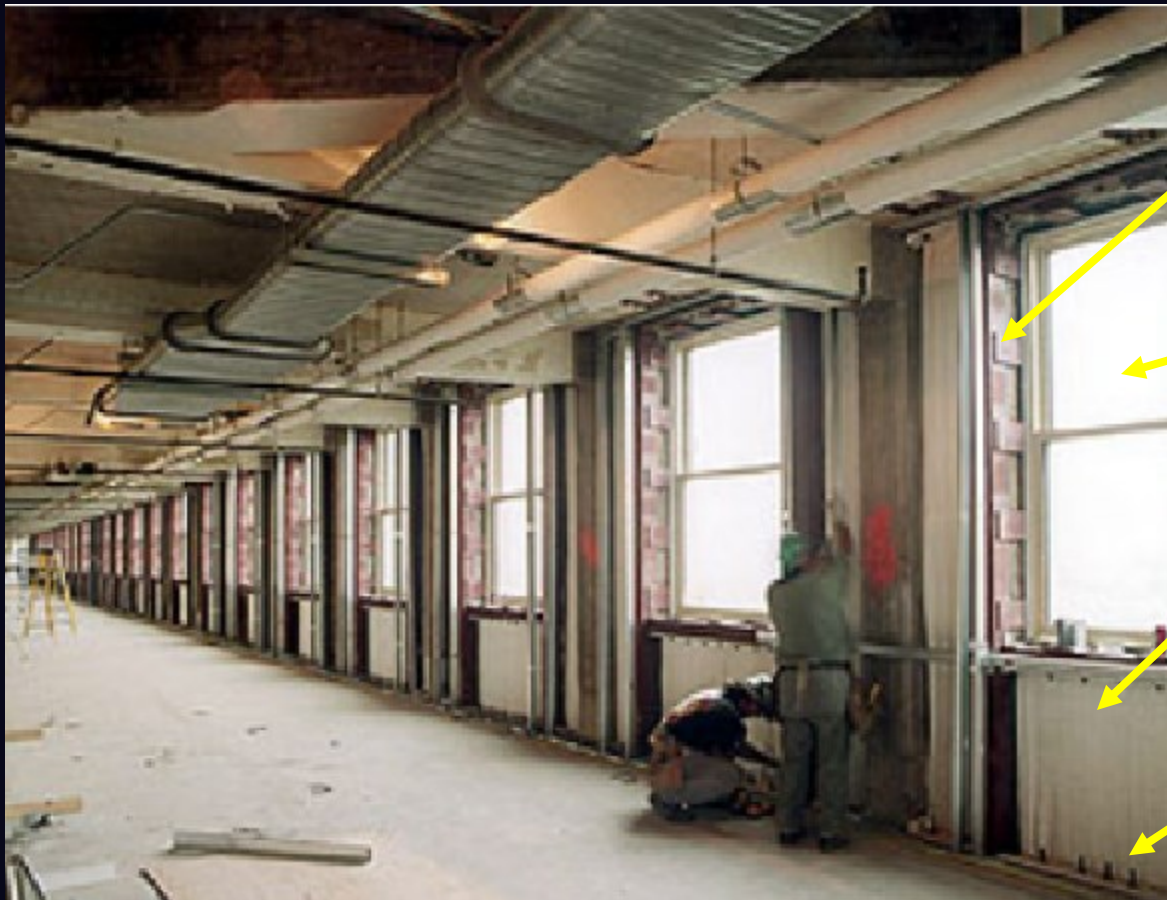
Window frame supports

Blast resistant windows

Kevlar for safety from blast related shrapnel

Bolted connections to floor via steel rail

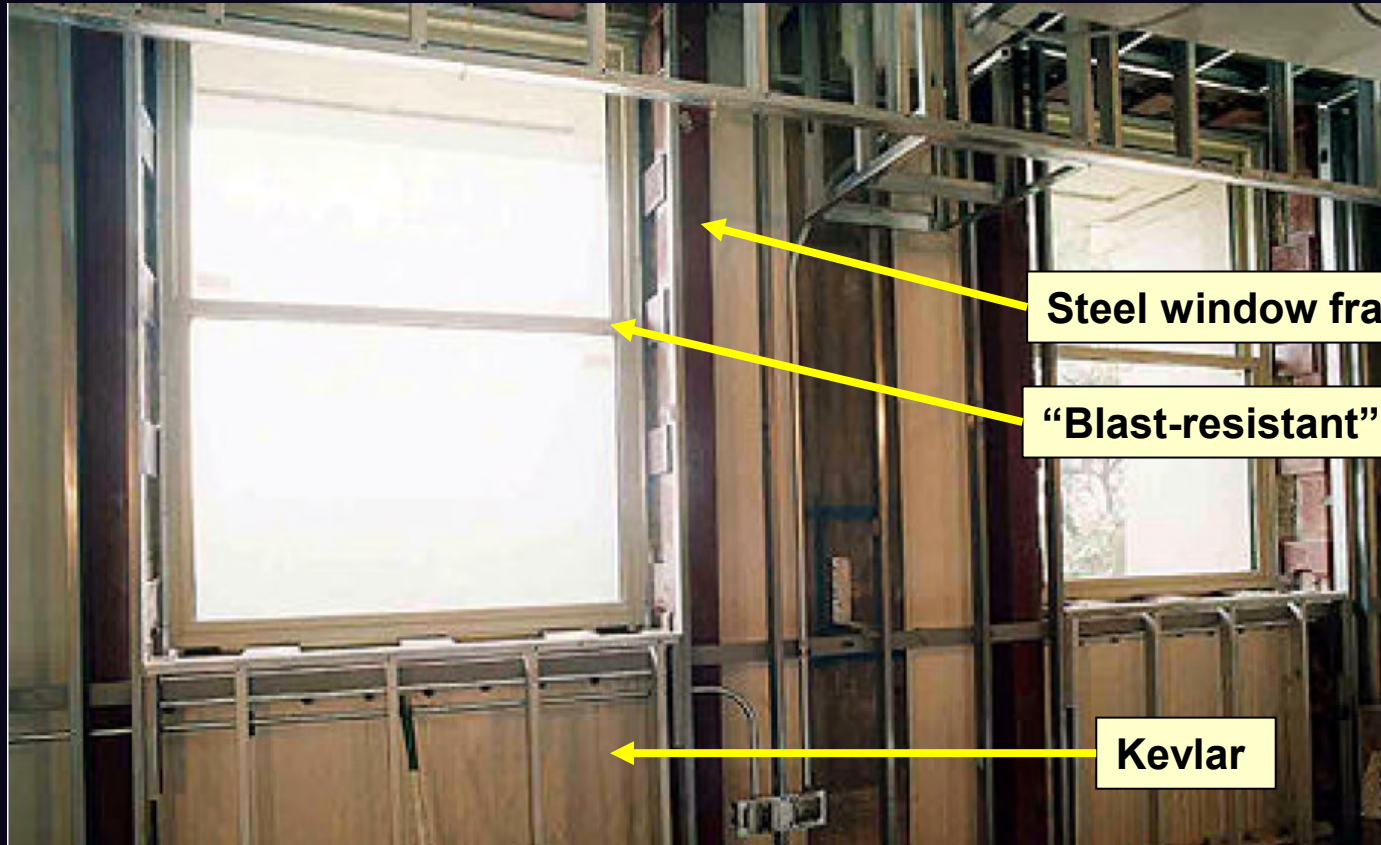
Steel window frame

“Blast-resistant” window

Kevlar

“Structural steel, running through all five floors, strengthens the walls around the blast resistant window units. A geo-technical mesh is stretched between the steel tubes to prevent debris from becoming shrapnel in the event of an external explosion.”

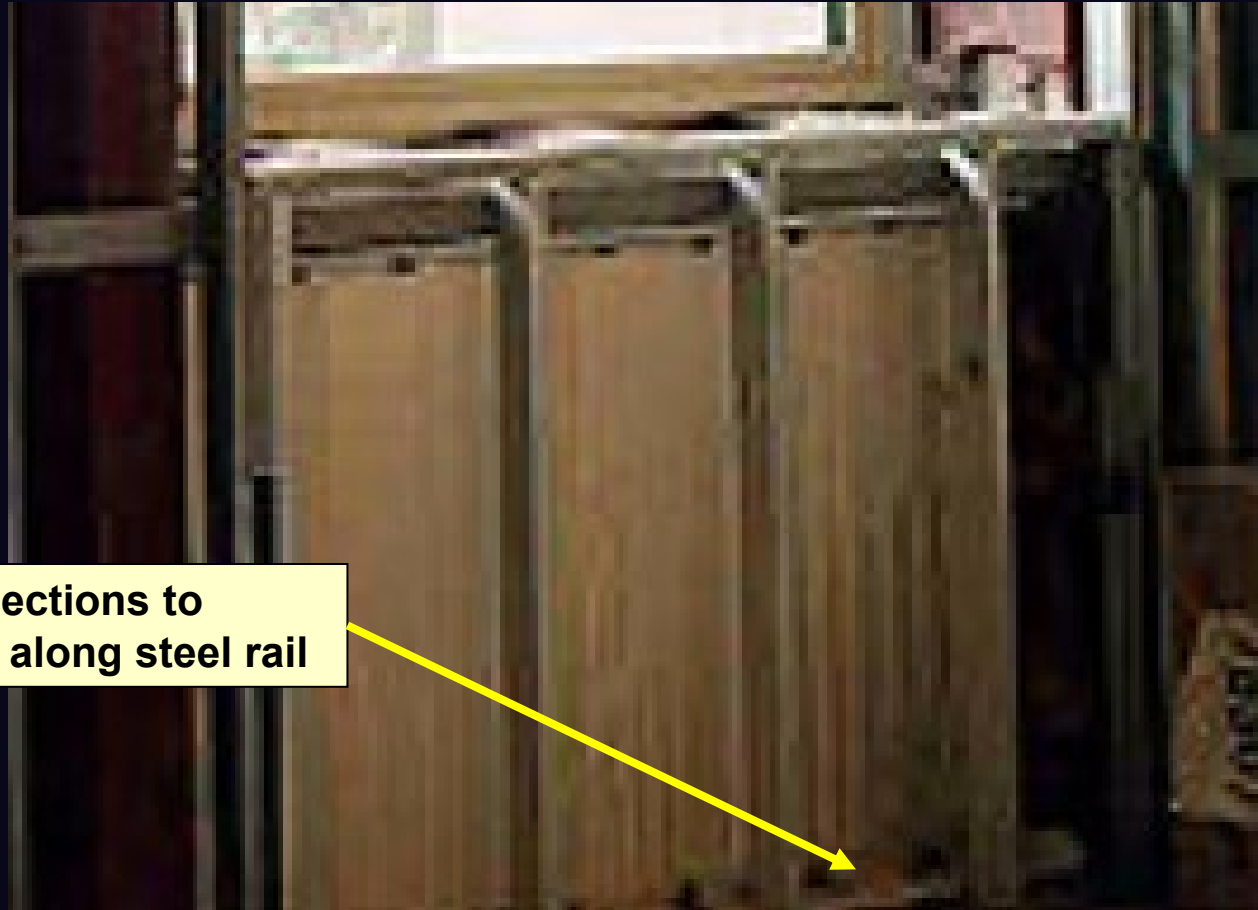
Bolted connections to  
floor/ceiling along steel rail

... The answer was to weld the tubes **to long, narrow plates running along the floor and ceiling. These plates connect to their counterparts on floors above and below with through-bolts**, using 3/4"-diameter A36 threaded rods. To maintain good connection to the slab for constructibility and to compensate for variations in tube length, the vertical tubes are also welded to opposed double gusset plates, which in turn are welded to the floor/ceiling plates. This solution connects the window frames from floor to floor. This design directs dynamic horizontal blast forces through the flexible tubes into the floor diaphragms. This approach was uniformly applied to the window panels on the second, third and fourth floors.

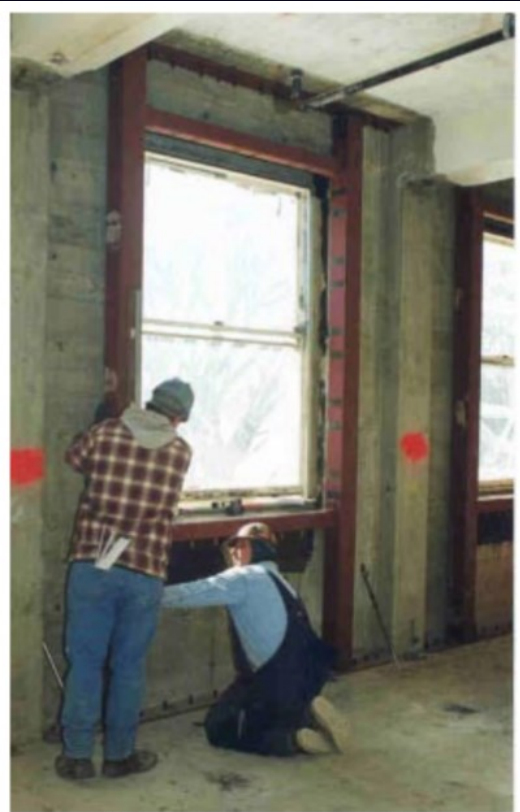
Workers in Wedge 1 install framework that will strengthen the walls around new blast-resistant windows.

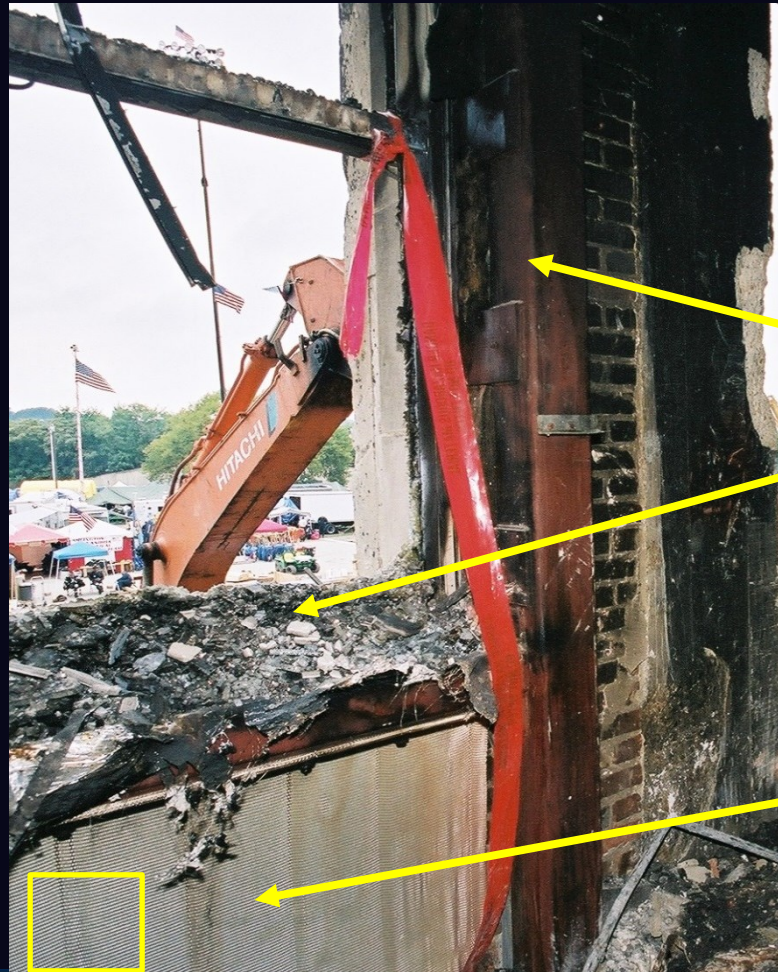
Steel window frame

“Blast-resistant” window melted

Kevlar

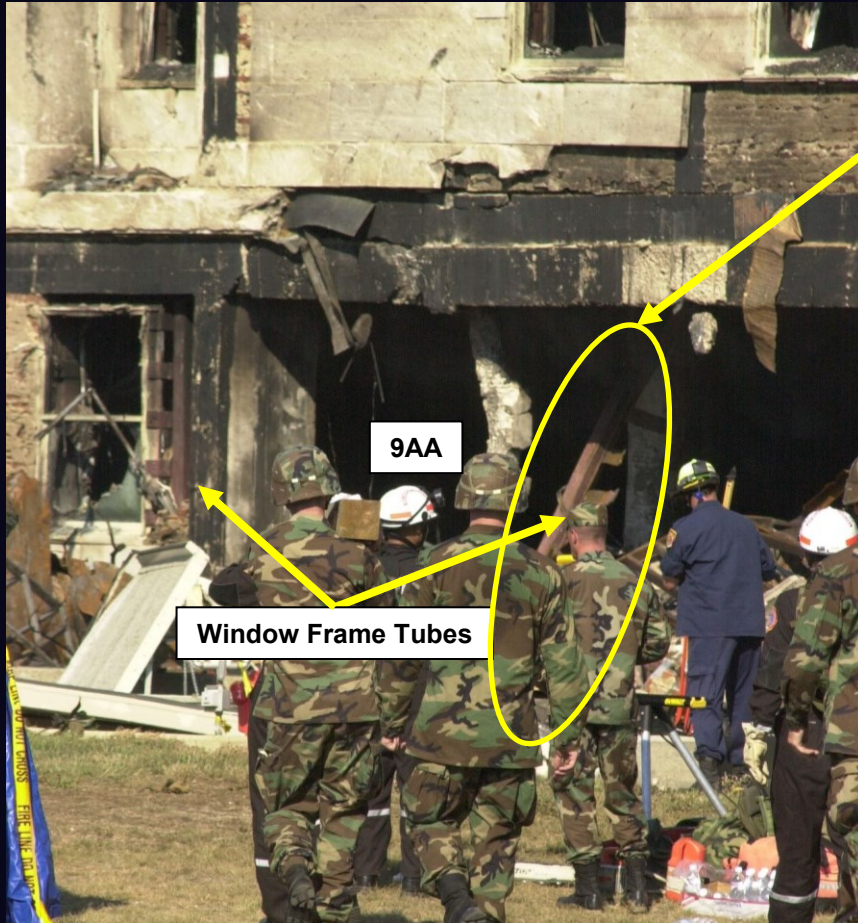
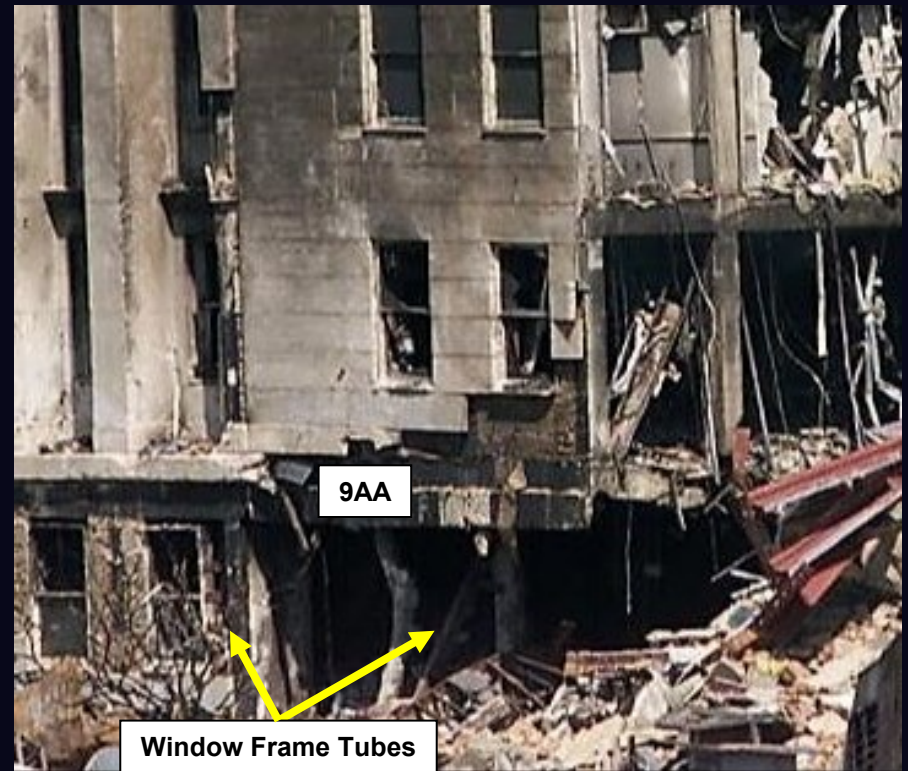
# Views of the North End Showing Column 9AA Window Frame Tube

Steel window frame tube bent inward

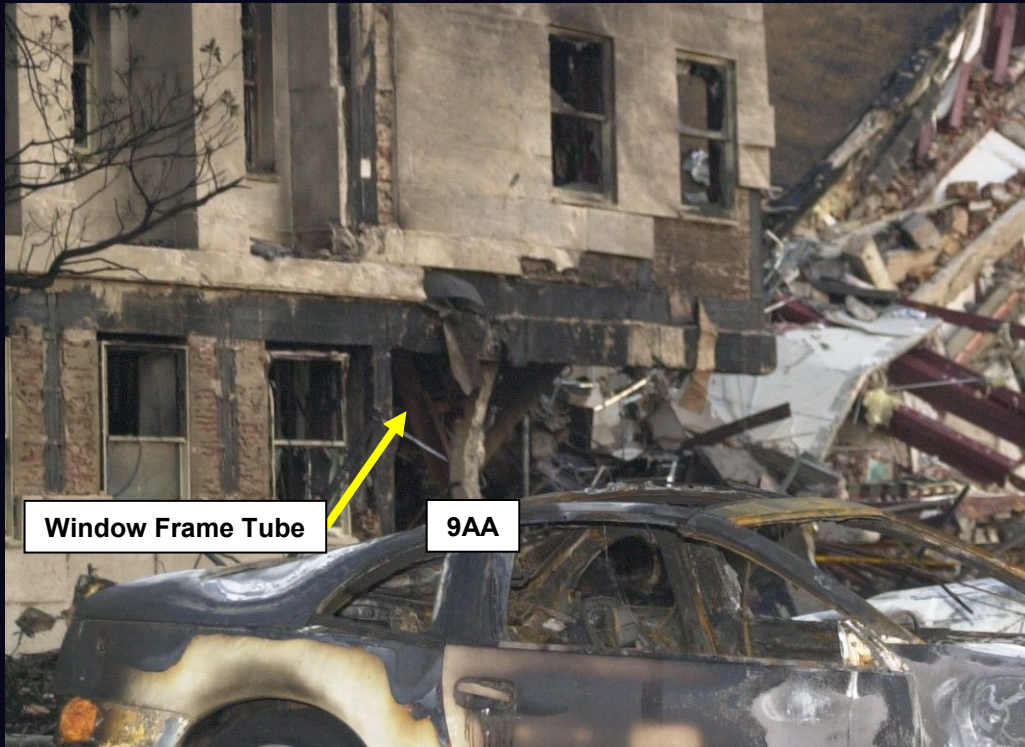
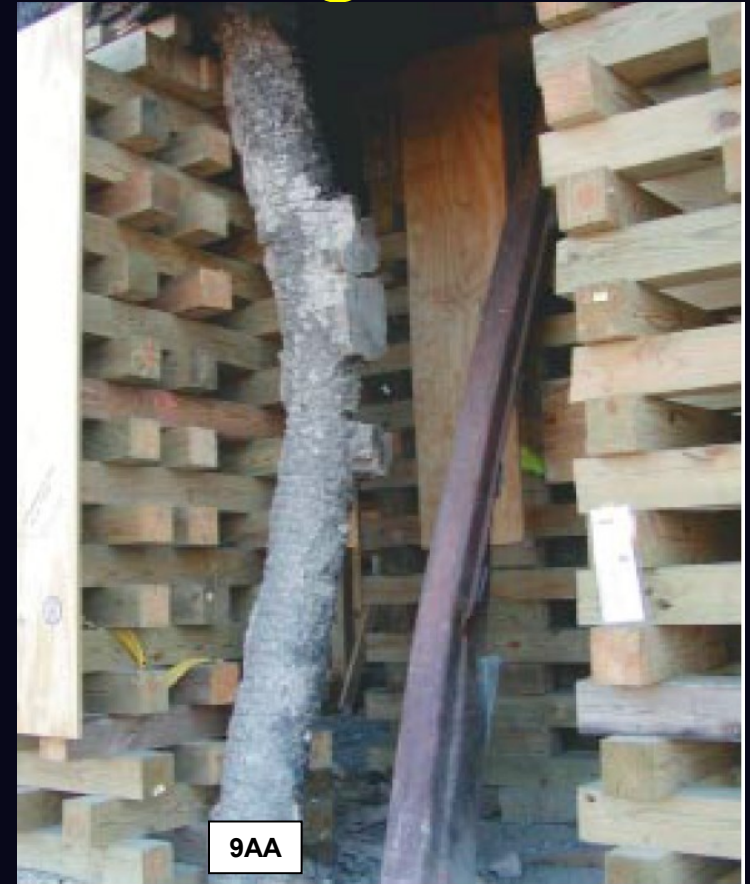
# Column 9AA and Window Frame Tube to its Right

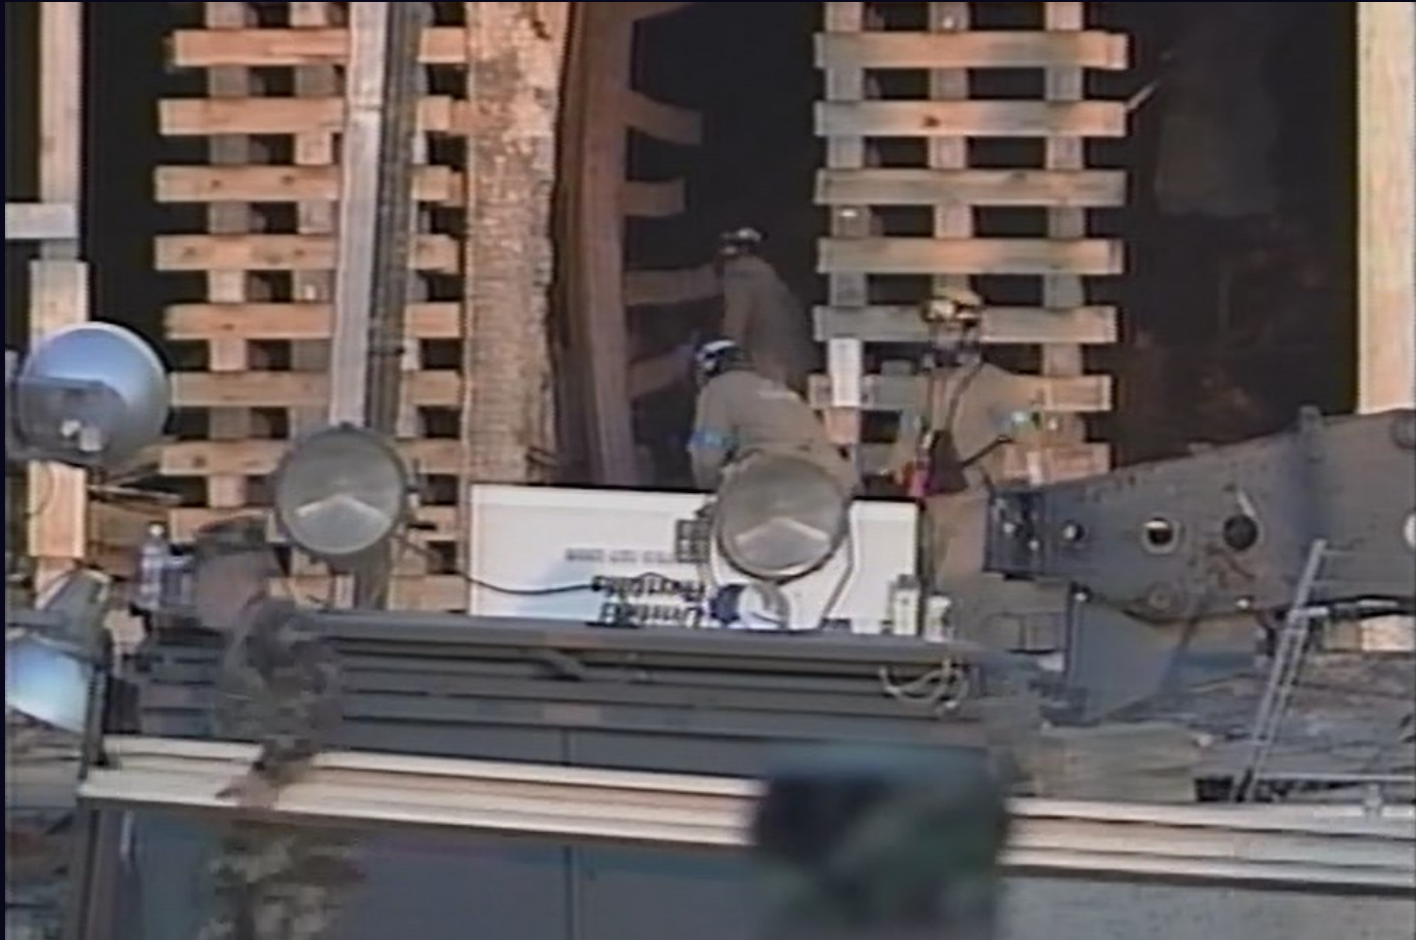
# Column 9AA and Adjacent Steel Window Frame Tube

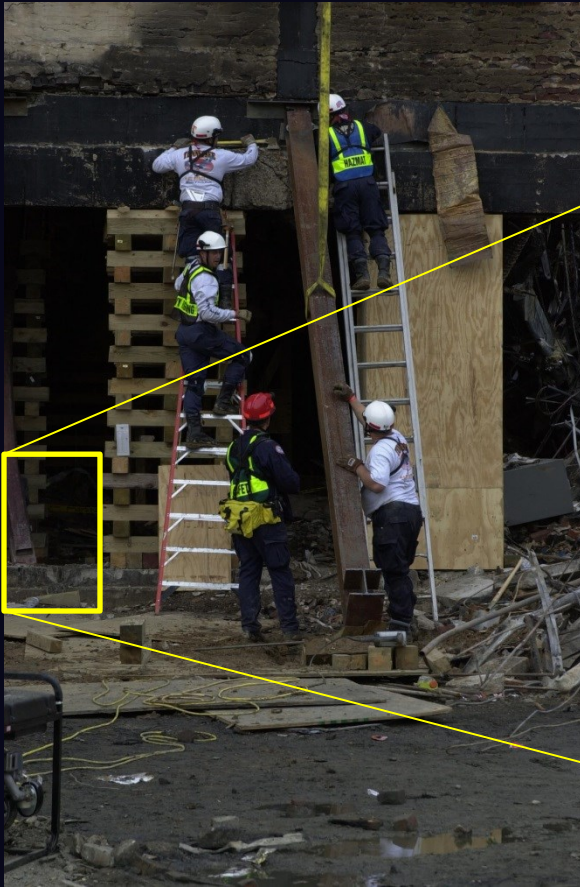
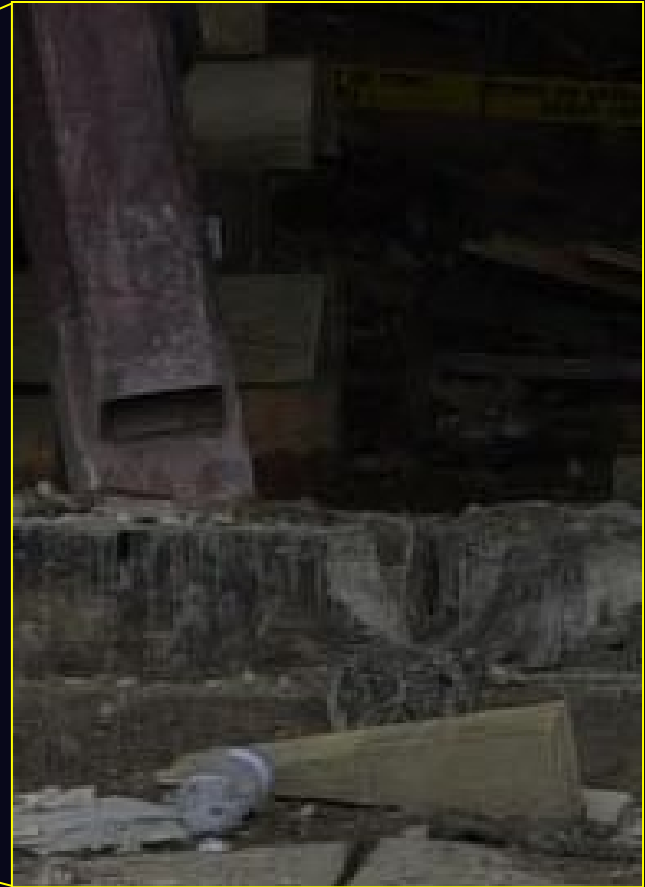
# Window Frame Connected to Ground Slab is as Described

... Because the first floor is slab on grade, connecting the tubes to the floor slab by through-bolting would not work. And since anchor bolts could not take the calculated tensile and shear forces, a different approach was required. **A core-drilled hole in the slab on grade accommodates the tube bottom so the tube will bear horizontally against the floor through a bearing plate.** After inserting the greased end of the tubes, the holes are grouted to create a bearing surface and protect the capped tubes' ends from soil moisture corrosion.

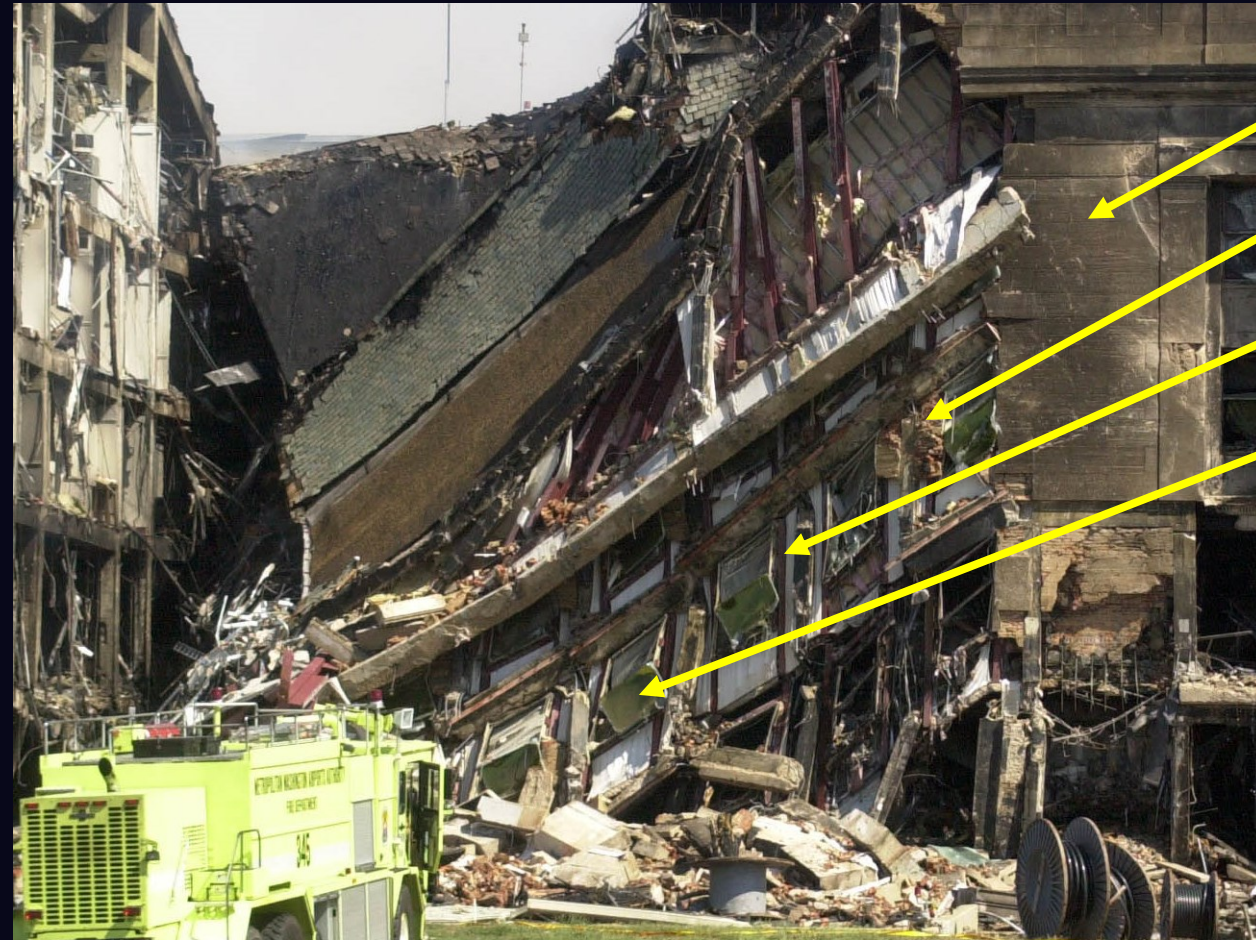
Limestone facing

Brick under limestone

Steel window frame

“Blast-resistant” window

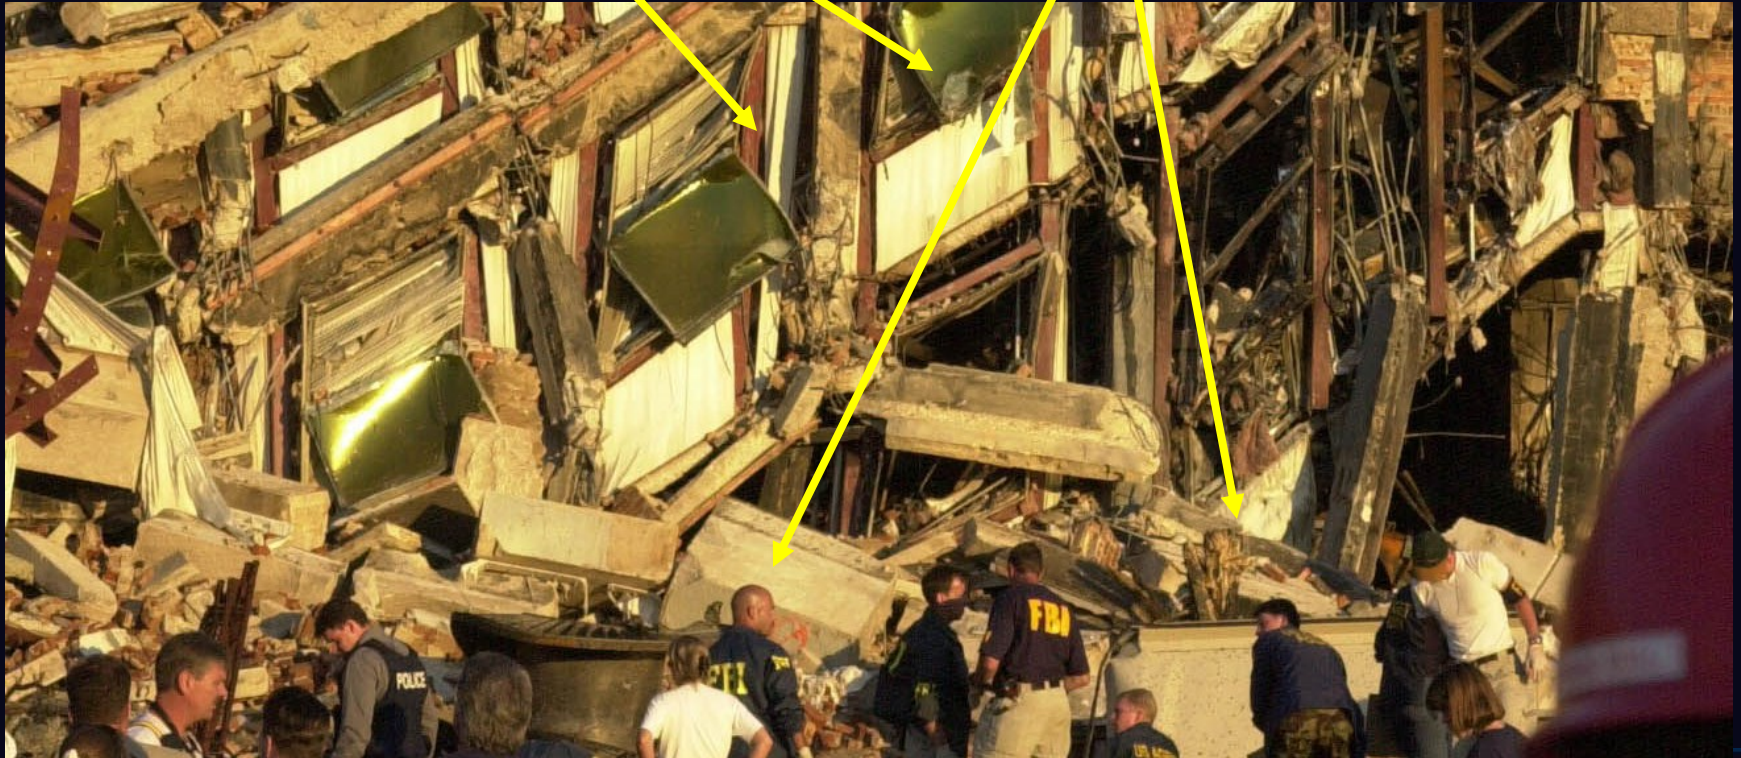
Blast-resistant windows

Steel window frames

wall blocks (Limestone?)

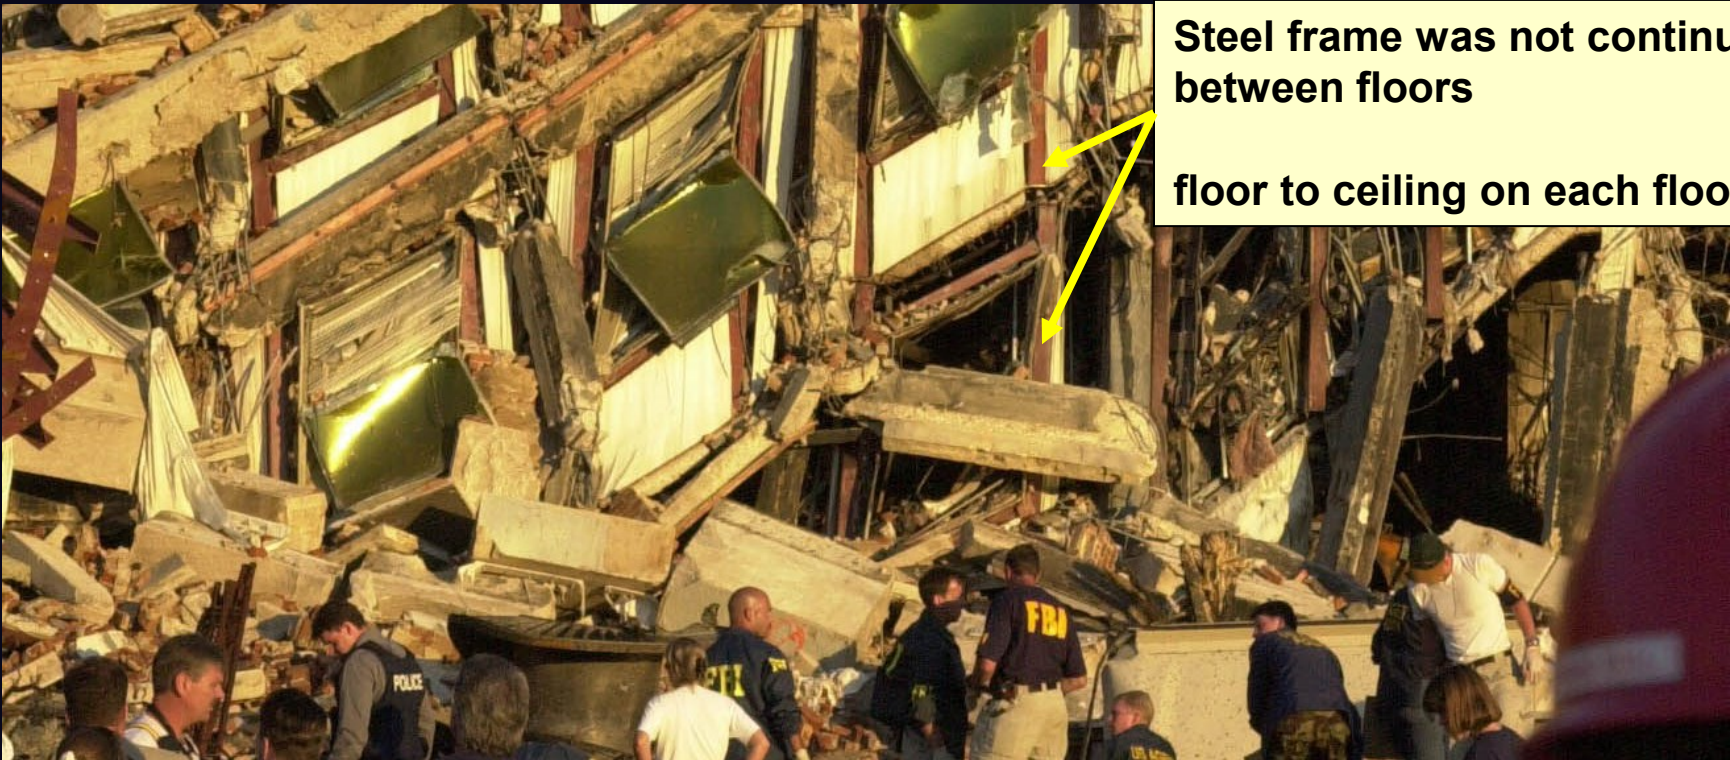
Steel frame was not continuous  
between floors

floor to ceiling on each floor

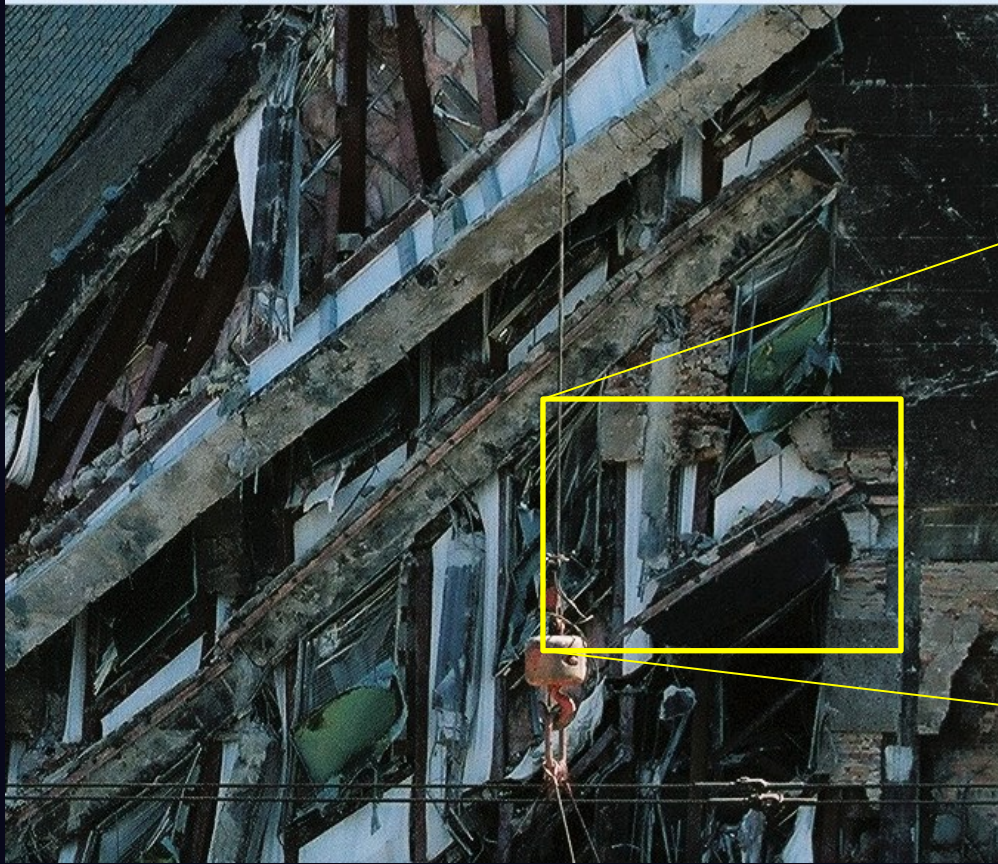
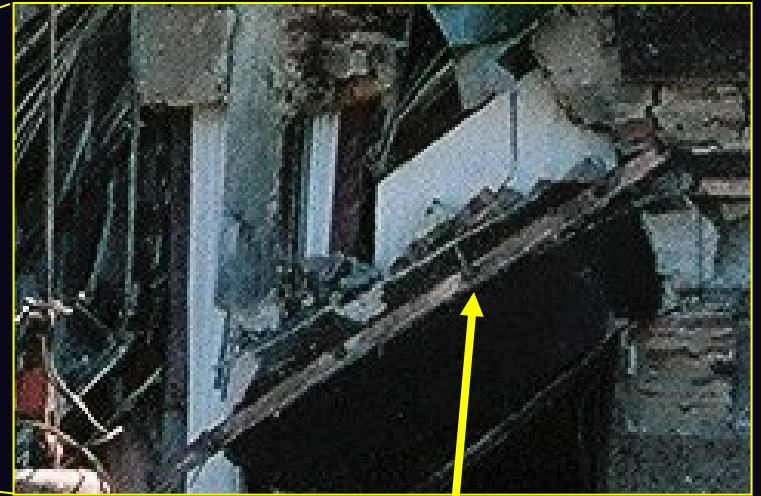
# Header that Window Frame was Bolted to is Visible

Through-bolt connection

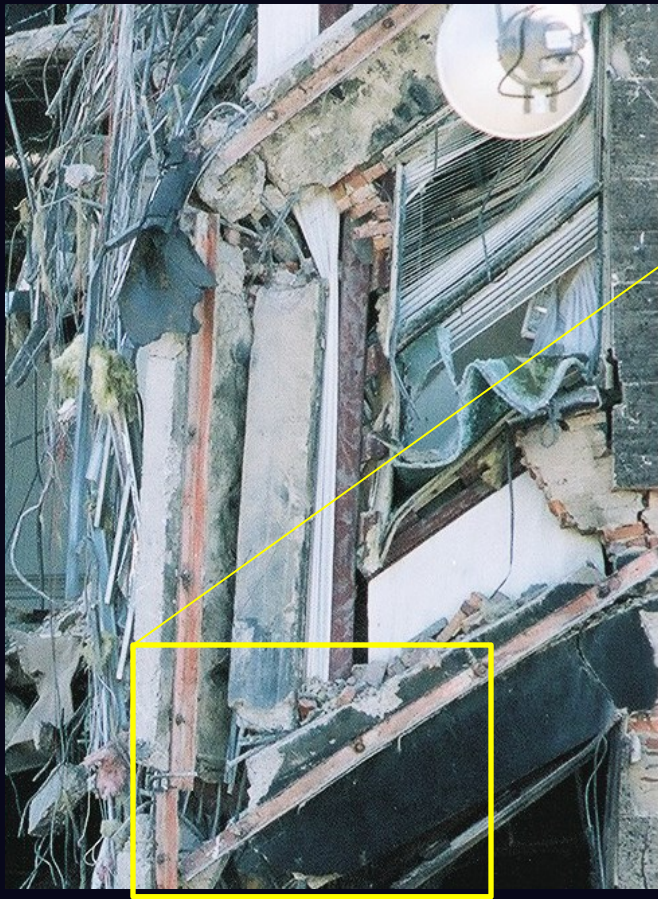
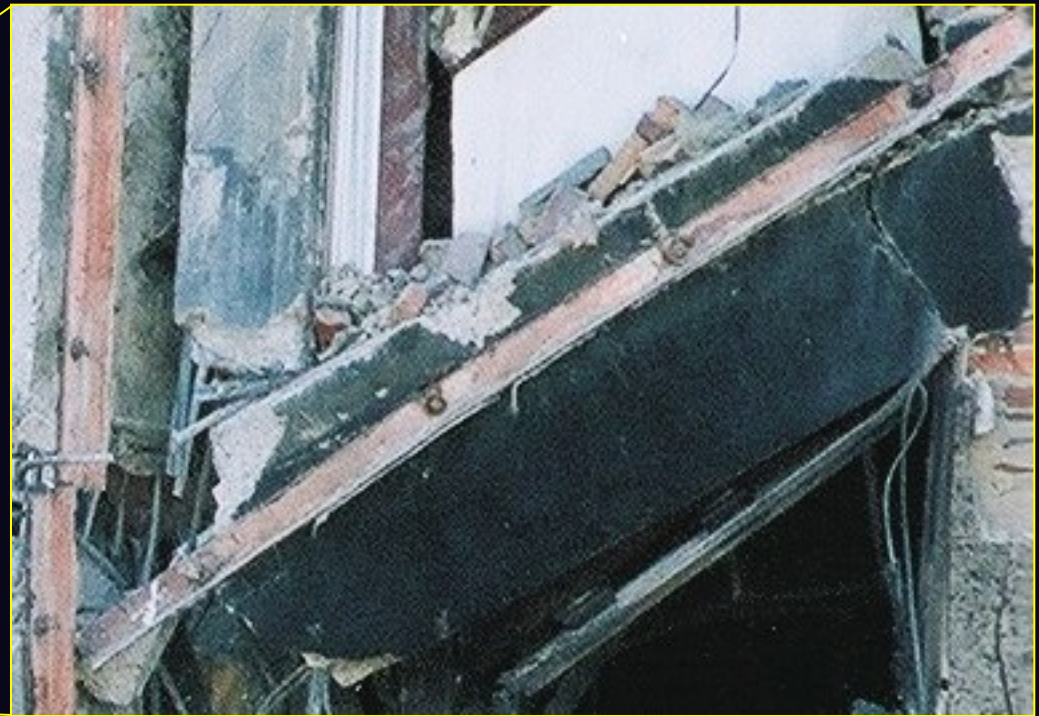
# Rail that Window Frame was Bolted to is Visible
