Size of the Opening in the Pentagon on 9/11

Prepared for the August 31, 2016
9/11 and Other Deep State Crimes Teleconference

Wayne H. Coste, PE
Truth Outreach, Inc.

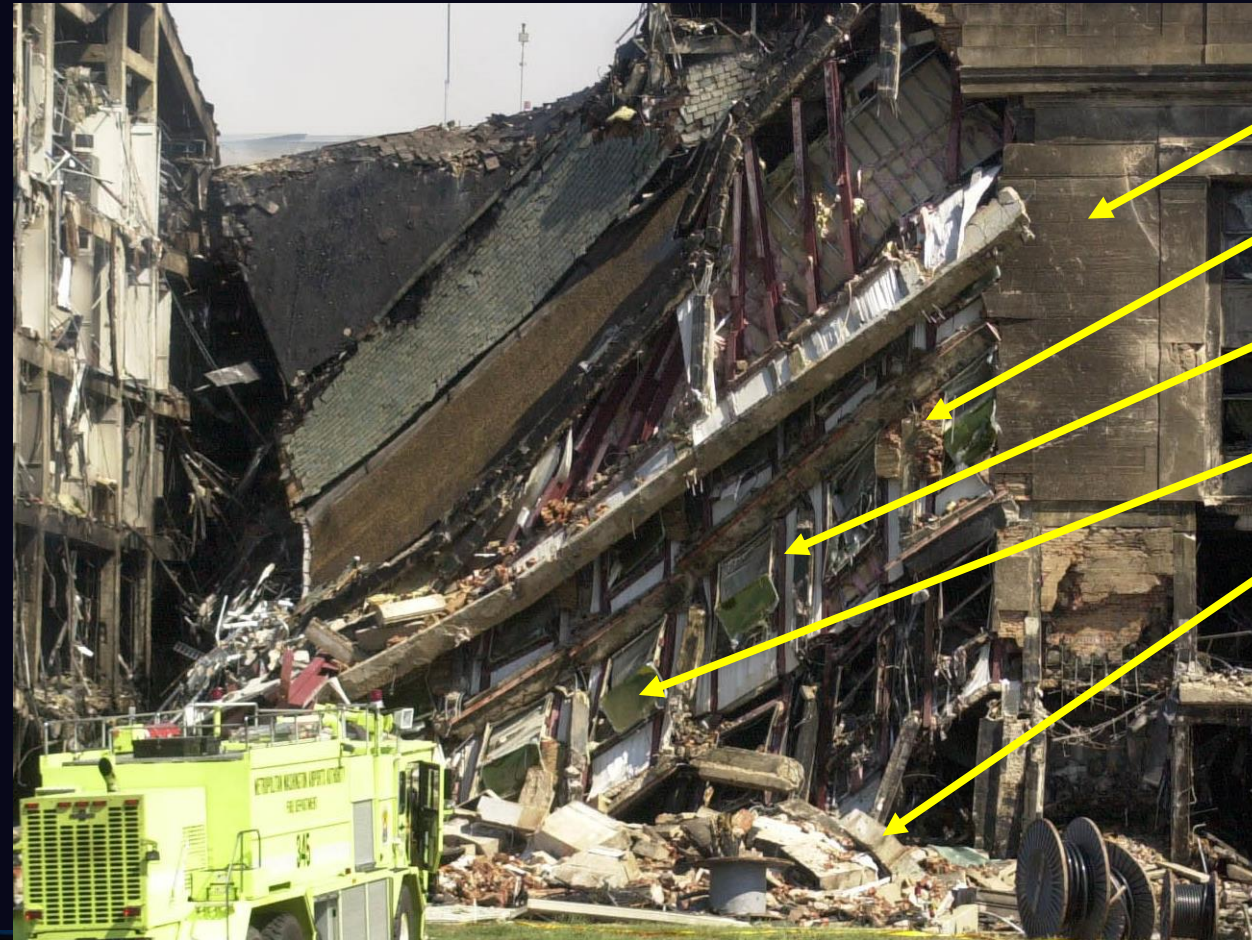
“Jenga Block” Wall Crumbled Exposing All Wall Components

Limestone facing pieces

Brick under limestone

Steel window frame

“Blast-resistant” window

Limestone border pieces

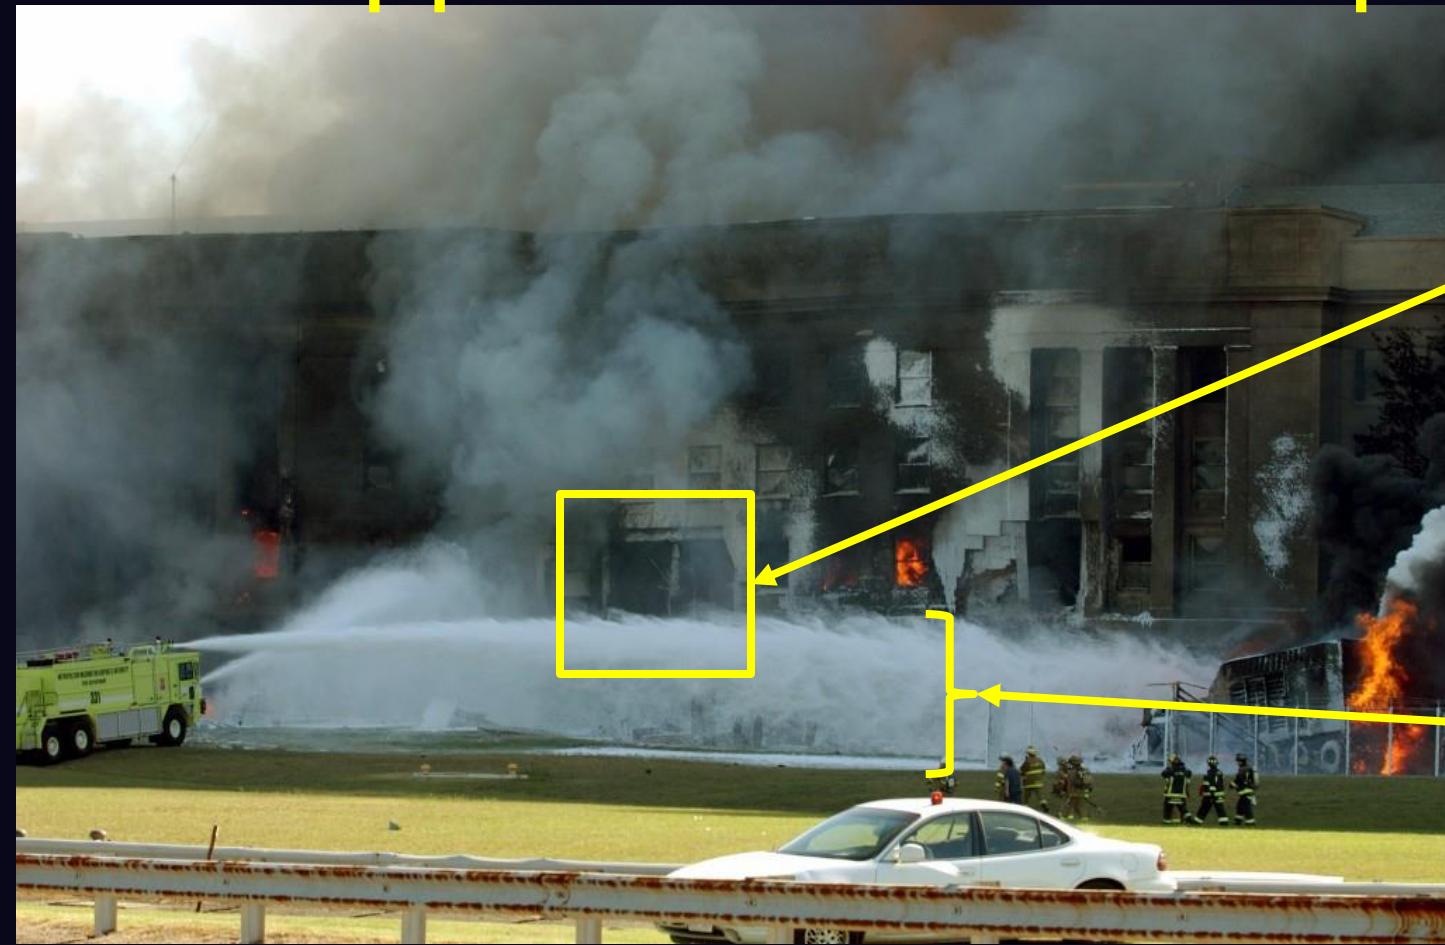
This Photograph is Used to Support an 18 Foot Opening

18 foot opening in second floor wall frequently asserted to be the largest opening in the wall.

Opening in first floor is not visible due to firefighting spray.

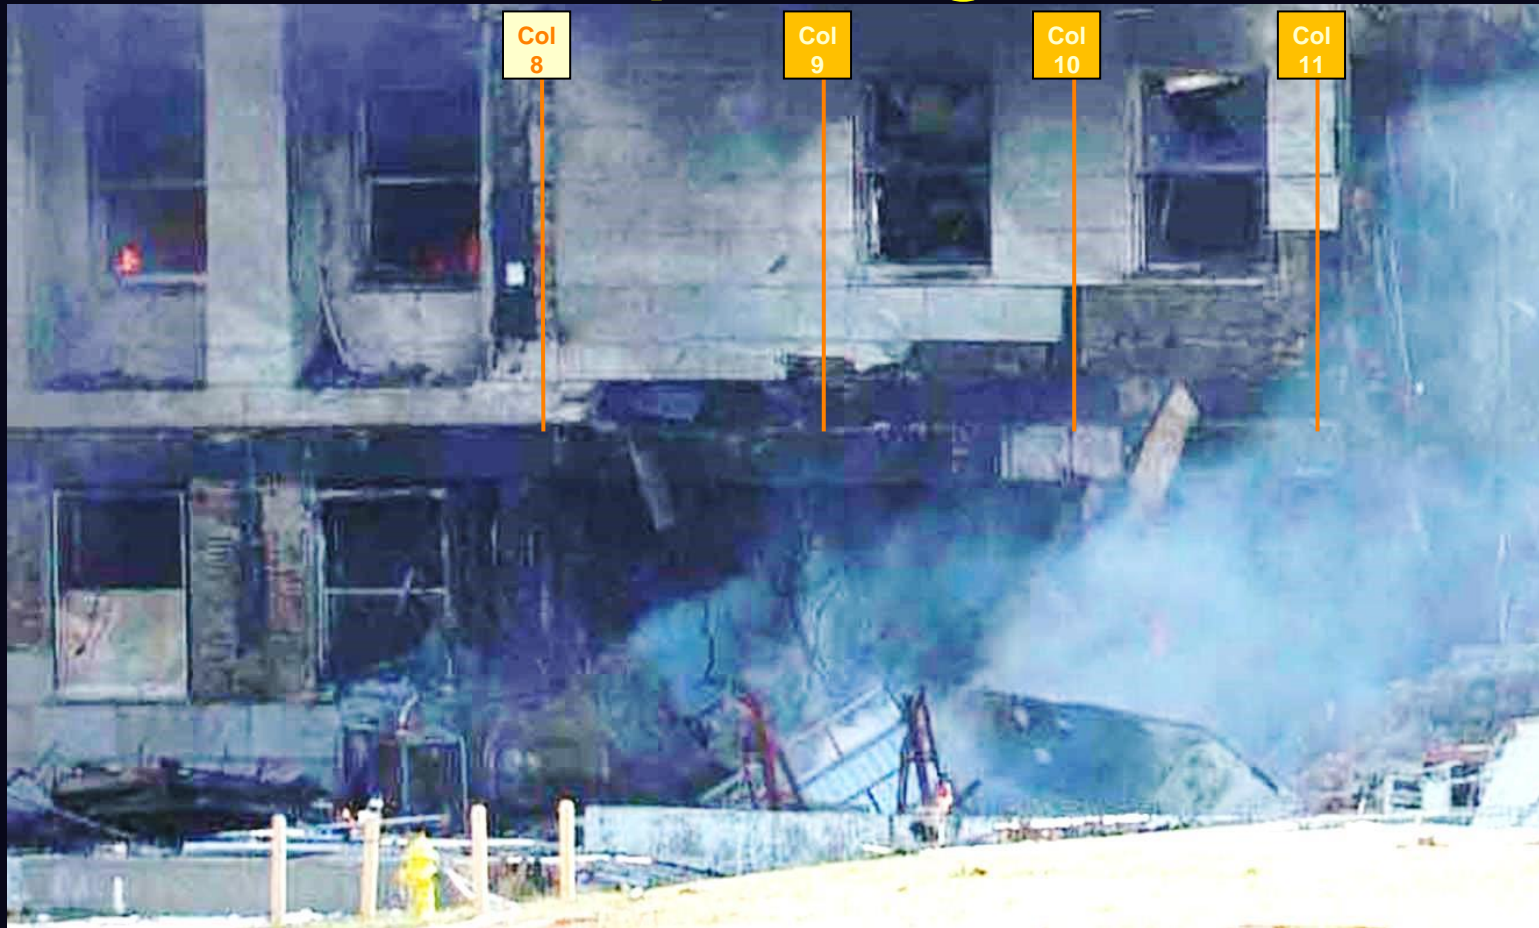
Close-up of North End of Opening

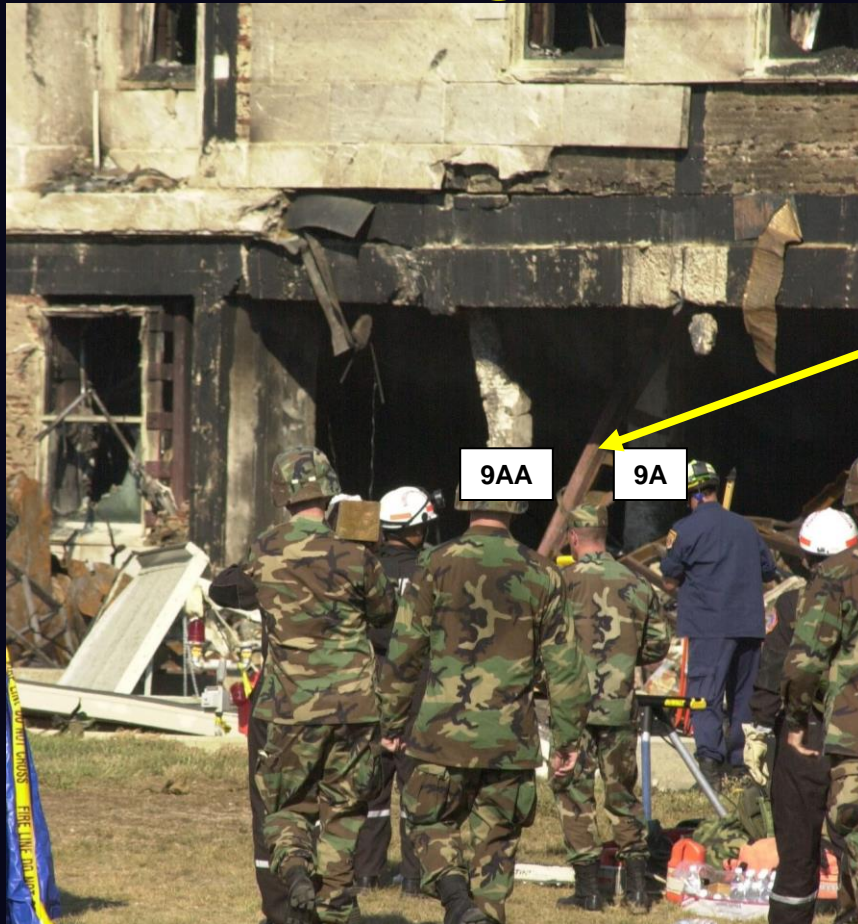
Other Views of the North End Showing Columns 9AA and “?”

Window Frame Support

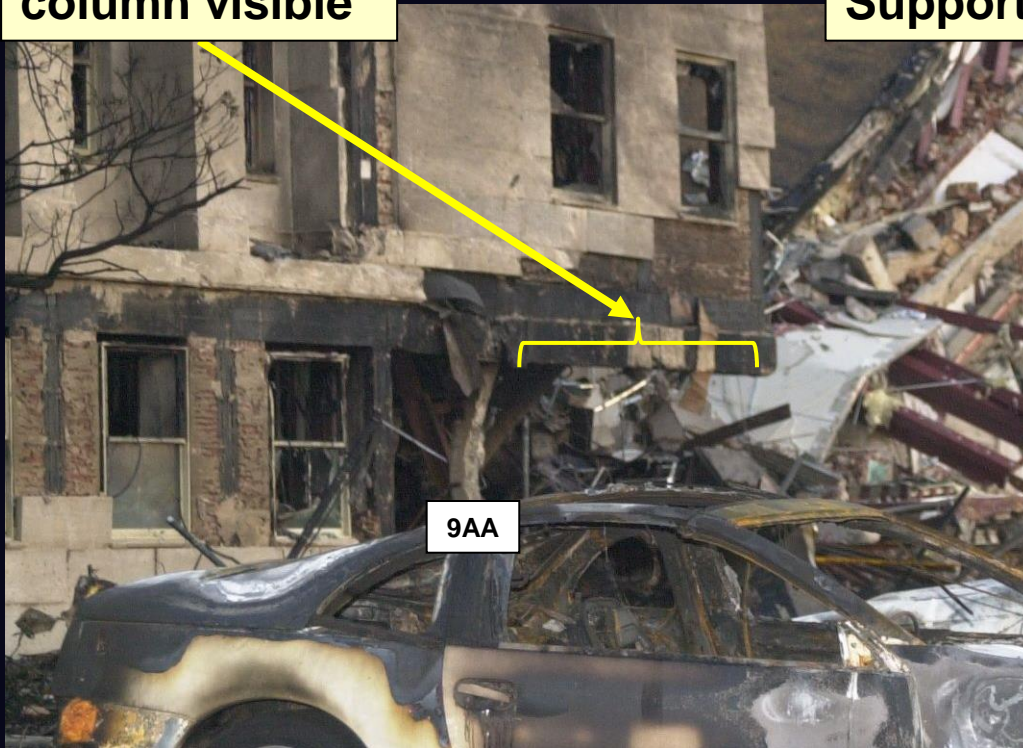
ASCE Pentagon Building Performance Report

Column 9AA and Nothing to its Right

No vertical
column visible

Window Frame
Support

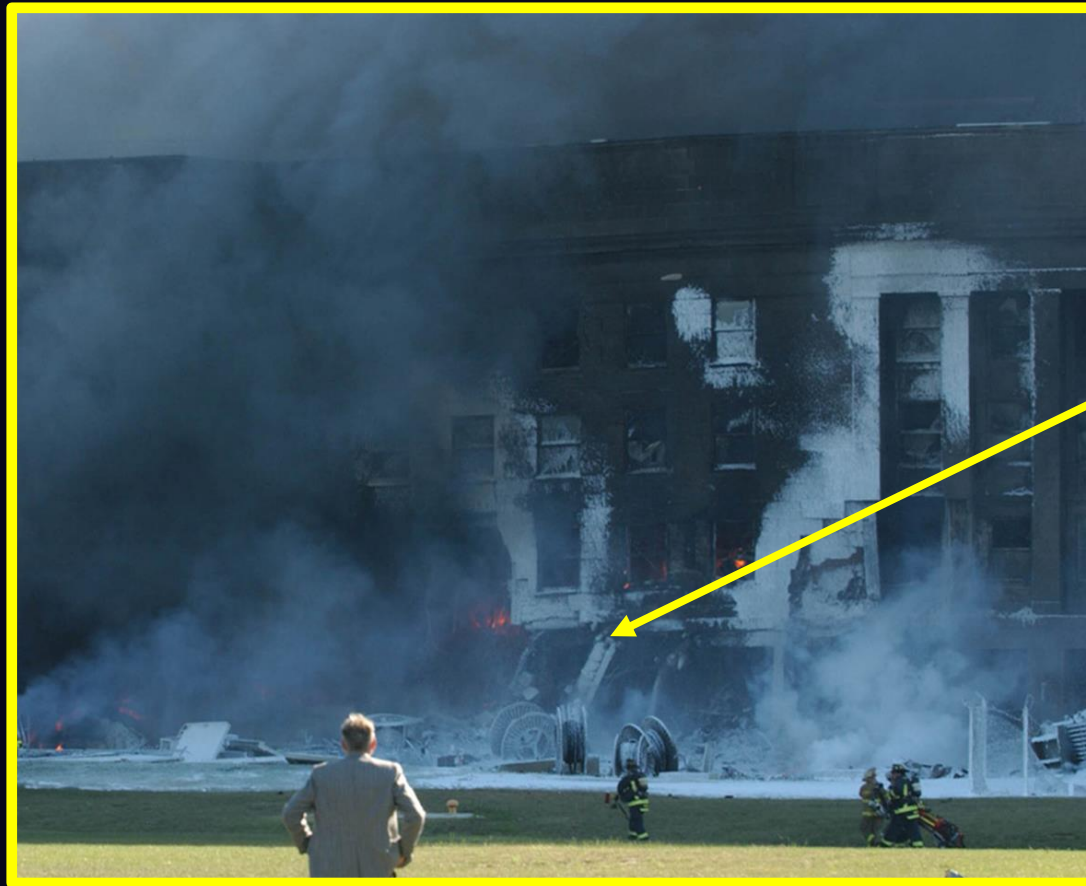
Pre-Collapse Image #1 (from right)

**Column 16
Hanging**

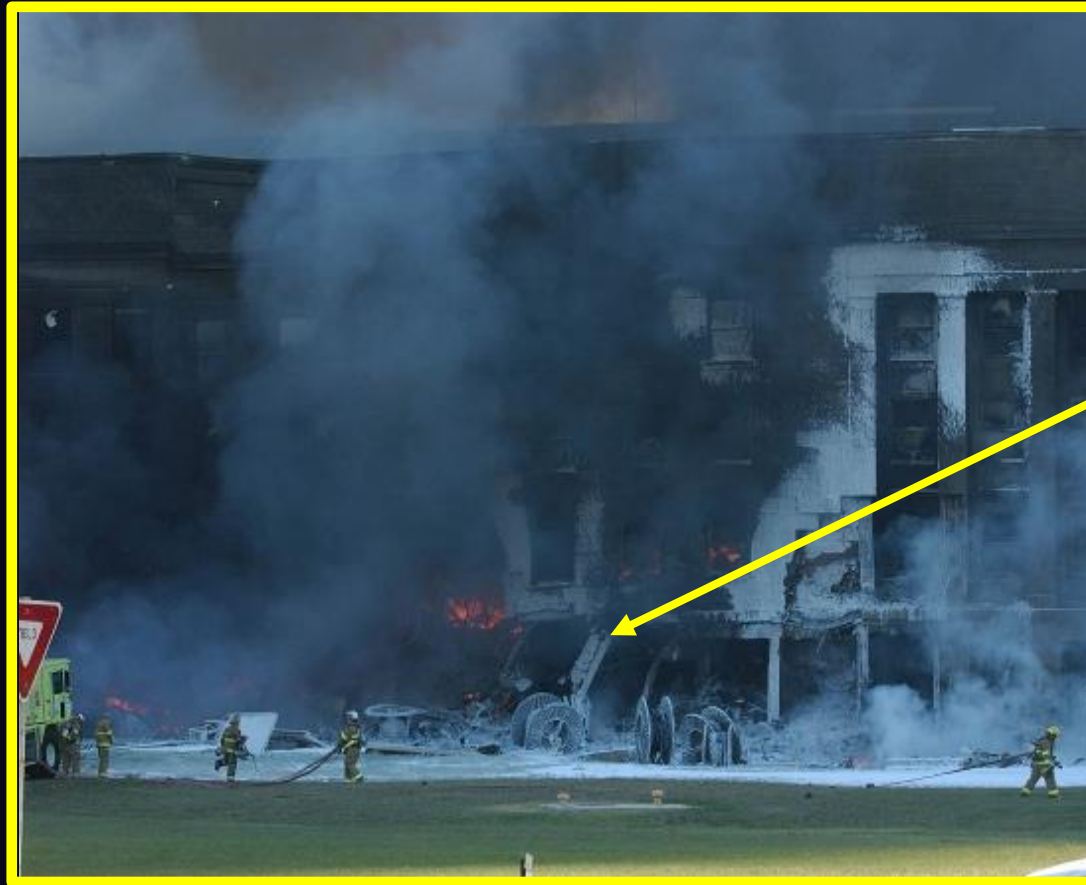
Pre-Collapse Image #2 (to left)

**Column 16
Hanging**

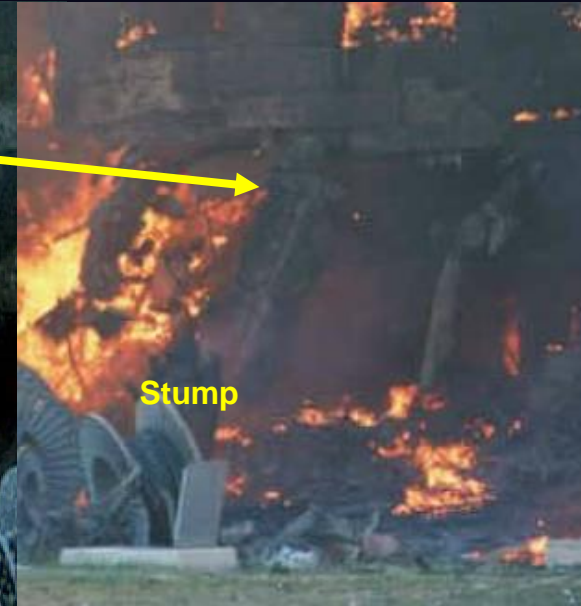
Col.16 Hanging from Second Floor View from Left and Right

Column16
hanging
from second
floor slab

Stump is
to right

View from left

View from center right

View from right

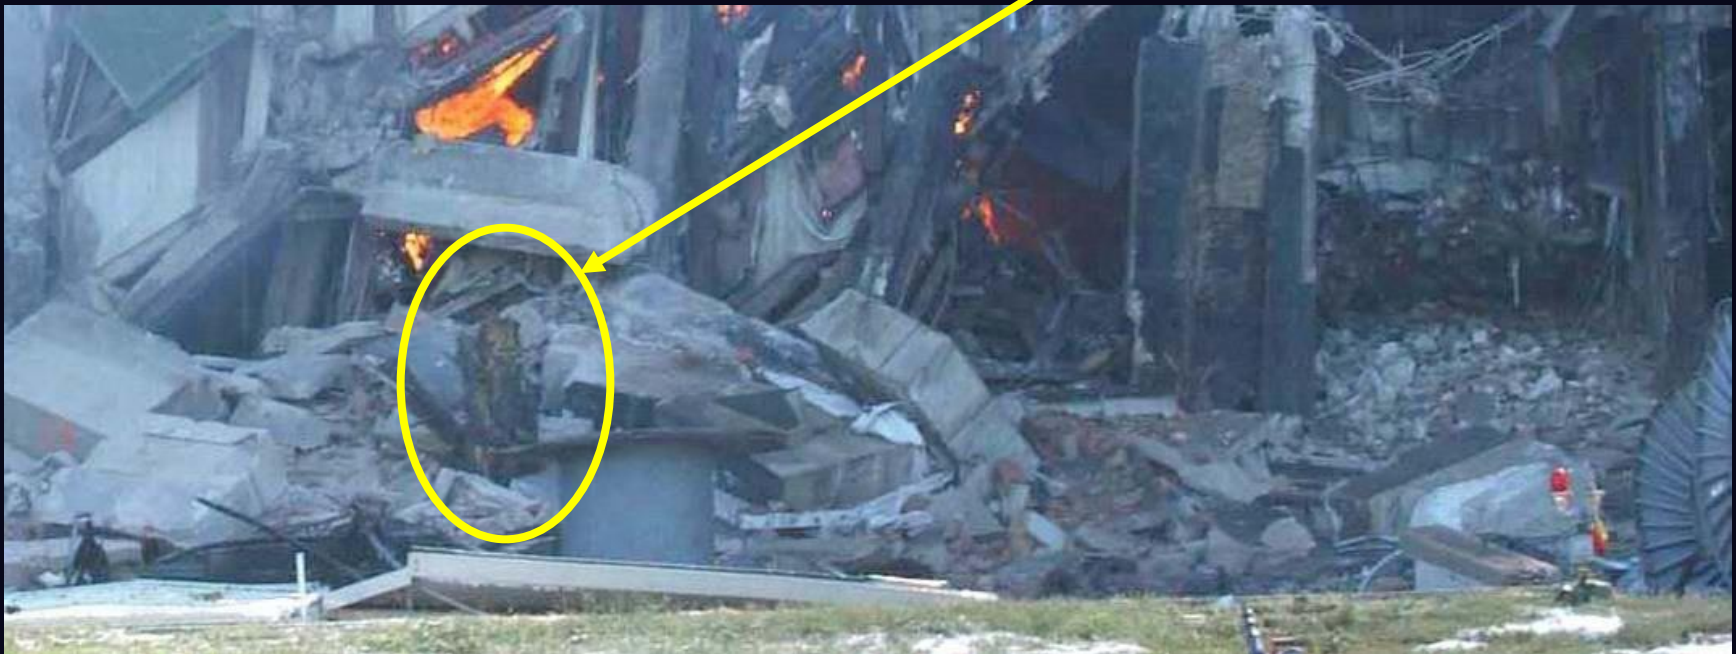
Zoom-In of Post Collapse Image Showing Tree Stump

Photo taken looking directly east

Splintered
Tree Stump

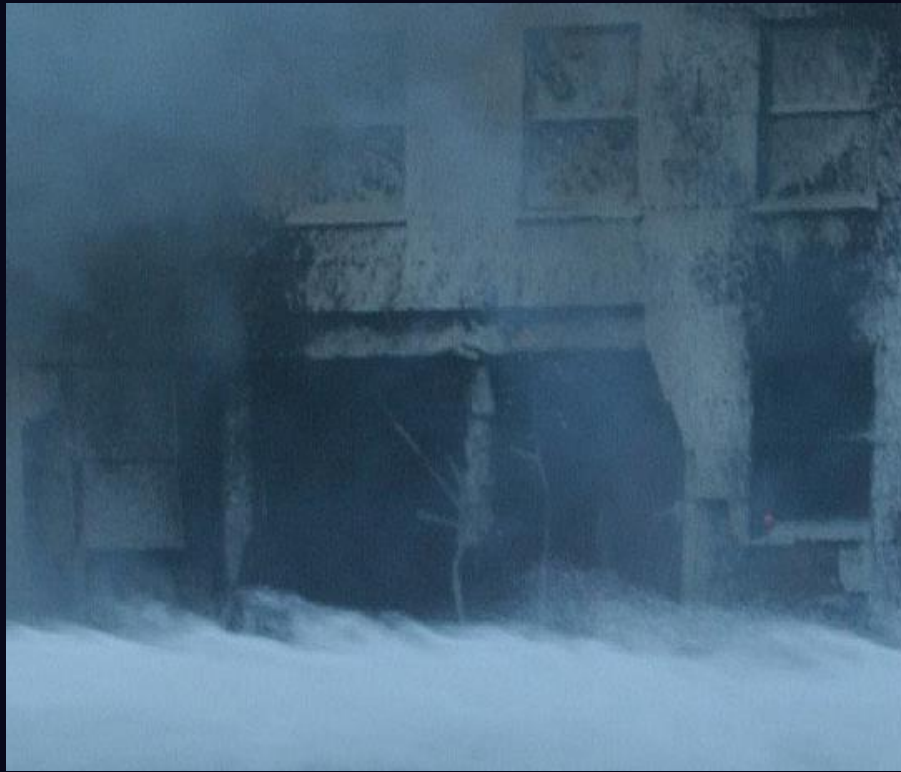
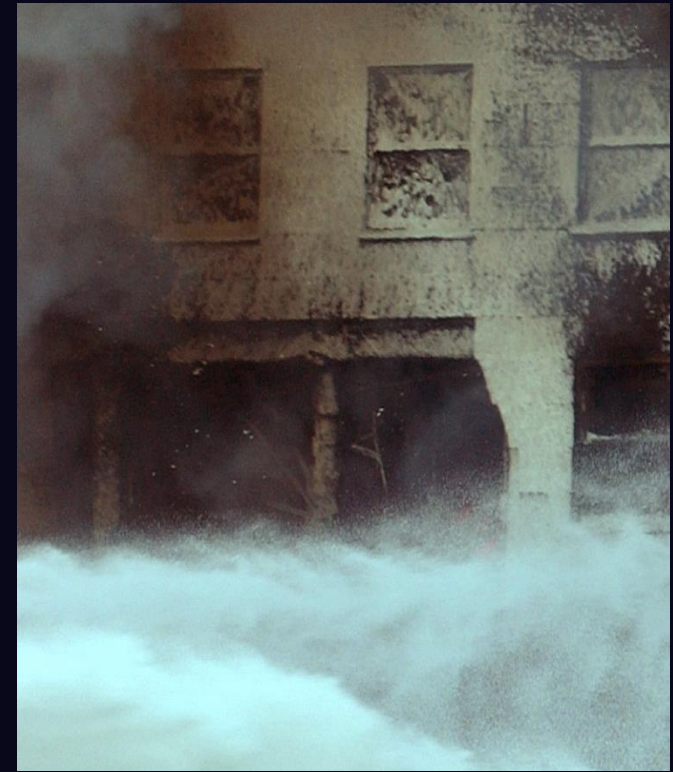
Opening in Second Floor Appears Like Sheet of Wall Fell

Clean break at the top and along sides suggest that the façade may have fractured and fallen away. Photos of debris removal could provide insights.
